**LYONS CMC
COAL MINING & GEOTECHNICAL
CONSULTANCY**

**COAL MINING RISK ASSESSMENT (CMRA)- FOR PROPOSED RESIDENTIAL
DEVELOPMENT AT STONEDALE, STATION ROAD, WORSBROUGH, BARNLSLEY S70 4SU**

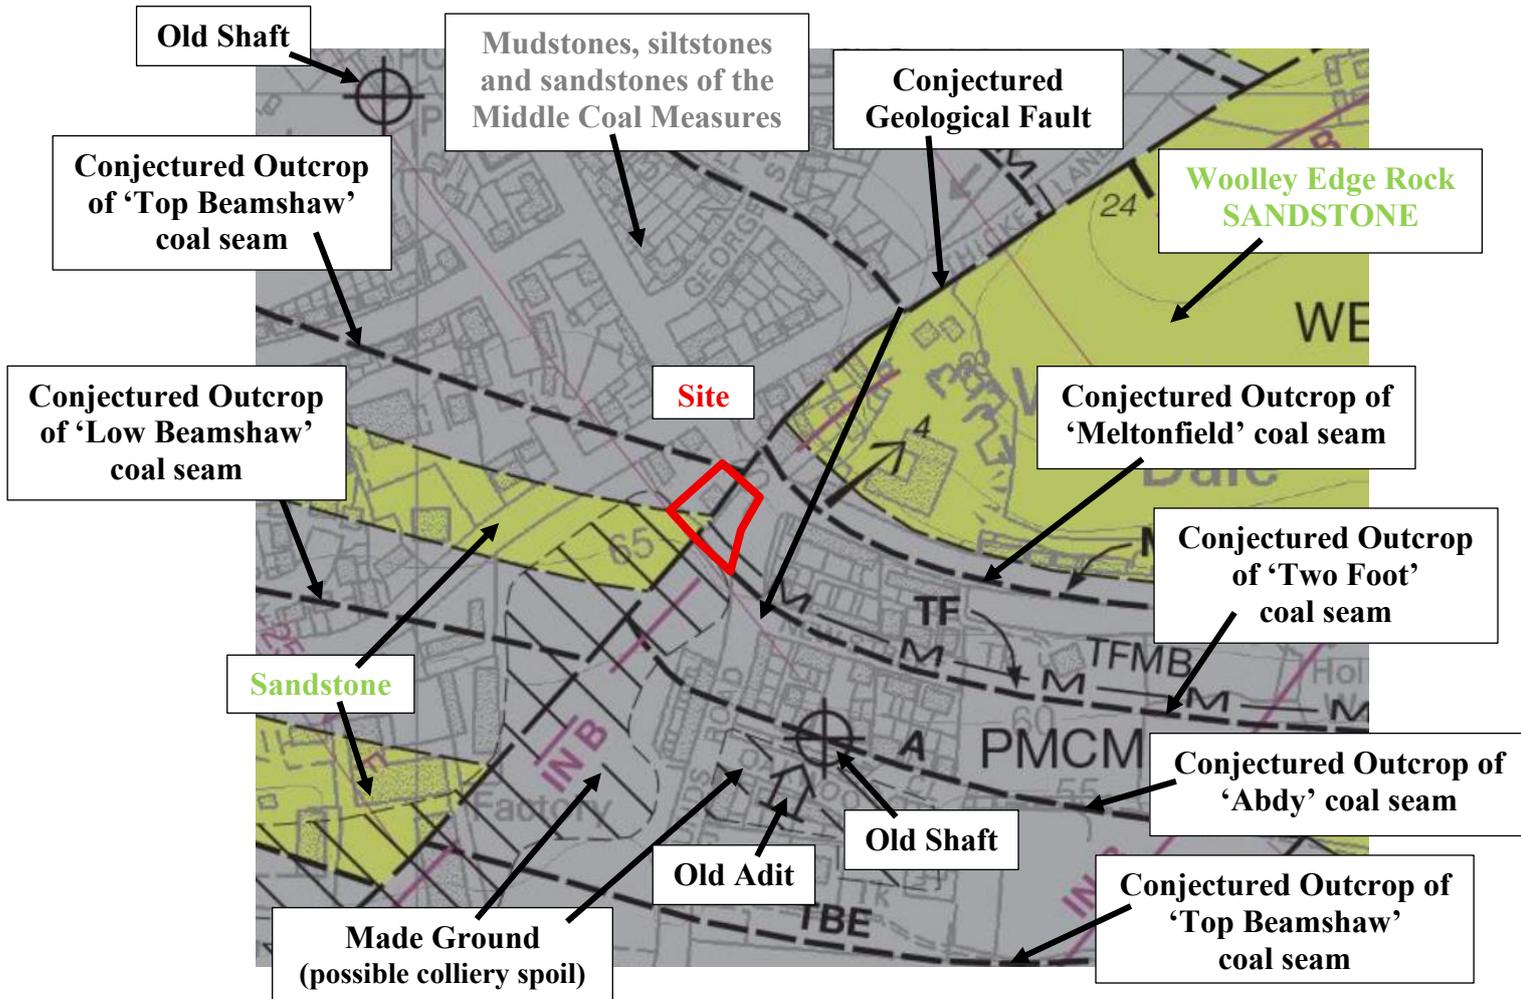
Records indicate the site to be located on mudstones, siltstones and sandstones of the Middle Coal Measure series from the Carboniferous formation. No superficial deposits are indicated in the vicinity of the site itself. The strata is shown to dip to the north-east at a rate of around 1 in 14 (4°) in this vicinity. A summary of the surface geology is illustrated on the image below which is an extract from the BGS Sheet SE30SE 2005 Edition:

Geological faulting is conjectured to pass through the site from south-west to north-east as indicated above (*it should be noted that as this is based on 'conjecture' the actual position may differ, in some case quite significantly*). Although no fissuring of sandstone bedrock is known in this vicinity, there will be some potential for such natural features of which there are no records that may have been 'opened out' to some degree by the past deep coal mining in the area.

As outlined on the extract image above, to the north-west of the conjectured geological fault the 'Top Beamshaw' coal seam is conjectured to outcrop on the northern boundary of the site, along with the 'Low Beamshaw' some 85m away to the south-west. On the south-eastern side of the geological fault the 'Meltonfield' coal seam is conjectured to outcrop some 10m away to the north-east, which will dip away clear of the site; along with the 'Two Foot' coal seam conjectured to outcrop on the southern boundary of the site; the 'Abdy' seam (also known as the 'Winter' coal seam) some 60m away to the south-west; and 'Top Beamshaw' seam some 180m away to the south-west. *(it should be noted that as this is based on 'conjecture' the actual position may differ, in some case quite significantly).* The anticipated thicknesses of these coal seams (in meters) are indicated on the following extract image from the BGS records:

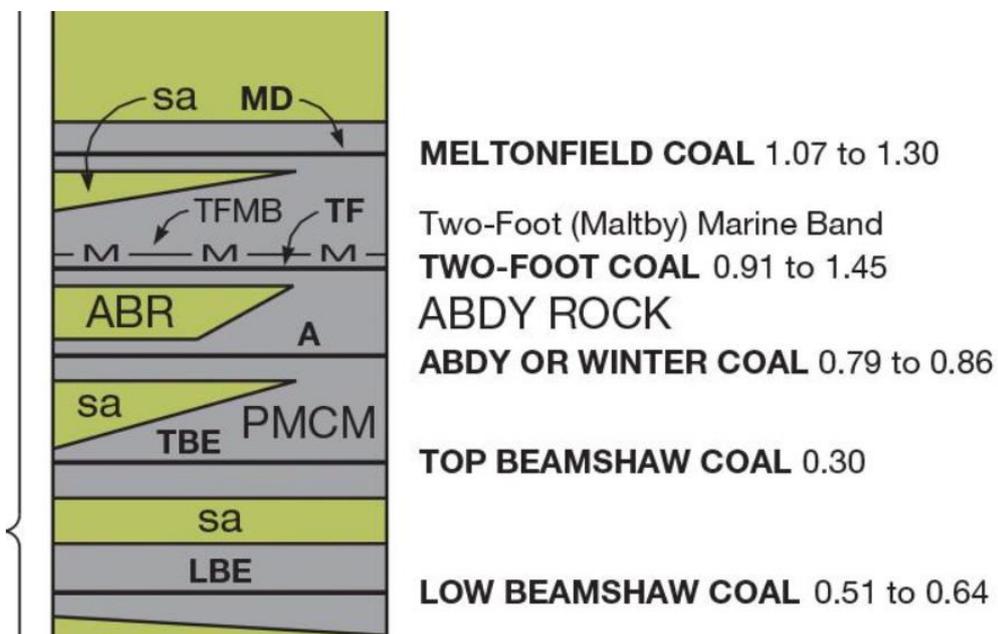
Given the detail, some potential will be present for encountering coal at the surface (beneath surface soils and/or made ground) in either the Top Beamshaw seam (to the north-west of the fault), or the Meltonfield and/or Two Foot seams to the south-east of the fault.

The Low Beamshaw seam is anticipated at shallow depth to the north-west of the fault line; the Two Foot, Abdy and Top Beamshaw seams are anticipated at shallow depth to the south-east of the fault.
