**Coal Mining Risk Assessment  
at  
Pine Lodge  
Stainborough Lane  
Hood Green, Barnsley  
For  
Mr Peter Dimberline**

**Design - it**  
**Structural Solutions Ltd**

**Appendix A**  
**Site location plan and proposed development**

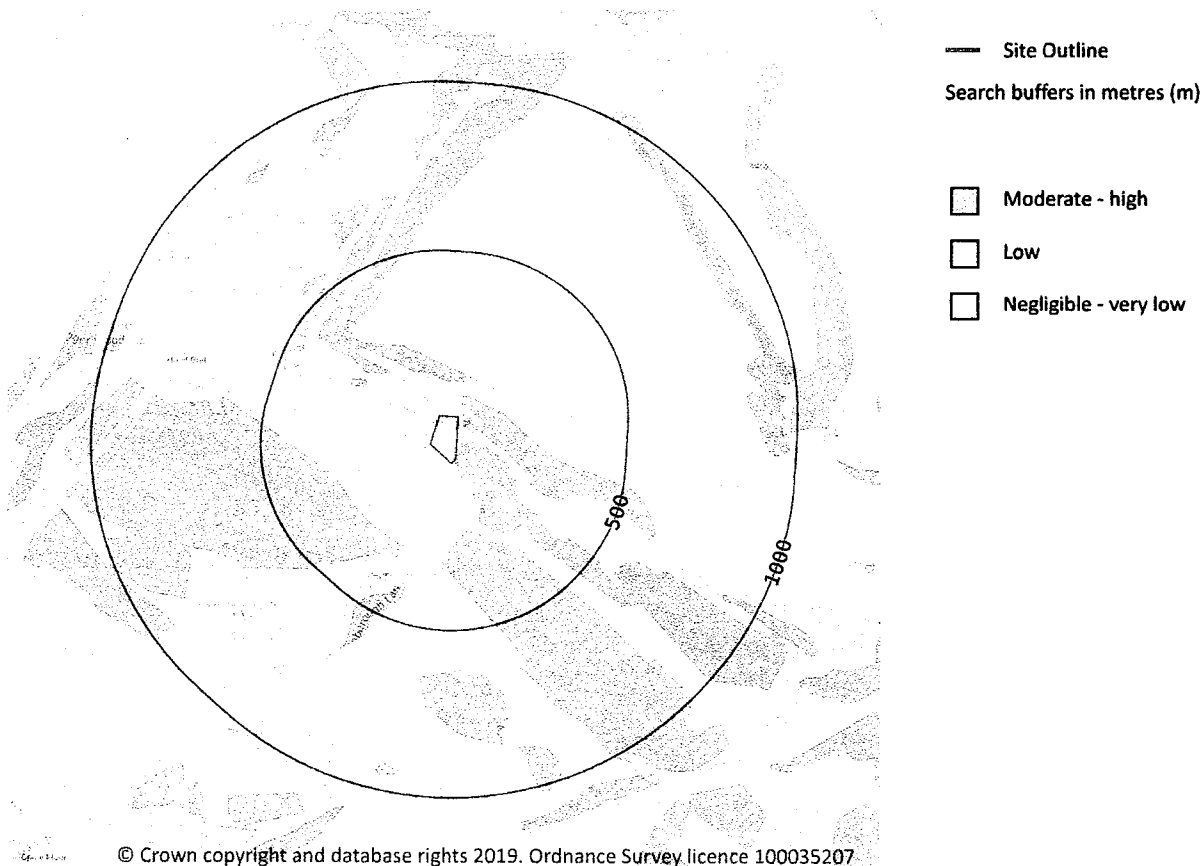
### Natural ground subsidence

The property, or an area within 50m of the property, has a moderate to high potential for natural ground subsidence. This rating is derived from the British Geological Survey's GeoSure database, and is based upon the natural qualities of the geology at the site rather than any historical subsidence claims or events. Additionally, this data does not take into account whether buildings on site have been designed to withstand any degree of subsidence hazard.

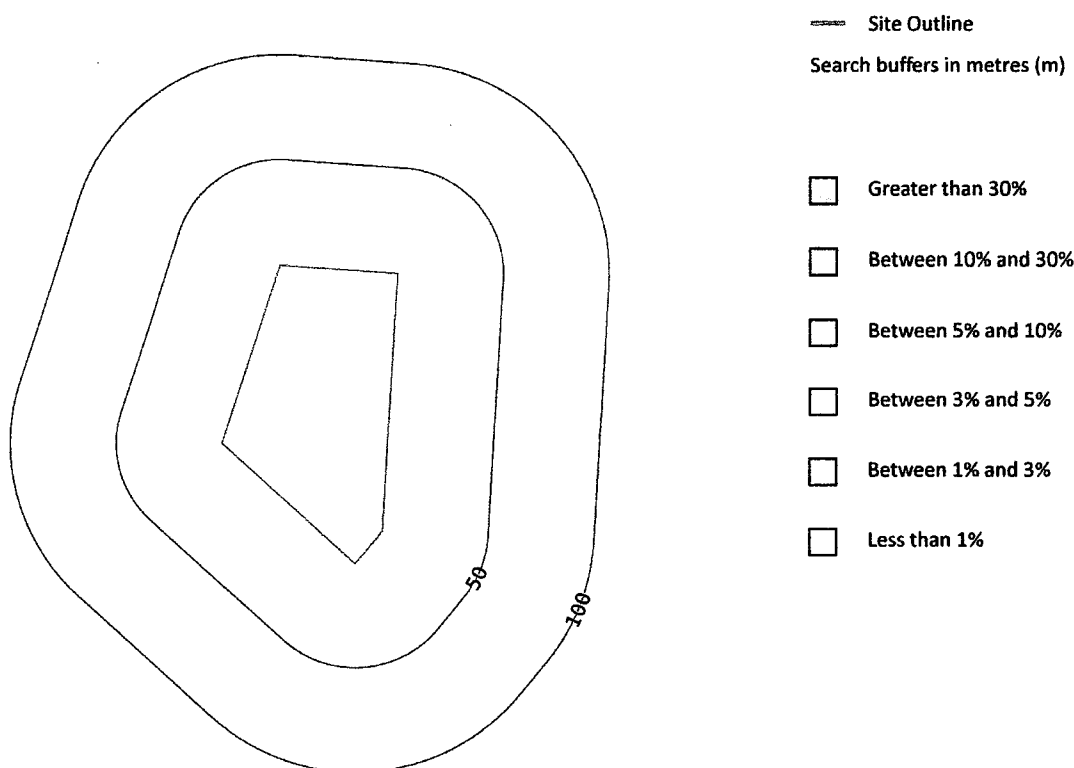
## Radon

The property is in a radon affected area, meaning the area has a general radon level above the radon Action Level. In order to determine if there is a problem at your property, a radon measurement in the building must be taken. Access to a testing service and further information on radon is available from Public Health England (PHE) or [www.ukradon.org](http://www.ukradon.org). Radon is a colourless, odourless radioactive gas present in all areas of the United Kingdom, usually at levels that pose a negligible risk. However, the property is situated in an area where levels of radon can be much higher and pose a health risk. High levels of radon can cause lung cancer, particularly for smokers and ex-smokers. The higher the level and the longer the period of exposure, the greater the risk. If you are buying a currently occupied property in a radon affected area, ask the present owner whether radon levels have been measured and, if they have, whether the results were above the radon Action Level. If so, what remedial measures were installed, were radon levels re-tested and did the re-testing confirm the measures have been effective.
