## **THURNSCOE HALL** **Change of Use to Private Dwelling**

### **Heritage Statement**

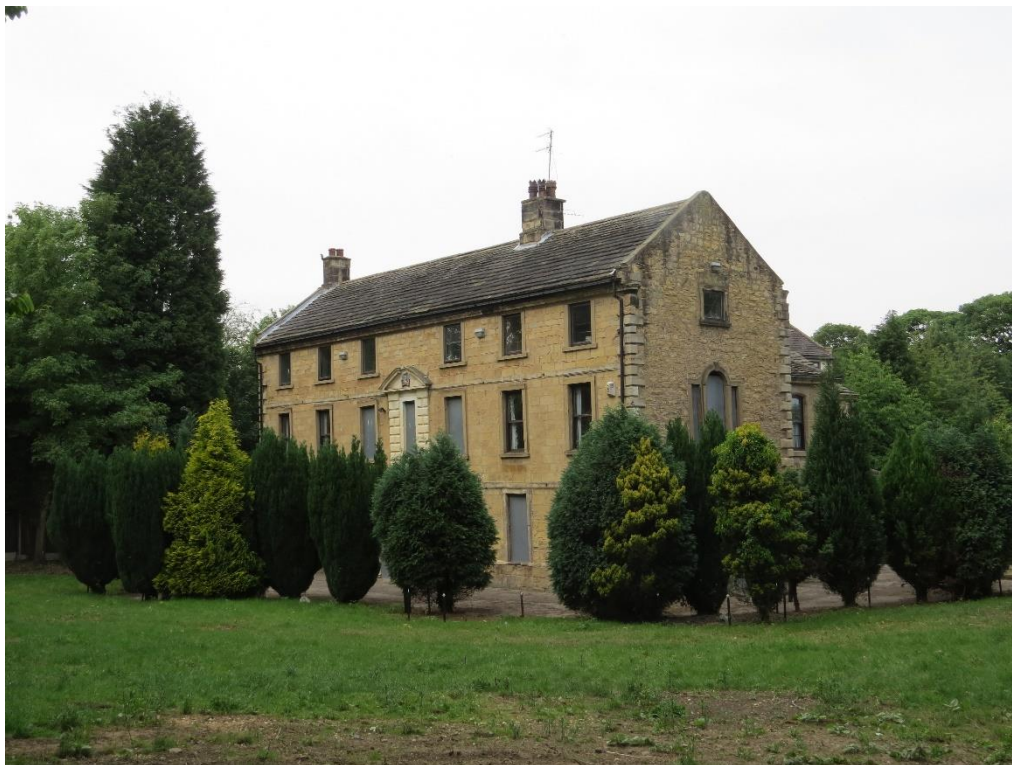
*Fig 1 – South Elevation, from SE*

Thurnscoe Hall was originally constructed in the late 17<sup>th</sup> Century. It is a 3 storey ashlar sandstone building, with a moulded plinth and a stone slate roof. There is a 3 storey north wing, part rendered, with 2 smaller 2 storey duopitch roofed wings to the north east. These are later than the original hall to the south, and have been substantially re-built as part of the conversion to a residential care home in 1987-89.

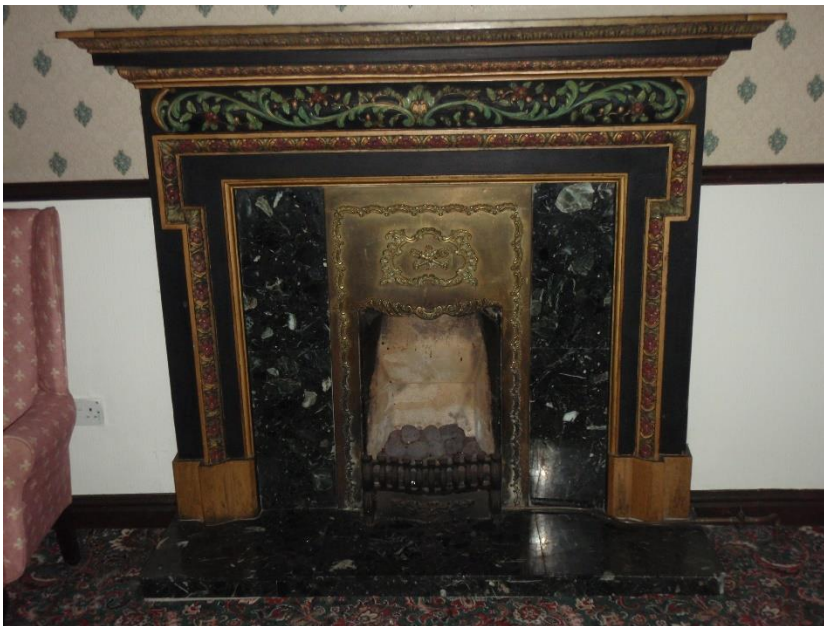
*Fig 2 – Fireplace, Ground floor, main hall*

Very little of the original interior remains. There is a Victorian cast iron surround to the fireplace on the ground floor south side. Beneath the south west corner of the main hall is a cellar with vaulted ceiling, accessed by a curved stone stairwell. There is a 19<sup>th</sup> Century bay window on the east end with French windows. There is a venetian window over, with decorative timber mouldings internally.

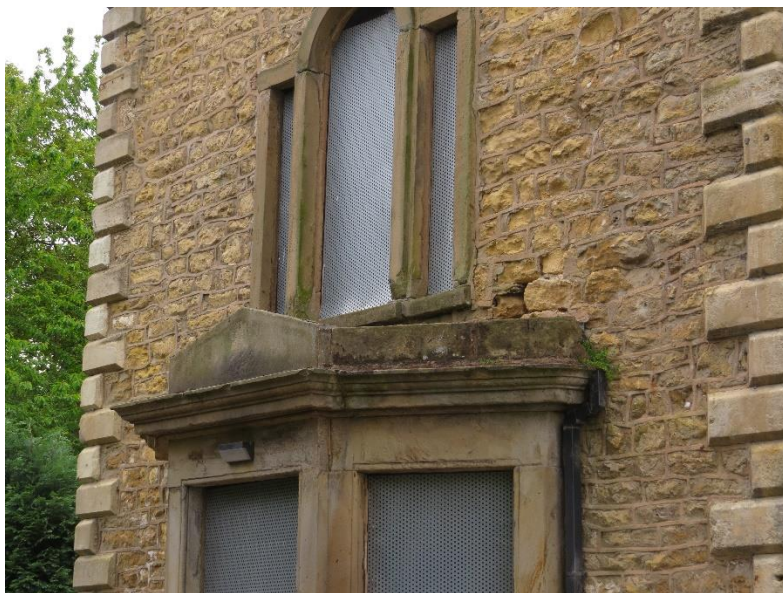
*Fig 3 – Bay Window with venetian window over*

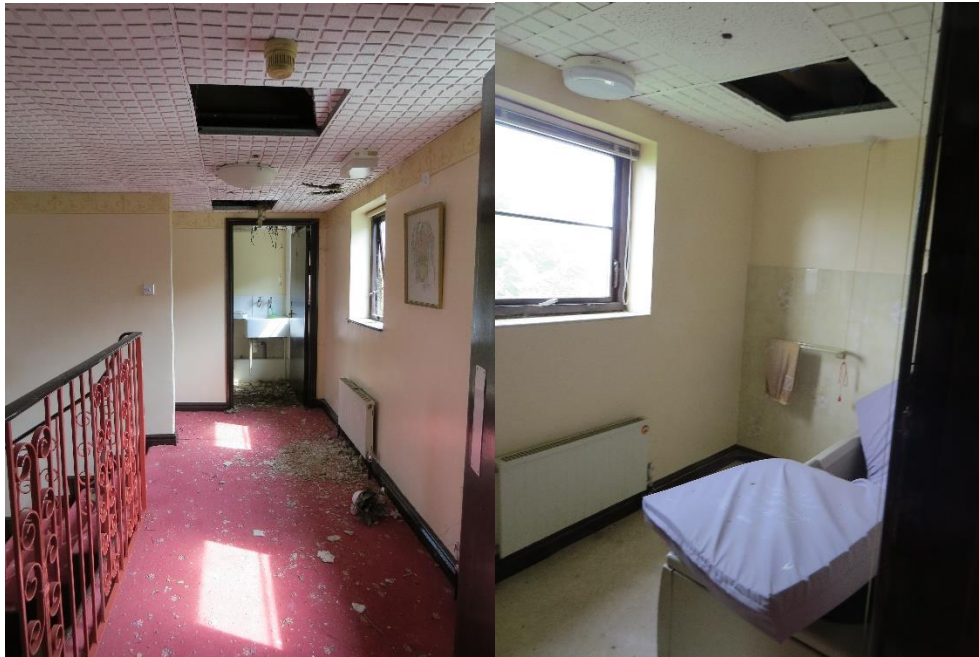
*Figs 4 & 5 – Second Floor – suspended ceiling to stairs, sluice, wc and shower rooms*

The aim of the refurbishment is to restore a more domestic quality to the property by removing the suspended ceilings on the ground and first floors and to the ancillary rooms on the second floor.

Unfortunately all the original ceilings were broken out, although the remains of the original lath is visible on the underside of the retained joists in the north east wing. New plasterboard and skim ceilings will be installed at the same level as the suspended ceilings., with simple pendant lights from a rose in lieu of the surface mounted downlights currently installed.

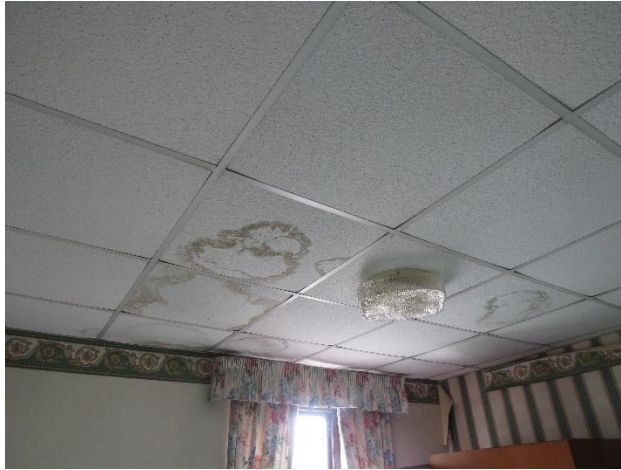
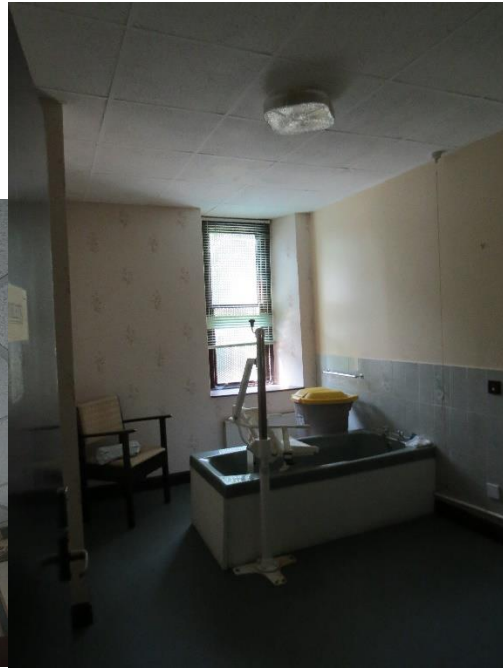
*Figs 7 & 8 – First Floor – suspended ceilings to bedrooms and bathrooms throughout*

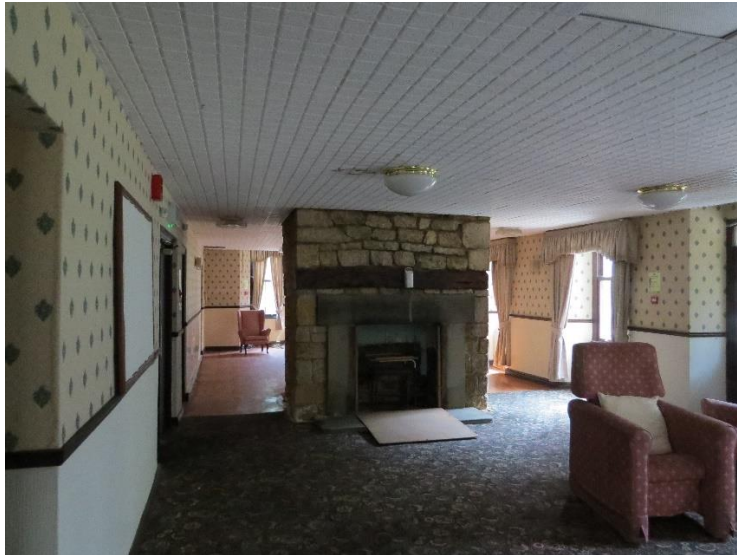
Fig 10 – Ground floor – suspended ceiling to main hall

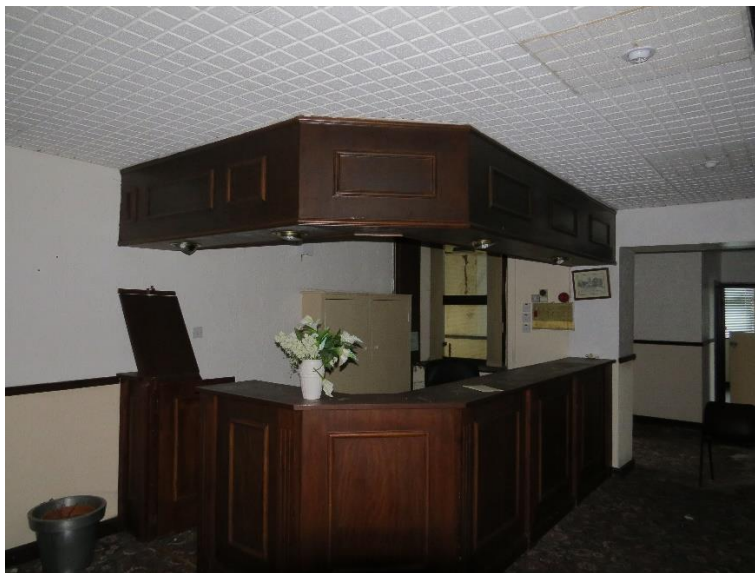
Fig 11 – Ground floor – suspended ceiling to former reception

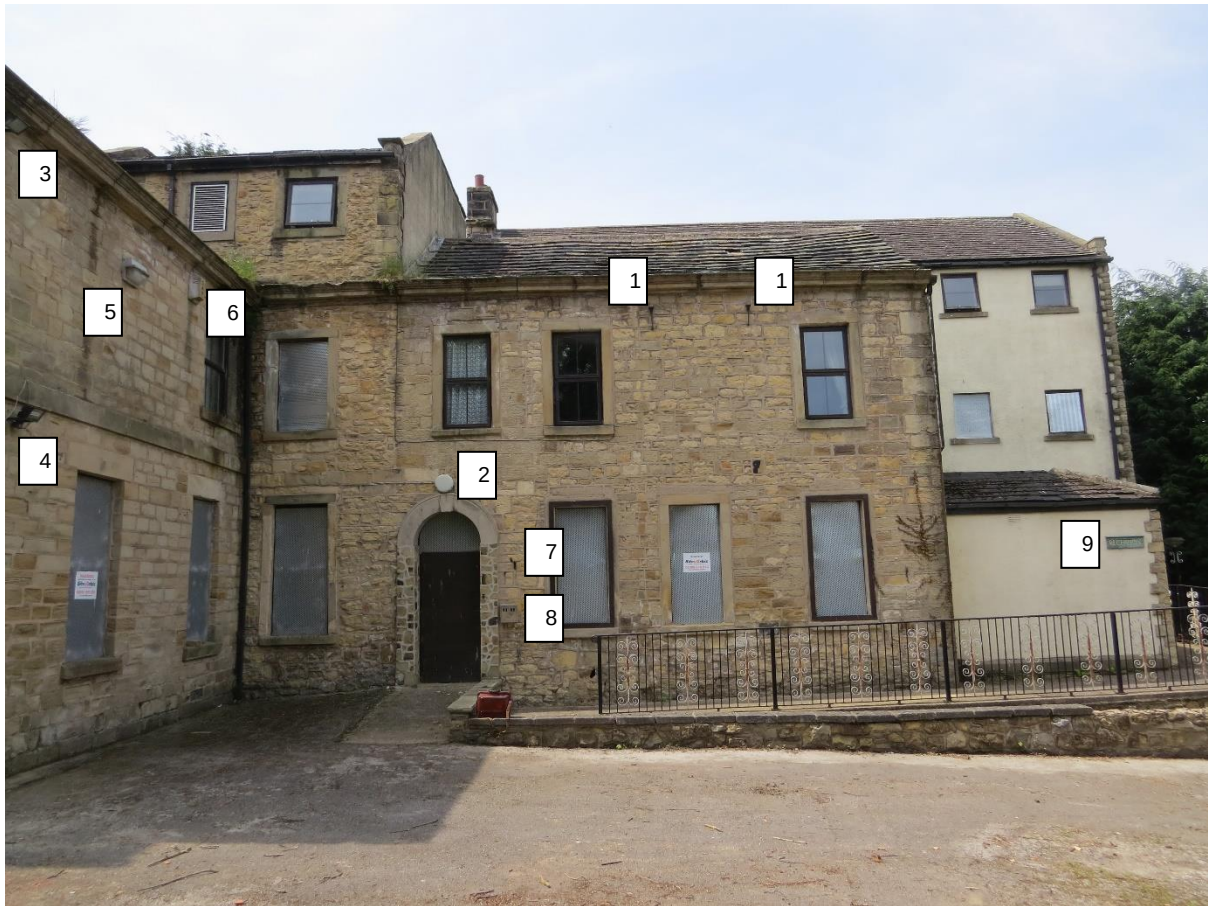
*Fig 13 – East Elevation – removal of redundant fittings*

- 1 Light sensors
- 2 Bulkhead light over entrance
- 3 Floodlight
- 4 Floodlight
- 5 Bulkhead light
- 6 Former intruder alarm
- 7 Black metal hanging basket bracket
- 8 Cigarette bin
- 9 Sign

The redundant external electrical fittings and signage will also be removed from the external elevations:

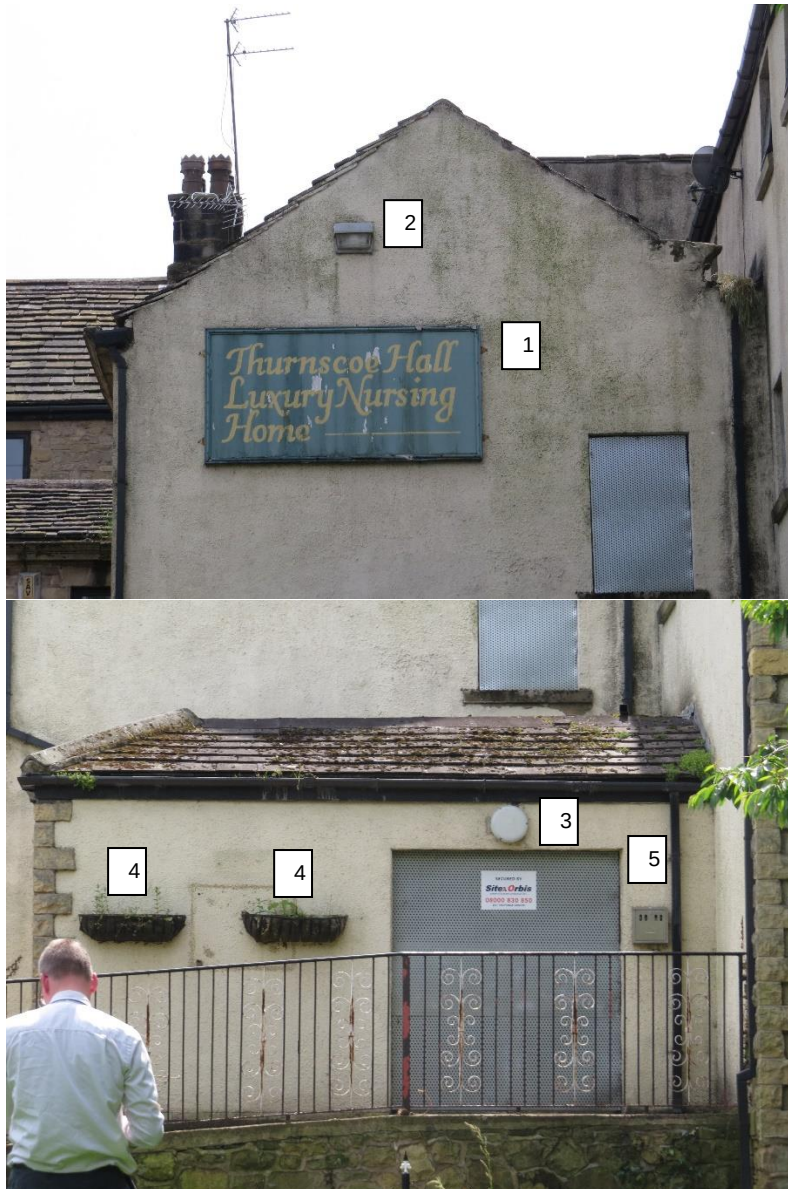
*Figs 14 & 15 – North Elevation – removal of redundant fittings*

- 1 Timber sign
- 2 Floodlight
- 3 Bulkhead light over entrance
- 4 Black metal planters
- 5 Cigarette bin
