Discharge of Condition - Technical Note

Ante Consulting Limited (Ante) is instructed by Sterling Capitol Junction 37 M1 Limited (the “Applicant”) to provide transport planning advice associated with the proposed extension to the Capitol Park employment site in Barnsley for which planning consent has been granted by Barnsley Council (BMBC).

The purpose of this brief technical note is to provide the information necessary for the partial discharge of Condition 12 associated with planning application reference 2024/0824.

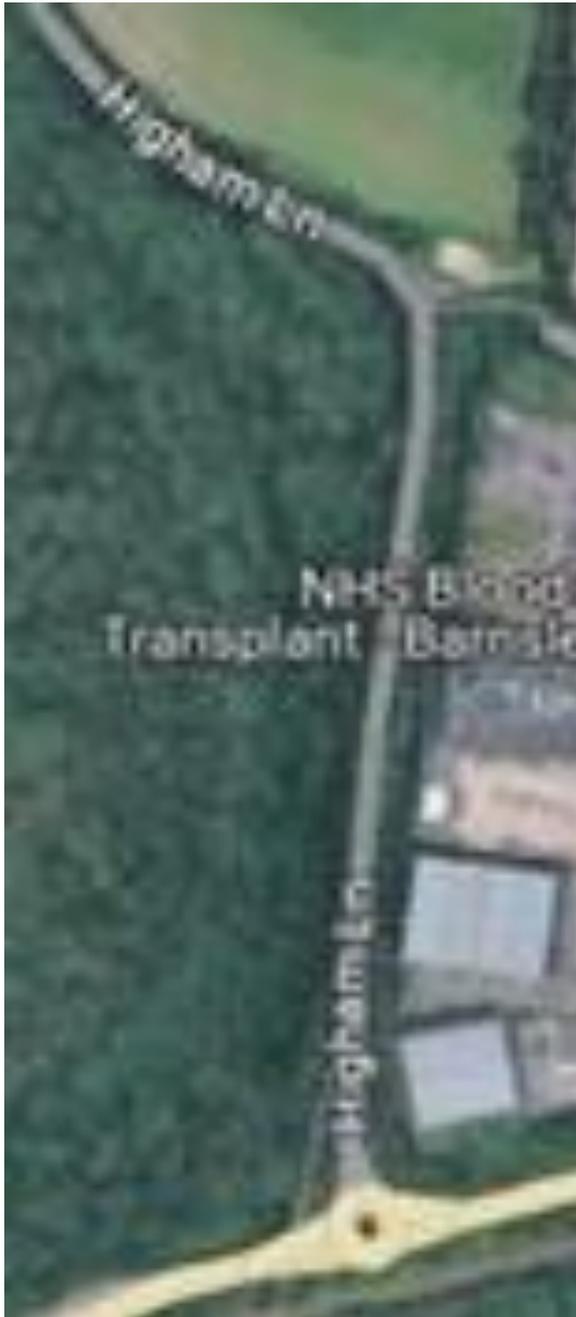
Location Plan - Approximate area of Higham Lane where photos taken on 18 March 2025

To undertake the highway condition survey, a site visit was held during the daytime of 18 March 2025 and this was attended by Paul Irwin (Ante) and Philip McGrath (BMBC). Photos were taken at the agreed location along Higham Lane around the existing residential site access to the bungalow, and on the route to the south along Higham Lane, including up to and around the A628 Whinby Avenue roundabout. The area of the photos is shown on a diagram below.
