# Trinity Academy, Barnsley

## Strategy for Grout Stabilisation of Shallow Coal Mine Workings and Mine Entries

Curtins Ref: 079532-CUR-XX-XX-T-GE-00001

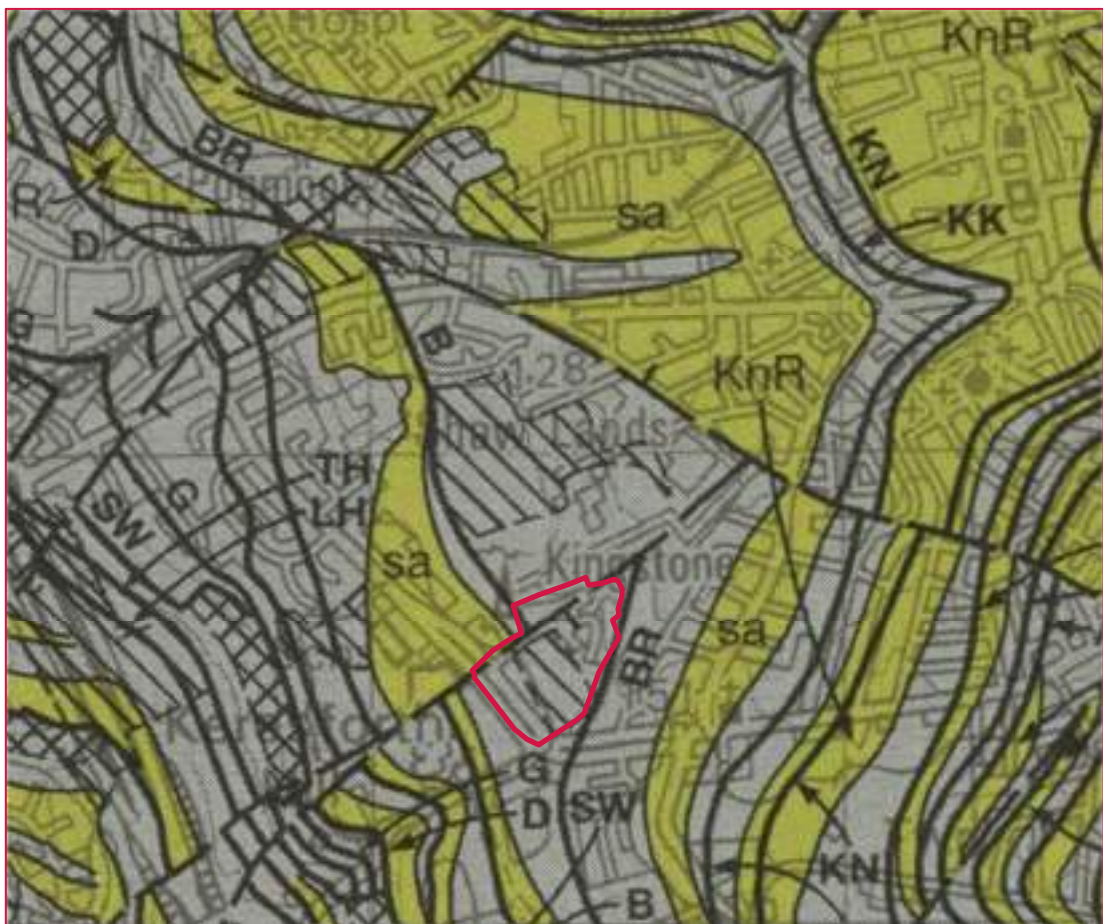
Figure 2.2 Site geology

The recorded geology of the development site is shown in Figure 2.2 below along with ground conditions for the eastern area as obtained from Reference 1.
