**OLD COAL DROPS - WORKS TO EXISTING
SCHEDULE OF REPAIRS/ ALTERATIONS**

Talbot Chambers 2-6 North Church Street Sheffield S1 2DH
 tel: +44(0)114 2490944 fax: +44(0)114 2490966 www.axis-architecture.com
Coal Drops
 Land at St Mary's Street
Penistone
 Fairbank Investments Ltd

Coal Drops & Signal House
 Works to Existing

Drawing Number **27845 A(18) 02 P01**

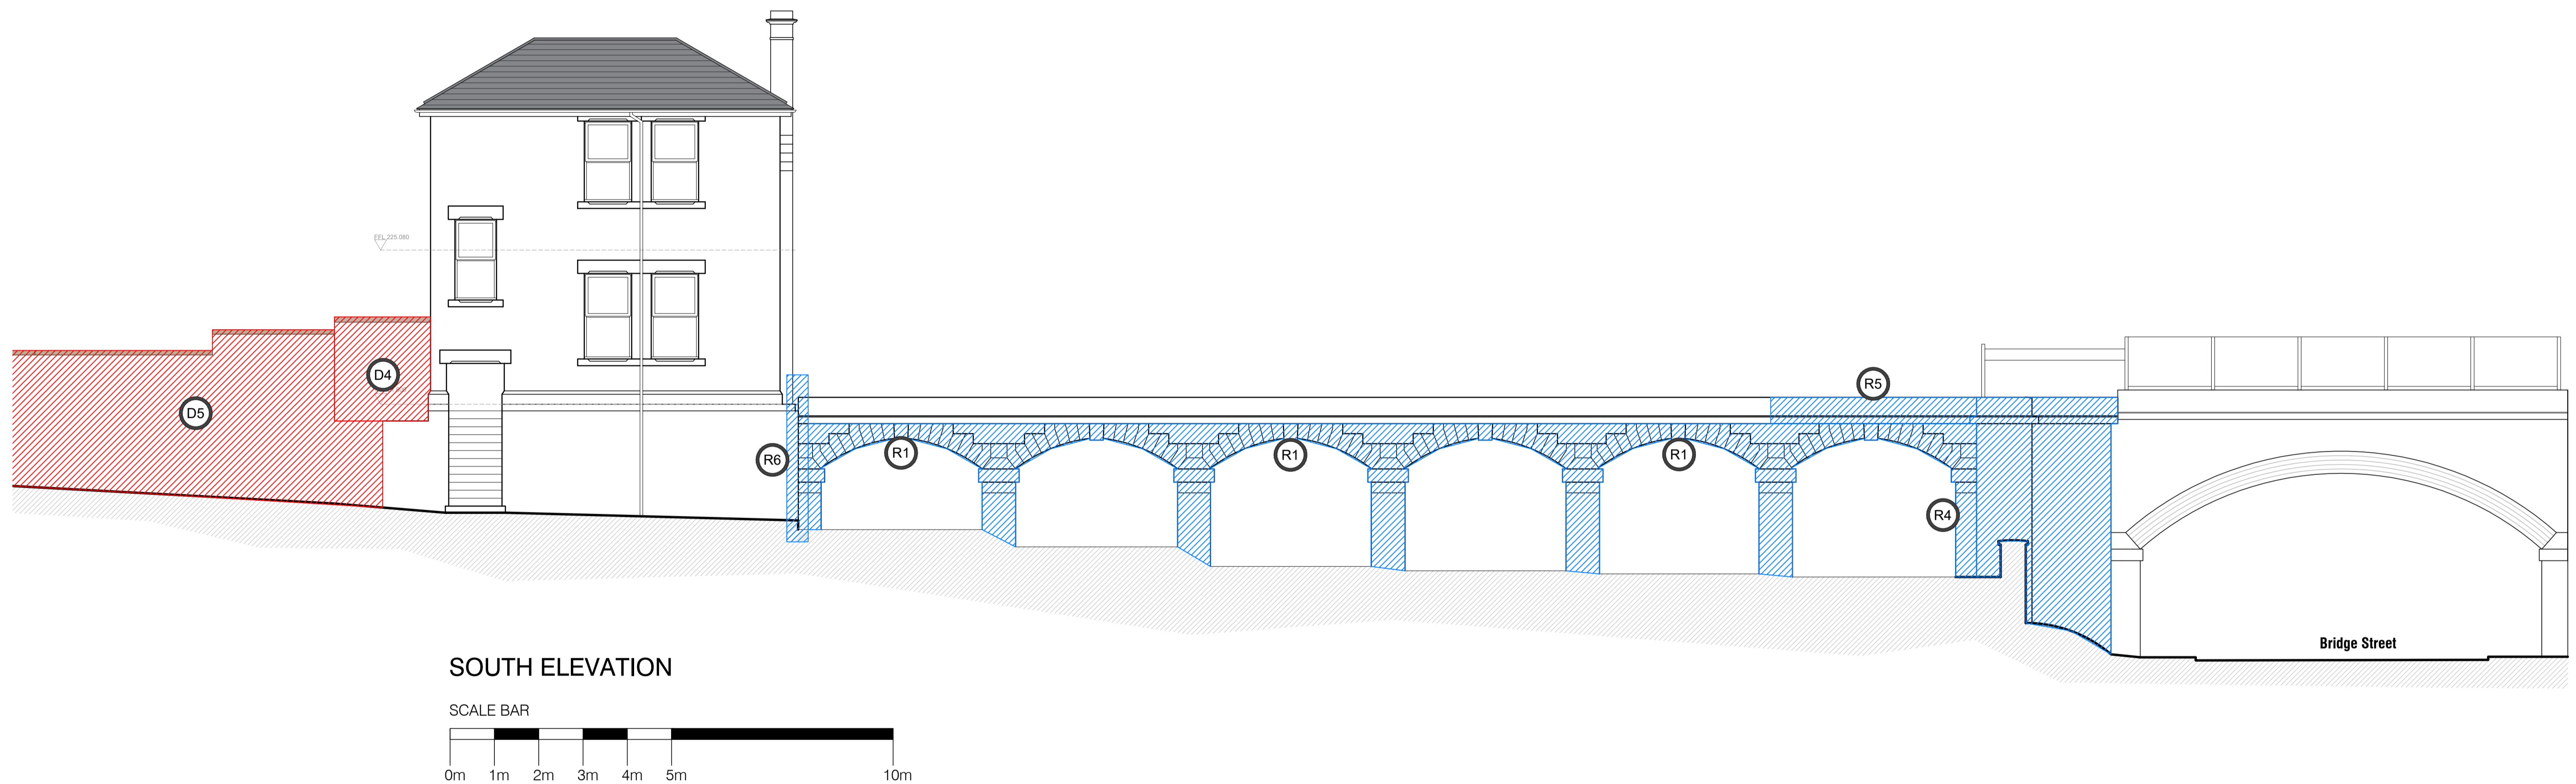
Refer to 'Structural Survey Report' by Castree Limited (Structural Engineer).
All repairs to be sensitively undertaken and to match existing (including stonework, coursing pattern and mortar jointing).

- ▨ **RED:** Indicates areas of removal of existing building fabric, and make good where affected.
- ▨ **BLUE:** Indicates areas of existing fabric to be repaired and made good

- D1** - Rear of Bay 3: Rear wall of Bay 3 removed to form the main entrance/ connection to the restaurant and bar.
- D2** - Rear of Bay 1: Small doorway opening formed to connect proposed kitchen to store.
- D3** - Side wall between Bays 5 and 6: Doorway opening formed to create large retail space.
- D4** - Existing toilet block to Signal House: Masonry toilet block removed. Planning precedent established in previous planning approval (ref 2013/0544).
- D5** - Retaining wall adjacent Signal House: Coursed stone retaining wall to southern site boundary, adjacent Signal House, to be removed. New curved retaining wall structure to vehicle access ramp to be built from reused stone where possible, to match existing coursing and mortar jointing. Planning precedent established in previous planning approval (ref 2013/0544).

- R1** - Repointing of stonework: Repointing of Coal Drop arches and wall where required, using suitable lime mortar.
- R2** - Western retaining wall to Bay 1: Areas of western retaining wall require rebuilding due to displacement, with stainless steel dowels to prevent repeat failure. The inner wall of front barrel vault requires rebuilding. The wall of the rear barrel vault requires partial rebuilding. Refer to Structural Survey Report section 4.1.2.

- R3** - Subdividing walls: Heads of inner walls strengthened with new mortar and relaying of some masonry where required. Refer to Structural Survey Report section 4.1.3.

- R4** - Bay 6 Arch/ Buttrressing Pier/ East Wall: Structural repair works required to Bay 6 arch due to vertical displacement; buttrressing pier due to lateral displacement; and east wall due to a large crack present. Options for repair are outlined in the Structural Survey Report section 4.1.4.

- R5** - Coping stones: Masonry and coping stones above arch 6 have cracked, and require rebuilding and repointing, using reused stone where possible. Coursing pattern and mortar jointing to match existing.

- R6** - Adjacent retaining Wall: Existing retaining wall between Coal Drops and Signal House is deformed and failed to a significant height -requiring dismantling and rebuilding, with possible strengthening works required. Refer to Structural Survey Report section 4.2.1.
