**11-1177-01
BARNESLEY CIVIC**

Drawing No.	Revision
BCE-HLM-01-ZZ-DR-A-00621	P01

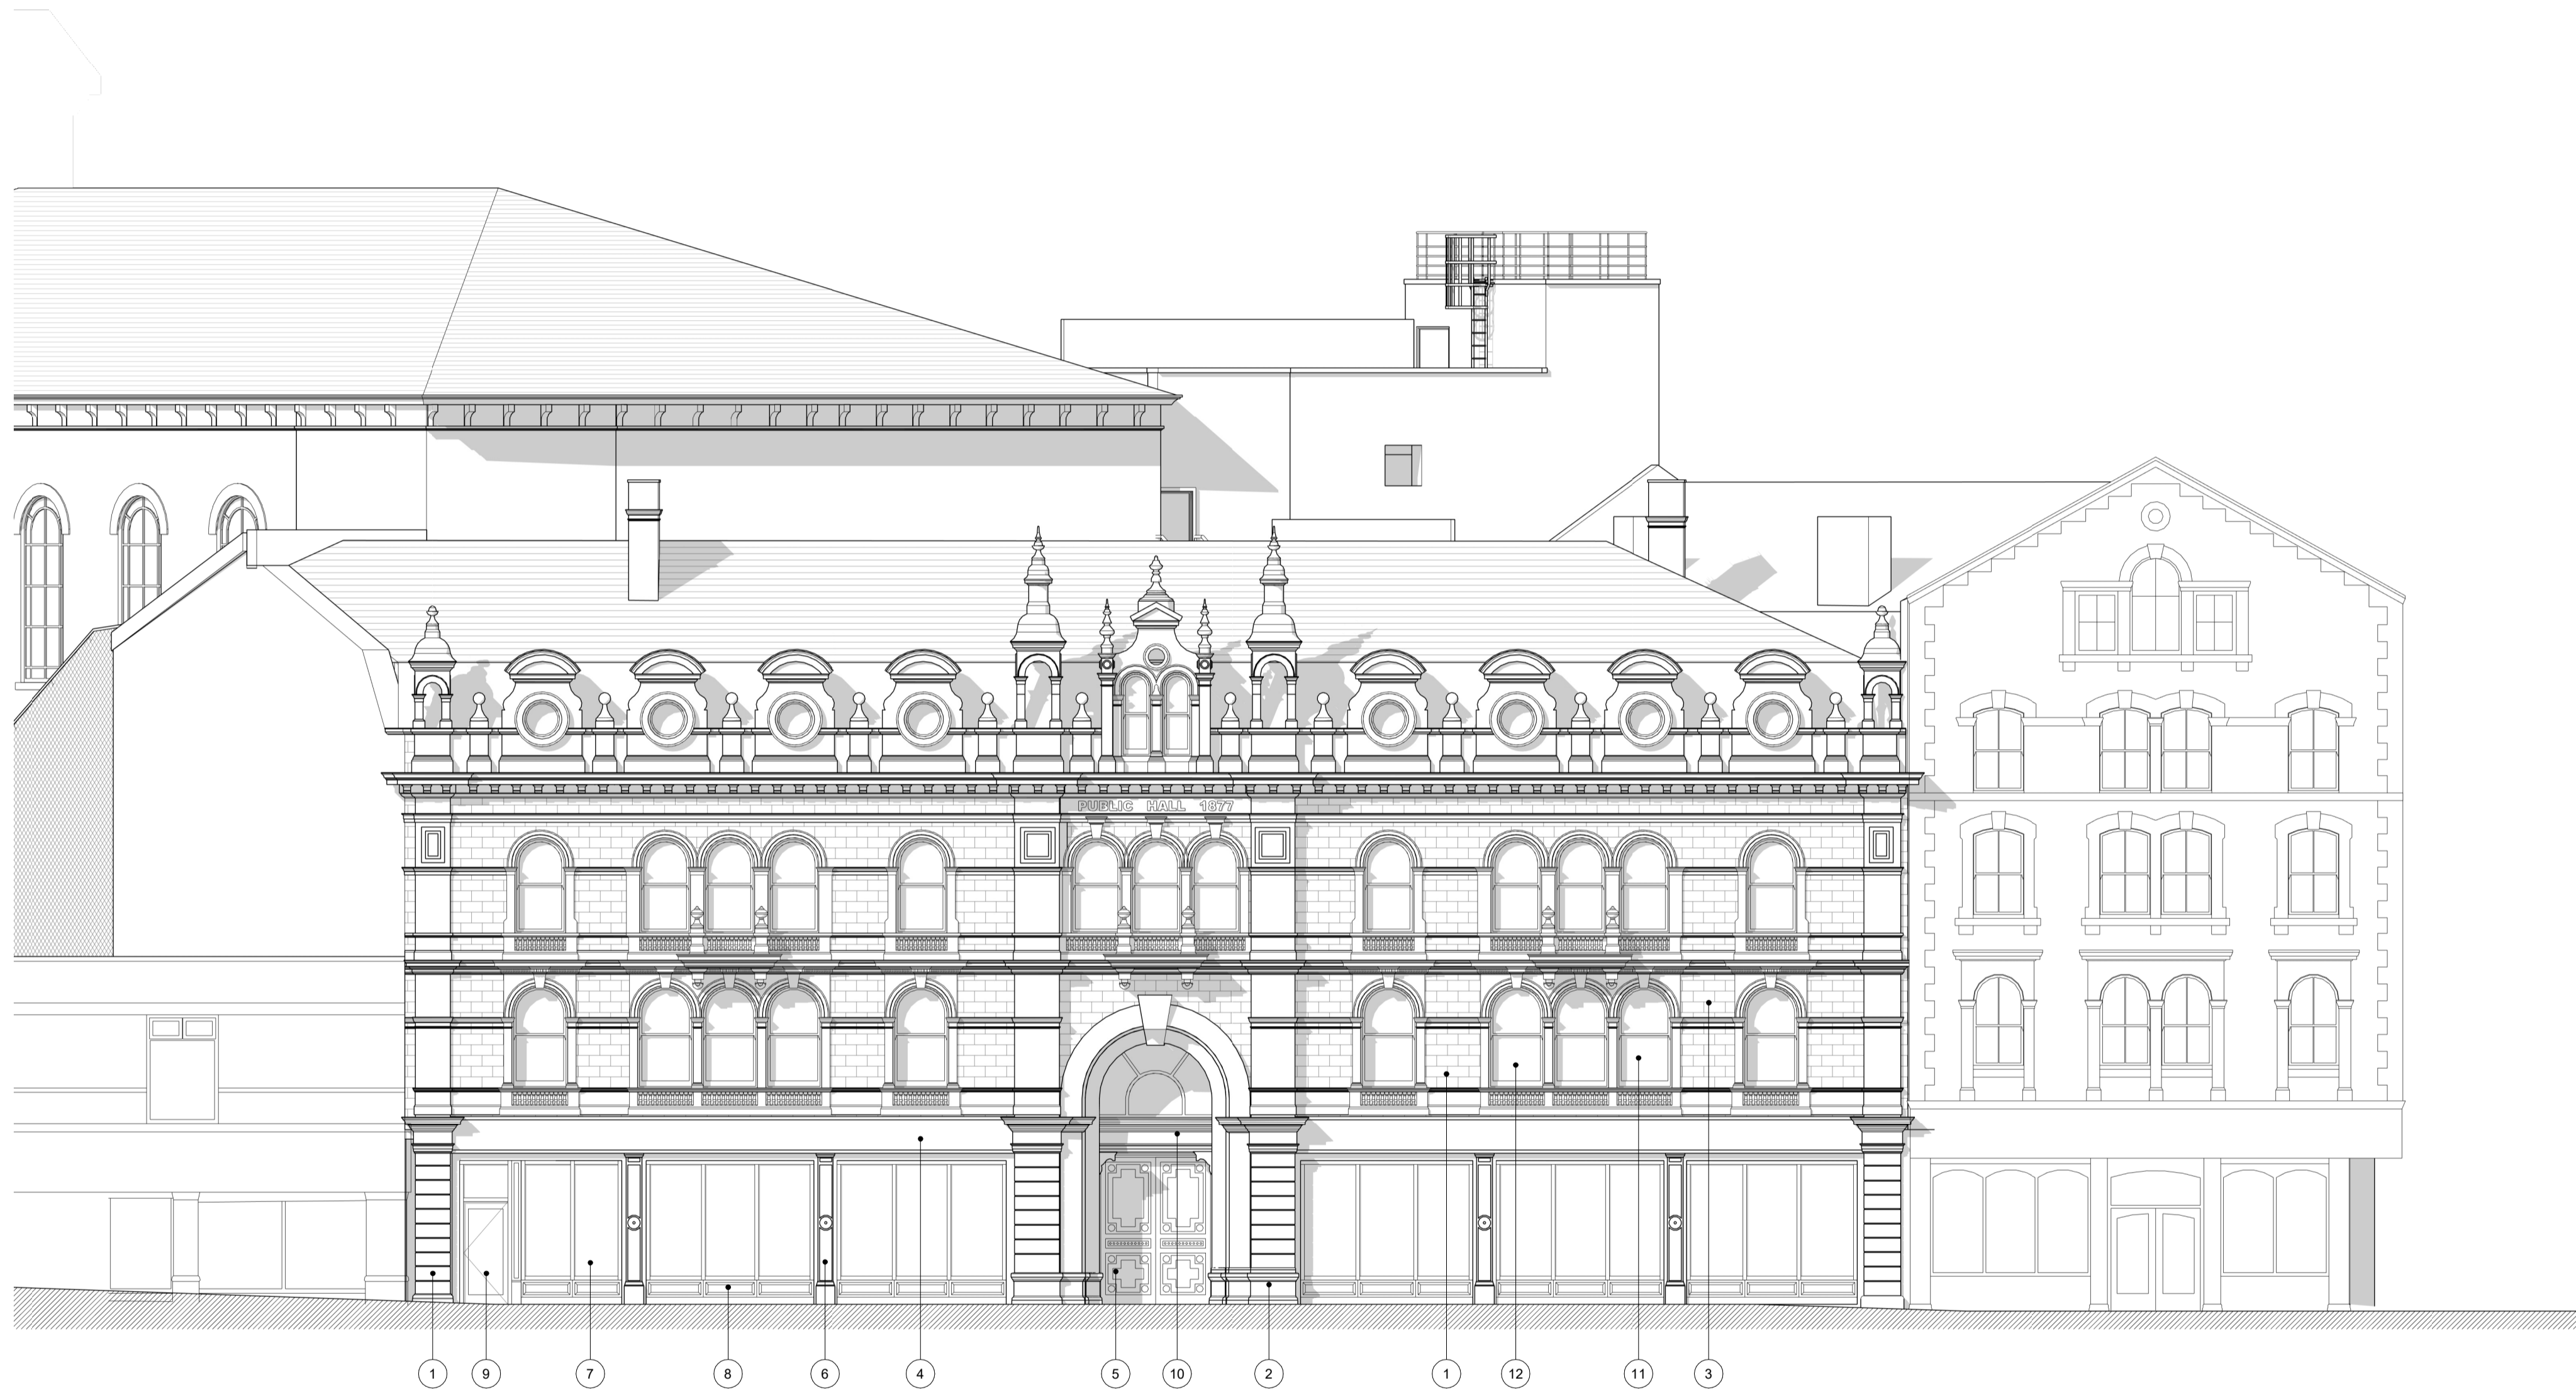
Elevation scope of work:

1. Ashlar and decorative sandstone to receive a gentle cleaning with DOFF system to remove algae & paint staining particularly to areas of water runoff. Cleaning to focus on the moulded details where the staining is the most significant and will be subject to a trial sample area to ensure that it is a suitable method, particularly to the areas of stone erosion. Following cleaning the sandstone will be brushed / dressed back to remove any loose and decaying masonry and a management & maintenance plan will be recommend along with a quinquennial survey routine.

2. Stone indents to damaged areas of the entrance area at low level, to prevent significant ongoing erosion and create a strong visual impact to welcome visitors to the building.

3. Areas of previous render repairs will require a high-level inspection and hammer test to determine the extent of any loose render repairs which will be removed. Minor repairs will be carried out to fix holes, some poorly patch repairs and open mortar joints. Allowance for repairs to stone surround on removal of roller shutter guides.

4. The current signage fascia with integral roller shutters will be removed and a replacement painted soft wood timber fascia will be provided to follow the historic profile.

5. The existing decorative timber main entrance door will be redecorated following a paint analysis.
6. The existing shopfronts will be carefully removed retaining the cast iron pilasters. A paint analysis will be carried out before the cast iron pilasters are repaired and redecorated. Open joint to the masonry to be closed off with burnt sand mastic.

7. New shopfronts, proposed between the pilasters, will be timber framed double glazed units. Windows will be slightly recessed behind the existing pilasters and stonework and reflect the proportions of the building. Timber mullions will be used to break up the window into smaller panels as indicated.

8. New stall riser will be provided as a visual and structural base for the shopfront with a moulded projecting cill. The panelled timber riser will be sat on the existing plinth and finished with a sacrificial skirting detail.

9. New painted timber double glazed door and slim timber pilaster divider to create a new access.
10. The replacement of early 1900's canopy as part of the 2006-2009 works will be removed to expose the building's roundarched centrepiece. This is topped by a carved keystone depicting Henry Harvey and two figures representing art and science in the spandrels to either side. The centrepiece will have external lighting to enhance the appearance of the building.

11. The existing bird protection netting across the facade will be removed. Alternative, less visible deterrents and a pigeon deterrent system will be installed.

12. The sash windows at 1st and 2nd floor will be redecorated and sealed with new burnt sand mastic. The circular casement windows / smaller sashes at 3rd floor will be replaced with pivot openings for internal cleaning.

Stone repairs scope of work:

Cleaning
The facade should be thoroughly cleaned down using the Doff or Thermotec or similar cleaning system.

Repointing
Sound pointing to be retained intact. Mortar joints identified as open or defective are to be carefully raked out without damaging adjacent stone, and repointed with an approved lime based colour matched mortar.

Redressing
Areas of flaking friable stone to be brushed/redressed to reform a hard weathering surface.

Restoration to failed previous repairs
Falling/damaged previous mortar repairs to be carefully removed and assessed with a view to considering redressing in lieu of new restoration. Where redressing is not feasible, new repairs should be made with the approved restoration mortar incorporating reinforcement. Repairs to be squared off to mimic the appearance of an indent repair.

Where depth of stone decay precludes achieving a sound repair with mortar, it may be necessary to implement a new stone replacement.

Indenting or Replacement
Defective stone to be carefully cut out to create clean, square aperture. New stone units to be bedded on approved lime based mortar incorporating stainless steel rods secured with an appropriate polyester resin. On completion of fixing, beds and joints are to be carefully pointed to match the surrounding stonework.

Missing balusters
Stone balusters to second floor windows that are missing or beyond repair are to be replaced with new stone.

Fractures or Cracks
Fractures of cracks identified as needing repair should be pinned using stainless steel threaded rod set in a suitable polyester resin. Drill holes and fracture to be made good with approved restoration mortar.

Loose Finials
Loose finials at roof level should be pinned with stainless steel rods set in resin to secure in position and repointed with approved mortar.

Plant Growth
Plant growth to be poisoned and removed and damaged mortar joints to be repointed with the approved mortar.
