Report No: C398/RS  
Date: April 2021

**REMEDIATION STRATEGY  
for land off  
28 PADDOCK ROAD, STAINCROSS, BARNSELEY  
SOUTH YORKSHIRE**

Prepared by  
G&M Consulting Ltd, The Chestnuts, Brackenhill Road, Haxey, Doncaster DN9 2LR

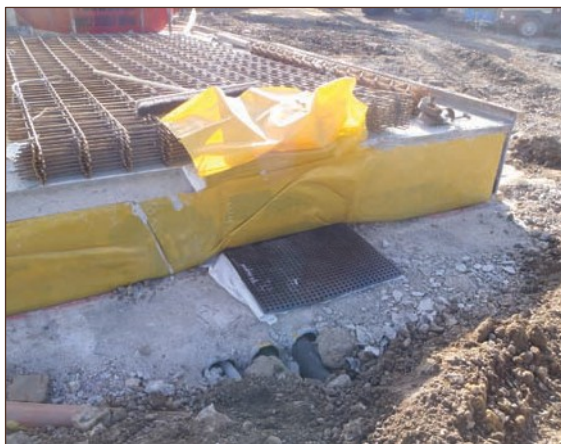
**Figure A4.7** Geovent protruding out of the frontage of the unit. Gas membrane along the sides of the slab preventing lateral gas ingress (courtesy Alderburgh Group)

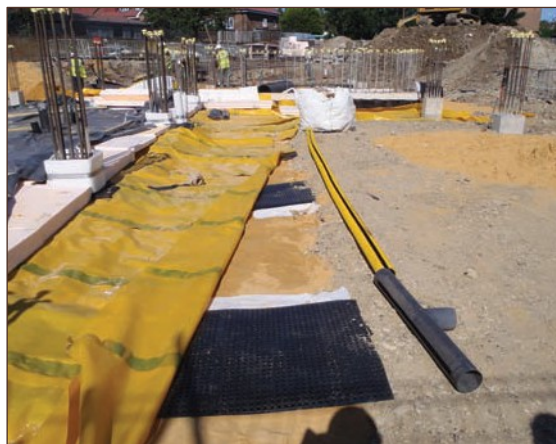
**Figure A4.8** Geovent beneath the 2000g taped gas membrane lined up with collector pipes (courtesy Alderburgh Group)

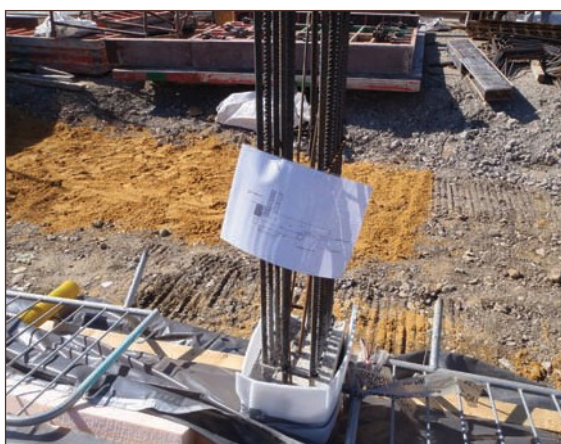
**Figure A4.9** On site schematics to aid construction workers build the gas protection system (courtesy Alderburgh Group)

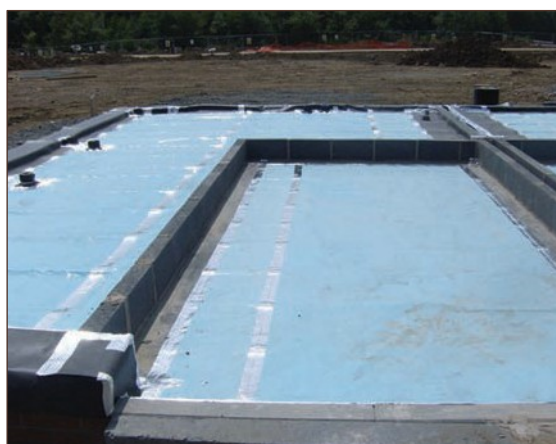
**Figure A4.10** Almost complete coverage available for inspection, minimal jointing, service entries suitable distance from walls, light traffic (courtesy Smith Grant)

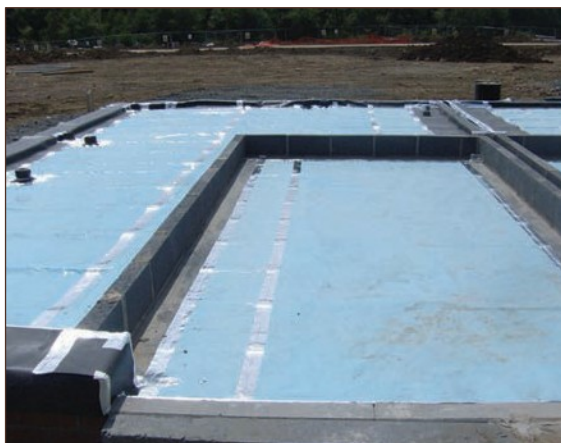
**Figure A4.11** Gas membrane continued through cavity wall and above air bricks (courtesy Hydrock)

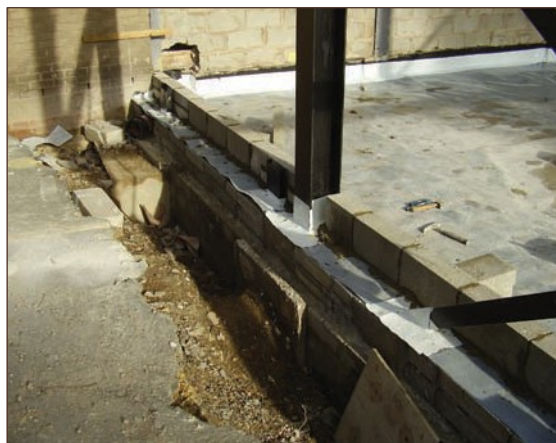
**Figure A4.12** Good edge detail across cavity (courtesy PAGEotechnical Ltd)

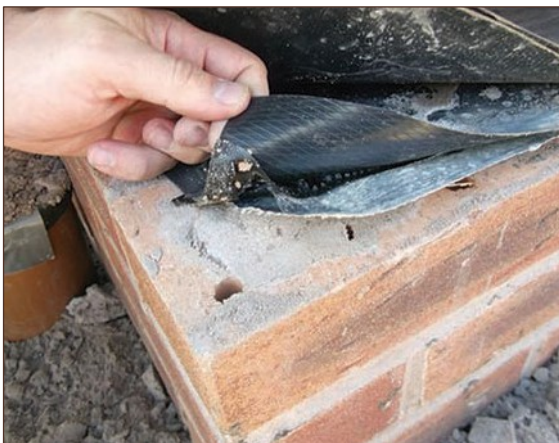
**Figure A4.13** Gas proof DPC adhered on top of gas membrane using butyl strips across cavity space (courtesy NHBC)

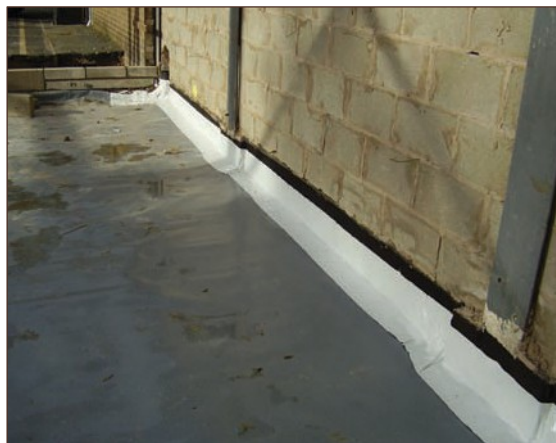
**Figure A4.14** Good perimeter seal (courtesy PAGEotechnical Ltd)

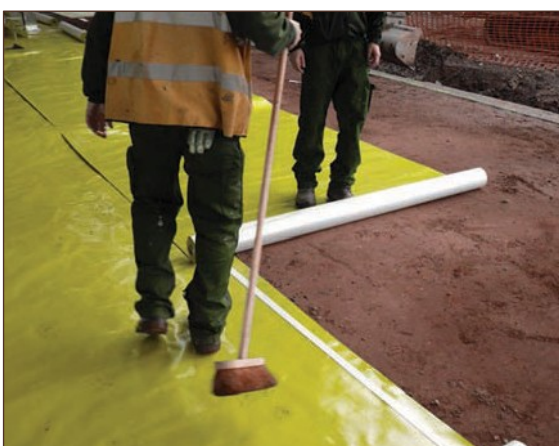
**Figure A4.15** LDPE type gas membrane overlap and double sided tape. Sand blinding to protect underside of gas membrane (courtesy A Proctor Group)

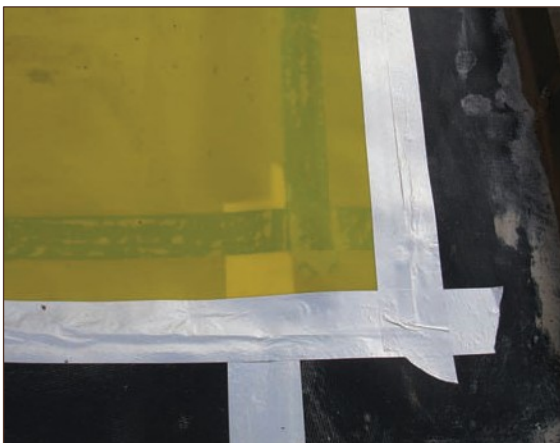
**Figure A4.19** Well-constructed joints with gas resistant DPC, lap and double sided butyl joints visible beneath semi-transparent gas membrane, secondary seal with proprietary single sided tape (courtesy Smith Grant)

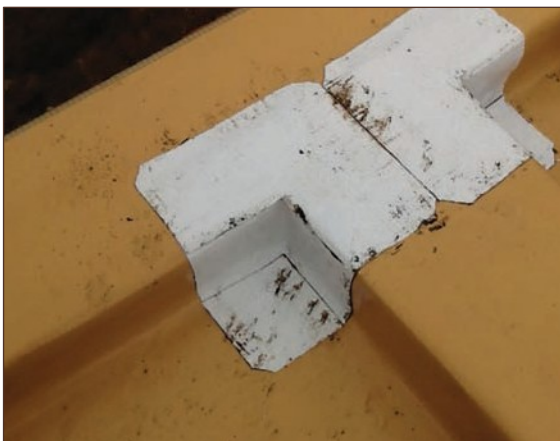
**Figure A4.21** Good prefabricated corner detail (courtesy MEC Environmental Ltd)

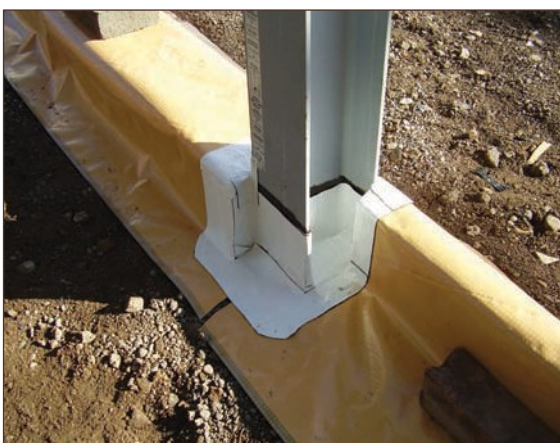
**Figure A4.23** Complex column seal (courtesy PAGeotechnical Ltd)

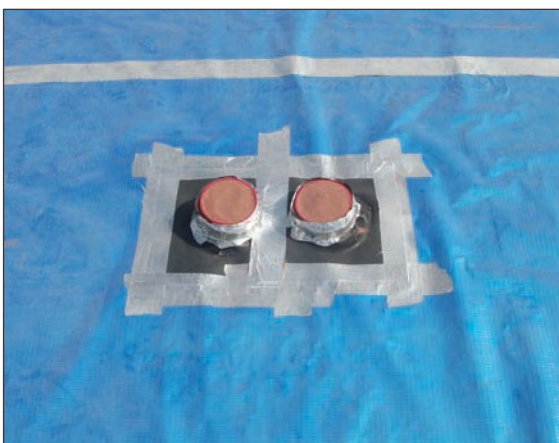
**Figure A4.27** Top hats placed around service entries secured with jubilee clip seals. Top hats secured to gas membrane with double sided butyl tape (courtesy Hydrock)

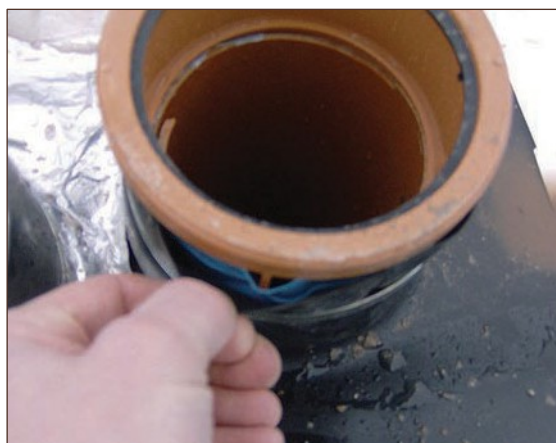
**Figure A4.28** Bead of double sided butyl tape provided between interfaces of ID top hat and OD service pipe. When compressed with jubilee clip, forms an effective seal (courtesy Smith Grant)

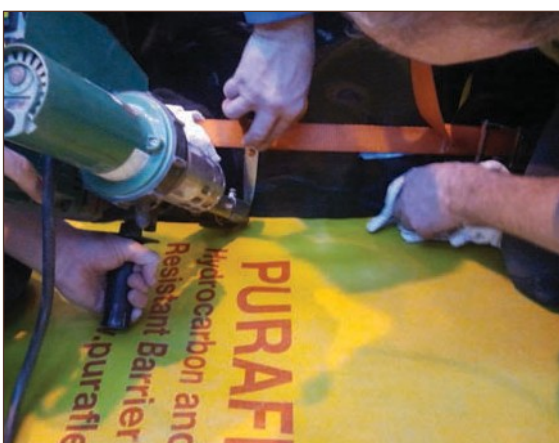
**Figure A4.29** Extrusion welding technique (courtesy Industrial Textiles & Plastics Ltd)

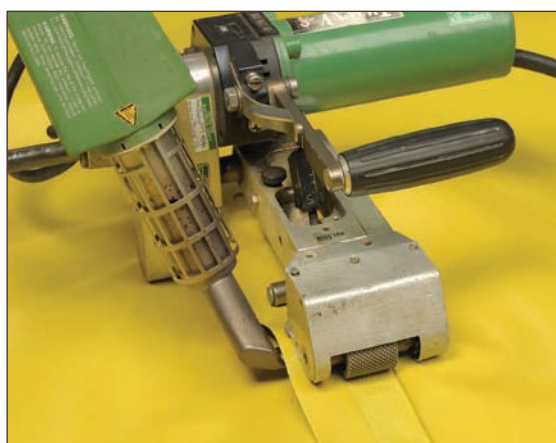
**Figure A4.30** Thermal welding technique (courtesy Industrial Textiles & Plastics Ltd)

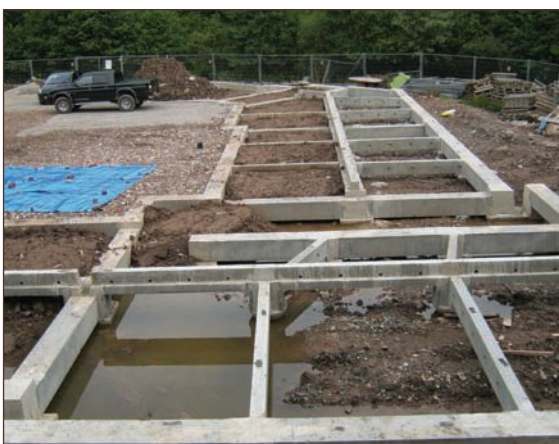
**Figure A4.33** Good ventilation in internal sleeper walls, cast into prefabricated beams (courtesy Smith Grant)

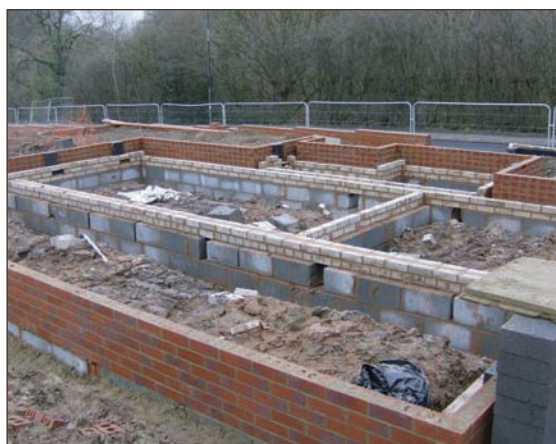
**Figure A4.34** Open void >300mm deep, good ventilation through internal sleeper walls (courtesy Smith Grant)

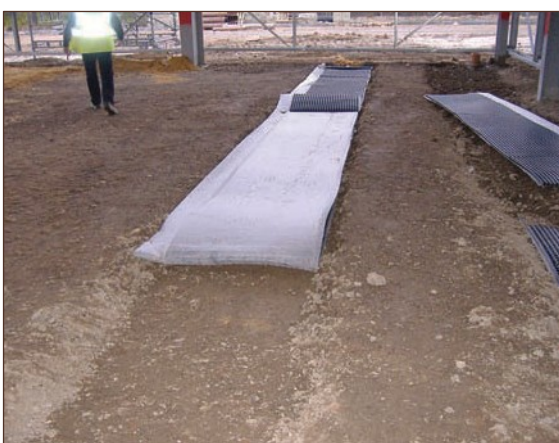
**Figure A4.35** Good installation of passive gas venting trenches and 'egg-crate' (courtesy Card Geotechnics Limited)

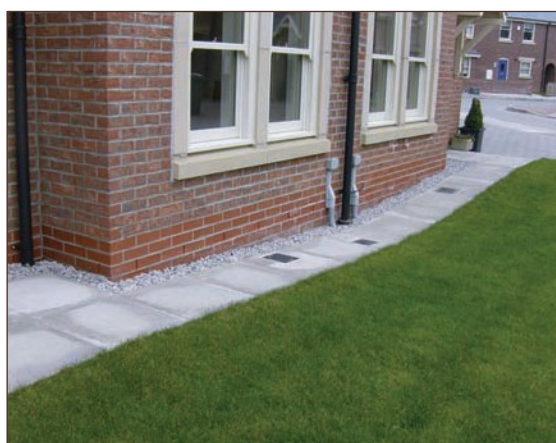
**Figure A4.36** Raised air bricks are preferable due to the reduced potential for blockade but the vent trench specified is provided with clean single sized stone (courtesy Smith Grant)

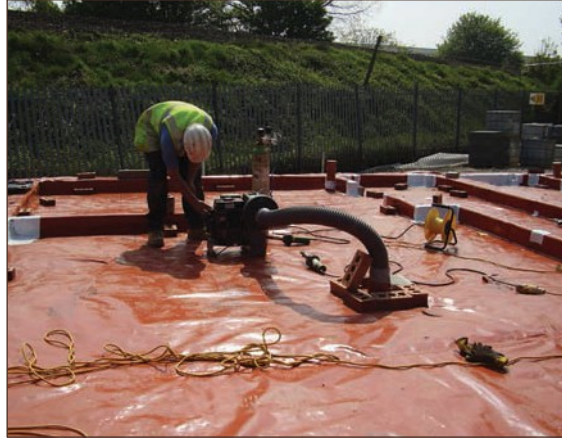
**Figure A4.38** Tracer gas testing (courtesy PAGEotechnical Ltd)

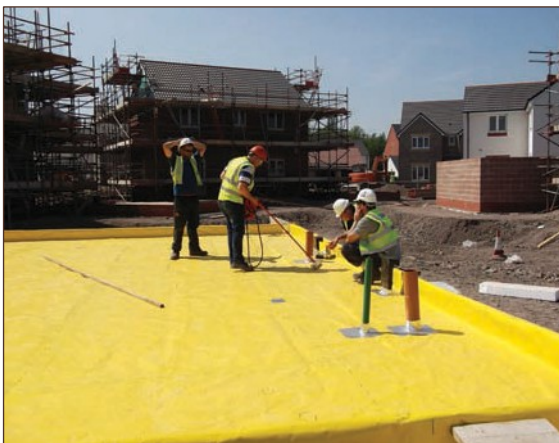
**Figure A4.43** Dielectric porosity testing for housing scheme (courtesy NHBC)

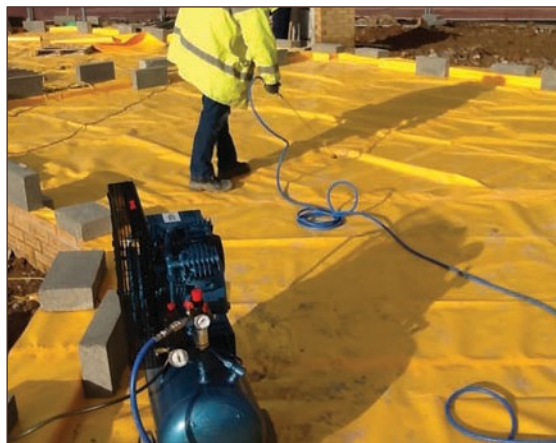
**Figure A4.44** Air lance test, used to test the quality of welded seams along gas membrane joints (courtesy MEC Environmental Ltd)

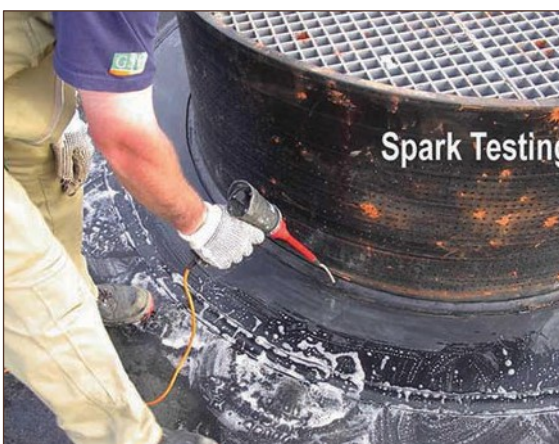
**Figure A4.45** Spark testing (courtesy GSE Environmental)

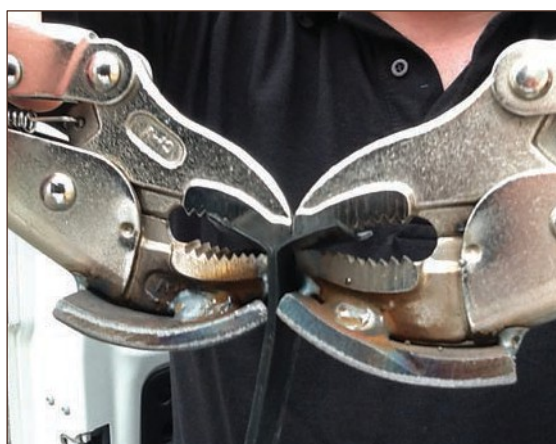
**Figure A4.46** Testing a weld with 'dog bone' grips (courtesy MEC Environmental Ltd)

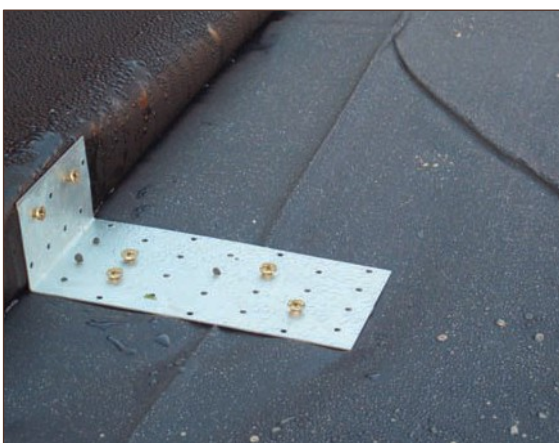
**Figure A4.47** Follow-on works purposefully penetrating gas membrane (courtesy Card Geotechnics Limited)

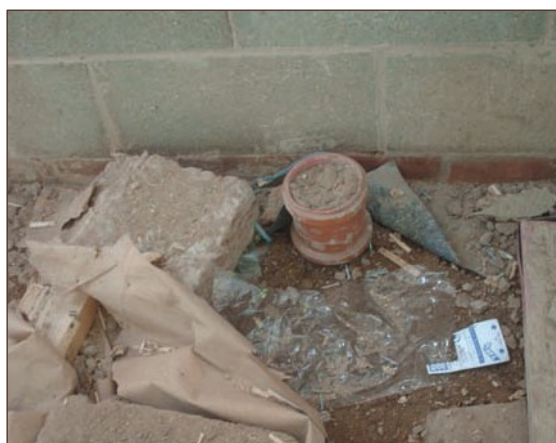
**Figure A4.48** Loose nails and over construction debris likely to be left in place beneath gas membrane – poor preparation of gas membrane prior to sealing service penetration (courtesy Card Geotechnics Limited)

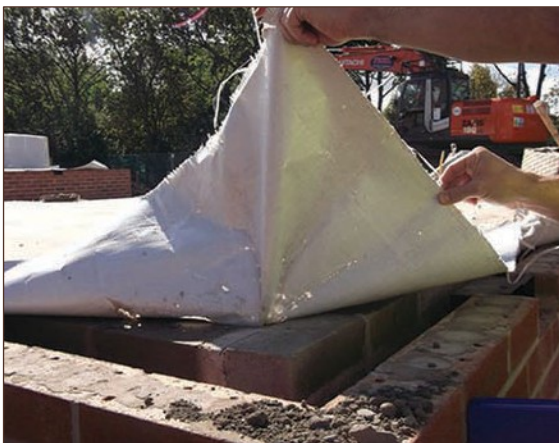
**Figure A4.49** *Lifted gas membrane at corner position. Light penetrating through confirms damage to aluminium internal core layer (courtesy NHBC)*

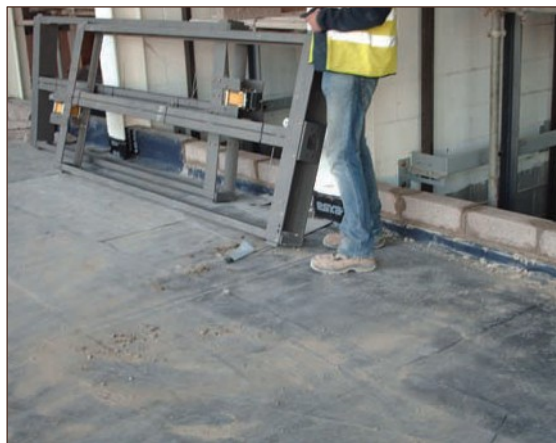
**Figure A4.50** *Large/heavy/sharp objects being moved over unprotected gas membrane (courtesy Card Geotechnics Limited)*

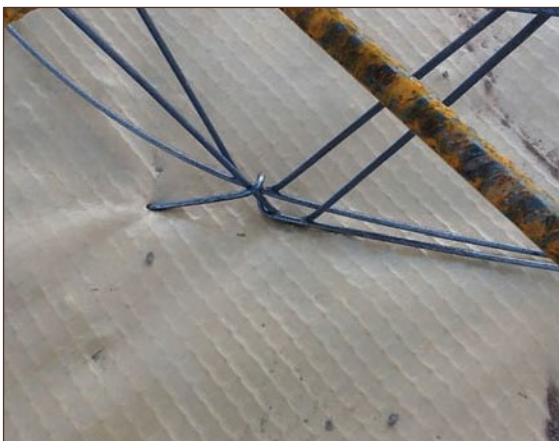
**Figure A4.51** *Gas membrane torn by reinforcement (courtesy MEC Environmental Ltd)*

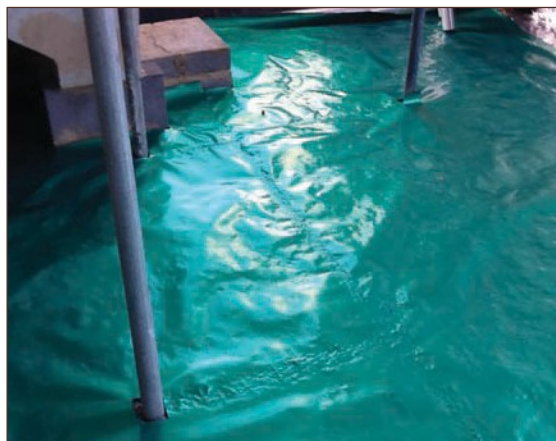
**Figure A4.52** *Gas membrane cut by scaffolders and bricklayers after installation (courtesy MEC Environmental Ltd)*

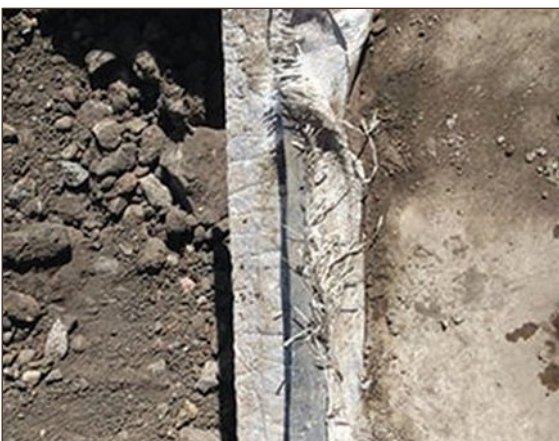
**Figure A4.53** *Gas membrane left exposed for long period of time, shows significant fraying at cavity edge (courtesy NHBC)*

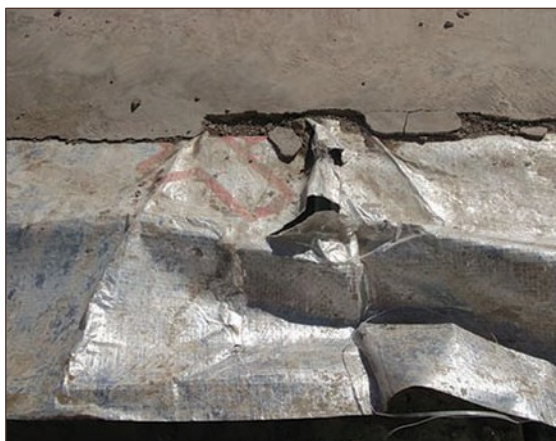
**Figure A4.54** *Gas membrane damage/tearing at edge of ground floor slab screed layer where it was left exposed to elements for period of time (courtesy NHBC)*

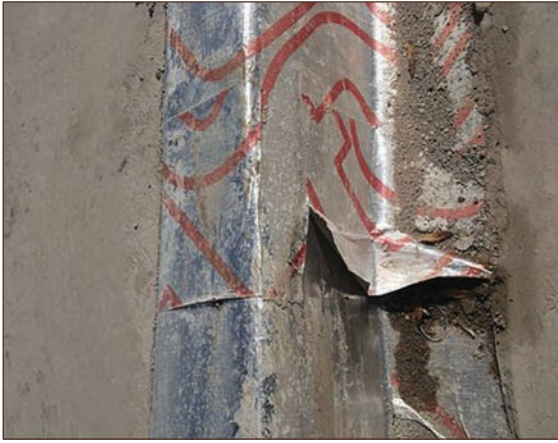
**Figure A4.55** Gas membrane at stepped junction of slab to integral garage, appears to be susceptible to tearing when screed is poured. Screed may also weigh down on gas membrane if fitted too tight (courtesy NHBC)

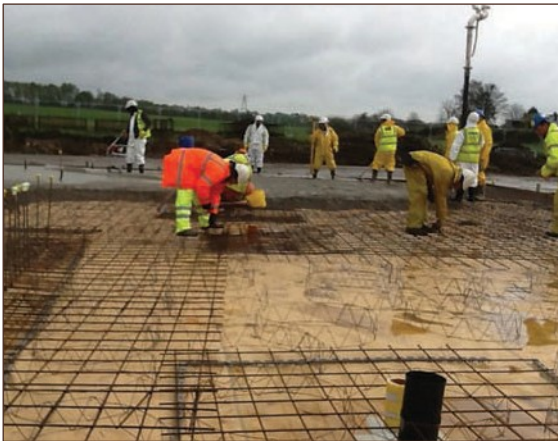
**Figure A4.57** Unprotected gas membrane damaged by heavy traffic (courtesy MEC Environmental Ltd)

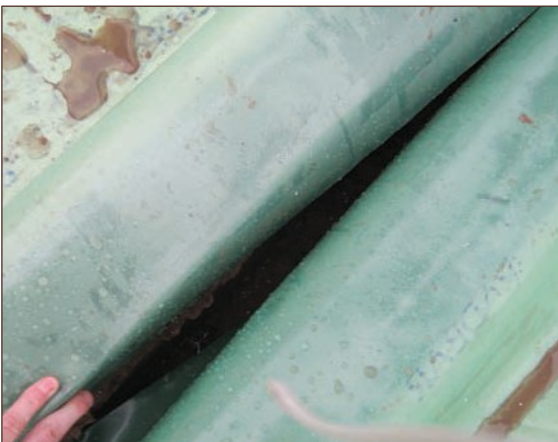
**Figure A4.59** Gas membrane slit at the bottom of a cavity tray to enable water to drain away (courtesy Smith Grant)

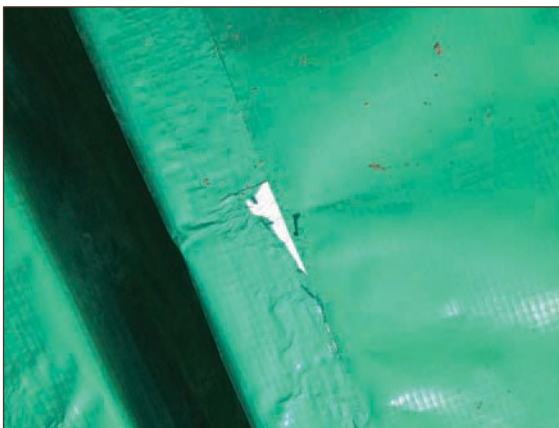
**Figure A4.61** 'Stripping' occurs on gas membranes that contain aluminium foil. The foil gets too hot under the outer layer of LDPE or PP and the top layer of the gas membrane sticks to the roller which strips it off, leaving the aluminium completely exposed (courtesy MEC Environmental Ltd)

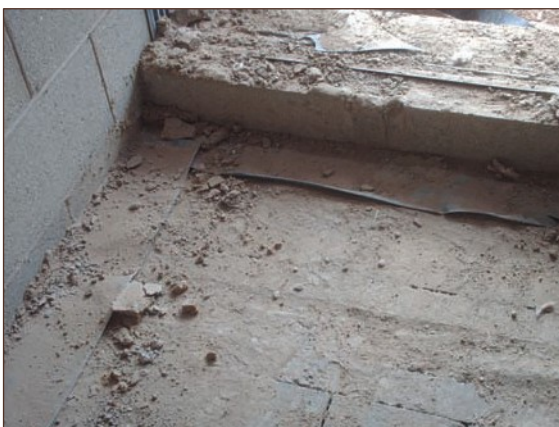
**Figure A4.63** Absence of surface preparation prior to laying of gas membrane, debris likely to pierce gas membrane (courtesy Card Geotechnics Limited)

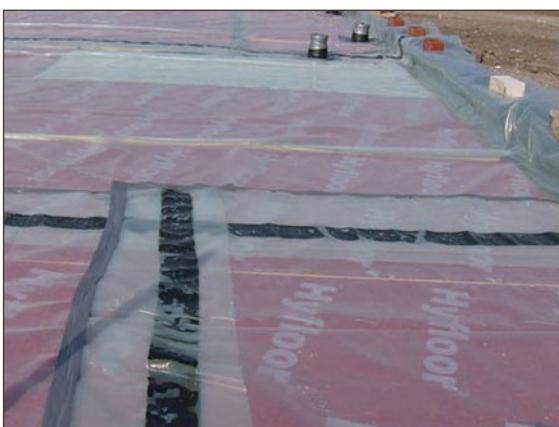
**Figure A4.65** Wrinkling of gas membrane over joint has resulted in gaps (only visible due to the use of a transparent gas membrane) and the secondary seal uses ordinary gaffer tape rather than a proprietary product (courtesy Smith Grant)

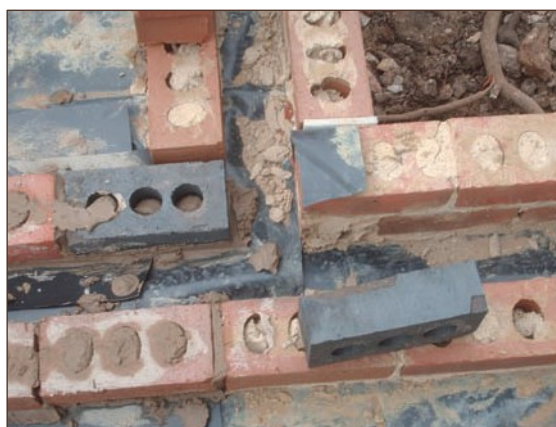
**Figure A4.66** Follow-on trades proceeded work before gas membrane joints sealed (courtesy Card Geotechnics Limited)

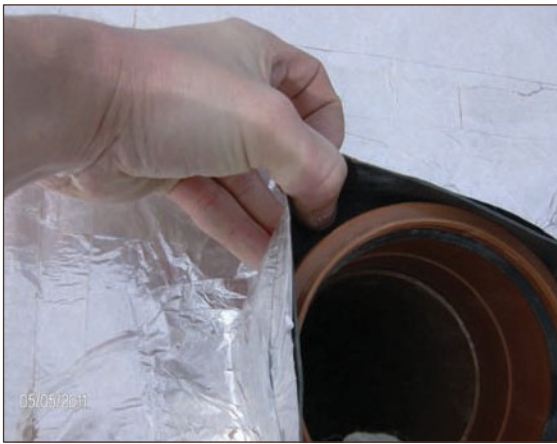
**Figure A4.73** No bead of double sided butyl tape provided between interfaces of ID top hat and OD service pipe: cannot be compressed enough to form seal (courtesy Smith Grant)

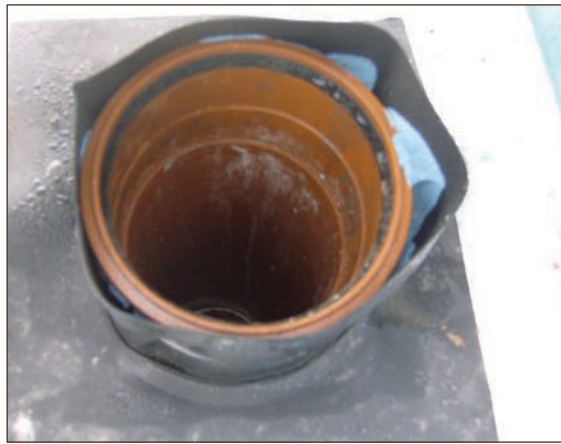
**Figure A4.74** Gap between OD of service pipe and ID of top hat too large: cannot be compressed enough to form seal, even with the application of additional tape (courtesy Smith Grant)

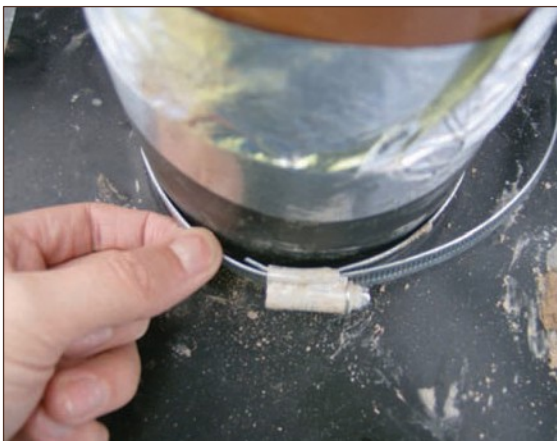
**Figure A4.75** Jubilee clip on service entry insufficiently tightened so joint is uncompressed (courtesy Smith Grant)

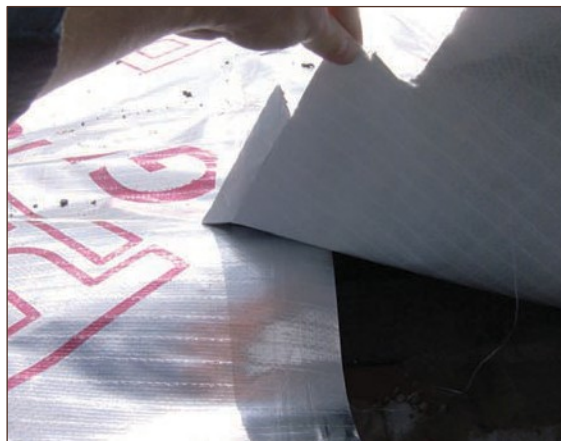
**Figure A4.76** No double sided tape used in joints (courtesy Smith Grant)

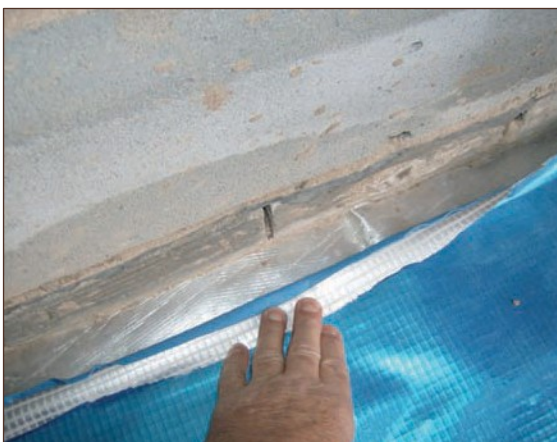
**Figure A4.77** Small lap and no single sided tape used to achieve secondary seal (courtesy Smith Grant)

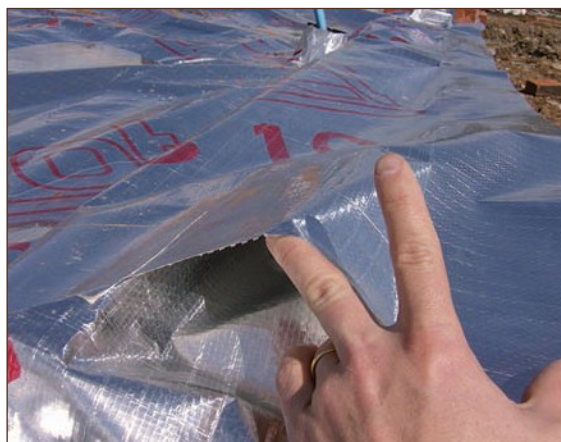
**Figure A4.78** Gap in jointing over wall cavity big enough to insert fist (courtesy Smith Grant)

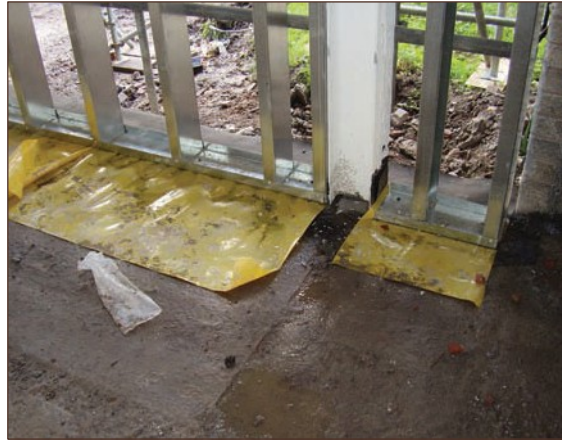
**Figure A4.80** Column left unsealed (courtesy PAGEotechnical Ltd)

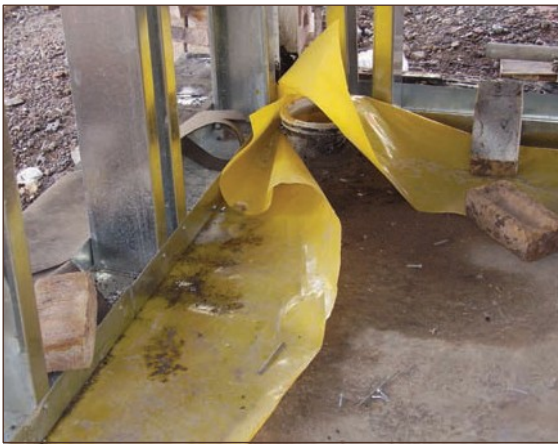
**Figure A4.81** No seal to perimeter pipe (courtesy PAGEotechnical Ltd)

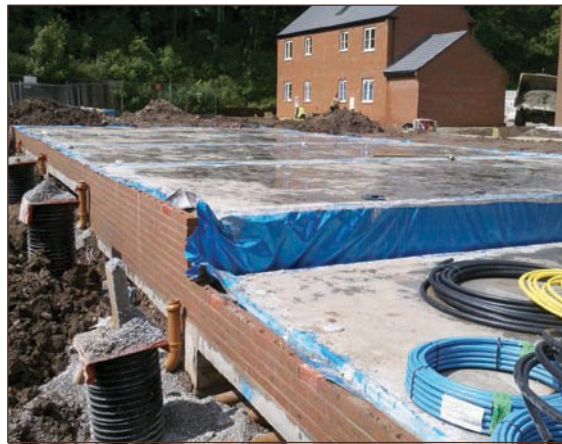
**Figure A4.82** Gas membrane used to bridge cavity wall instead of DPC, leaving it exposed to damage by follow-on trades (courtesy Smith Grant)

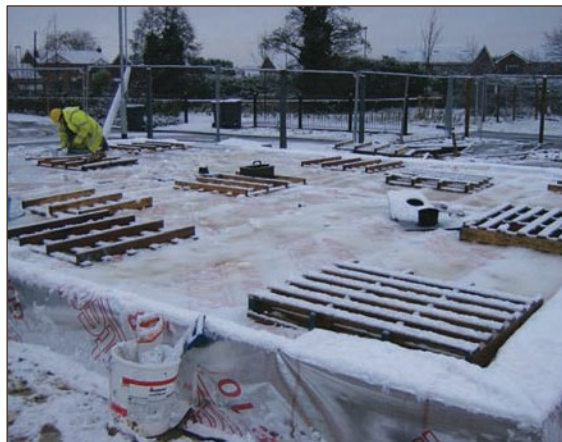
**Figure A4.84** Taped joints are difficult to construct in adverse weather. Also difficult to inspect if covered with snow (courtesy Smith Grant)

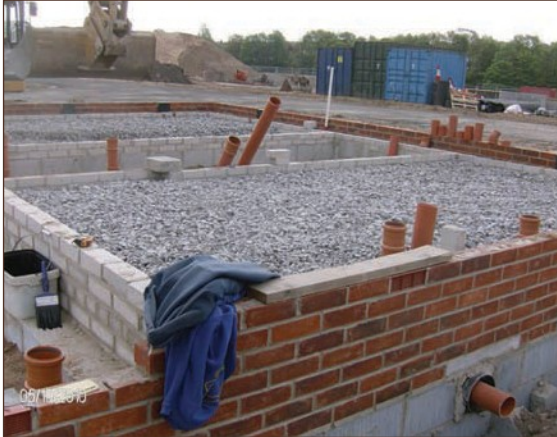
**Figure A4.85** Clean single sized stones with no fines acting as venting media, however no ventilation gaps in internal sleeper walls (courtesy Smith Grant)

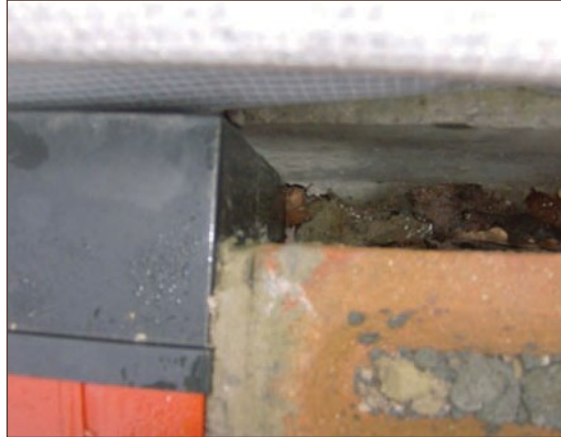
**Figure A4.86** Cavity is becoming blocked with detritus. The vent holes in the beam are no longer visible (courtesy Smith Grant)

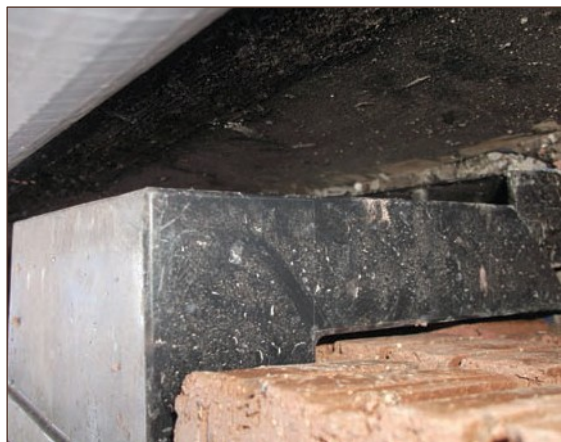
**Figure A4.88** Ventilator becoming detached to fit to external block work. This is due to builders requiring increased cavity widths to achieve thermal properties expected by Building Regulations (courtesy NHBC)

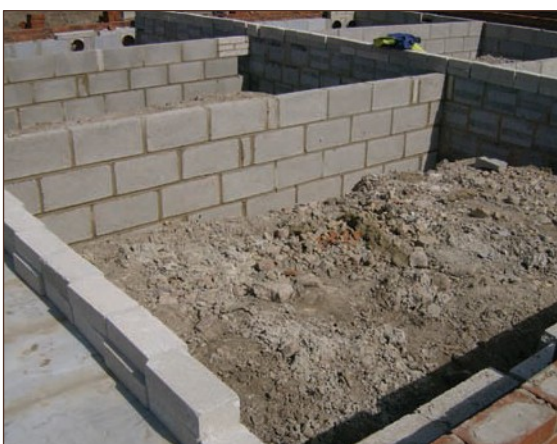
**Figure A4.89** No ventilation in internal sleeper wall (courtesy Smith Grant)

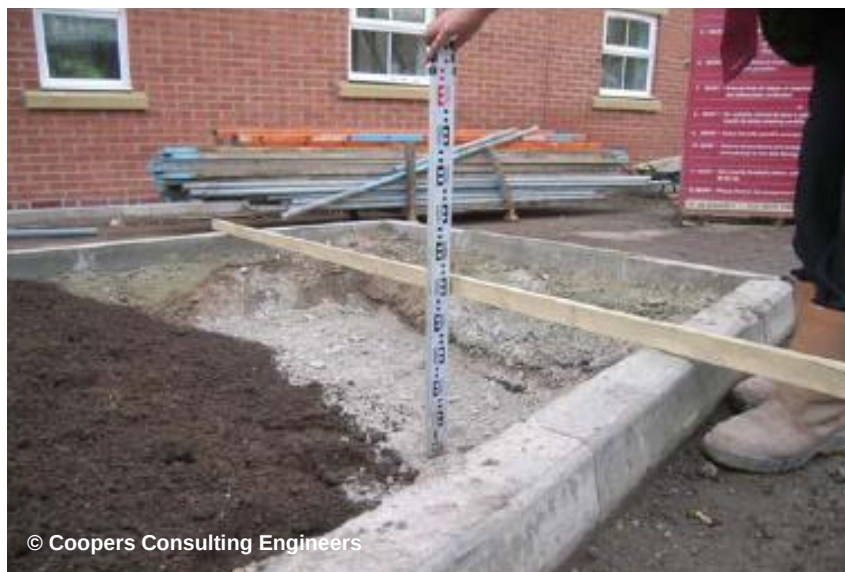
Photograph 1: Depth check of inert cover within area of public open space. Physical break layer and topsoil visible.

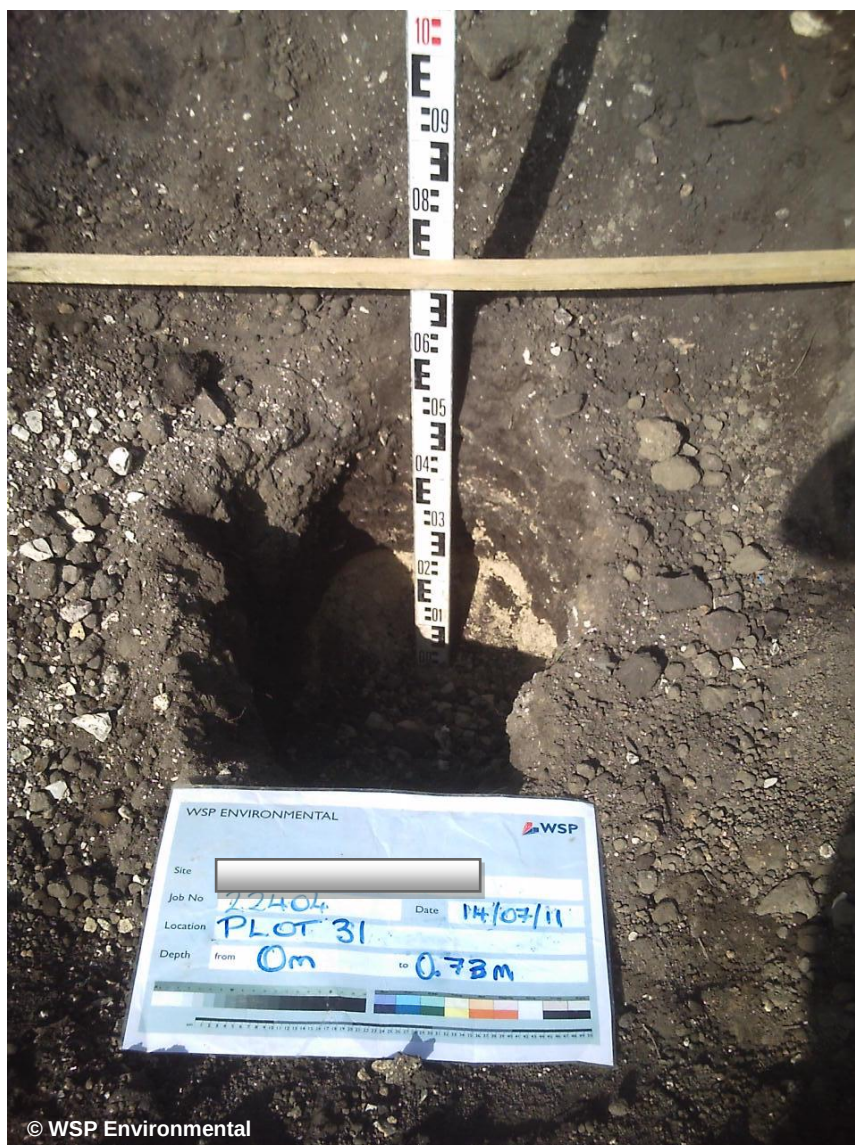
Photograph 2: Depth check of inert cover with Site & Location Information Board.

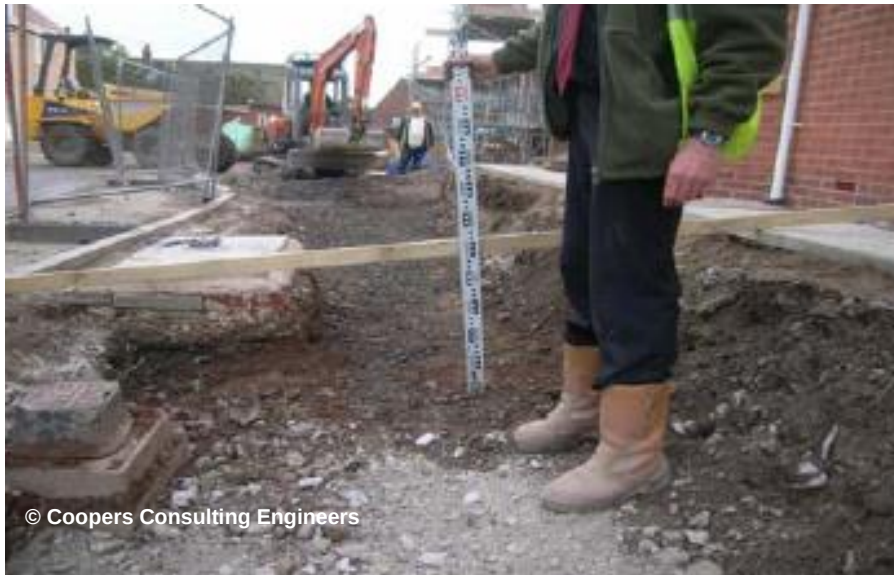
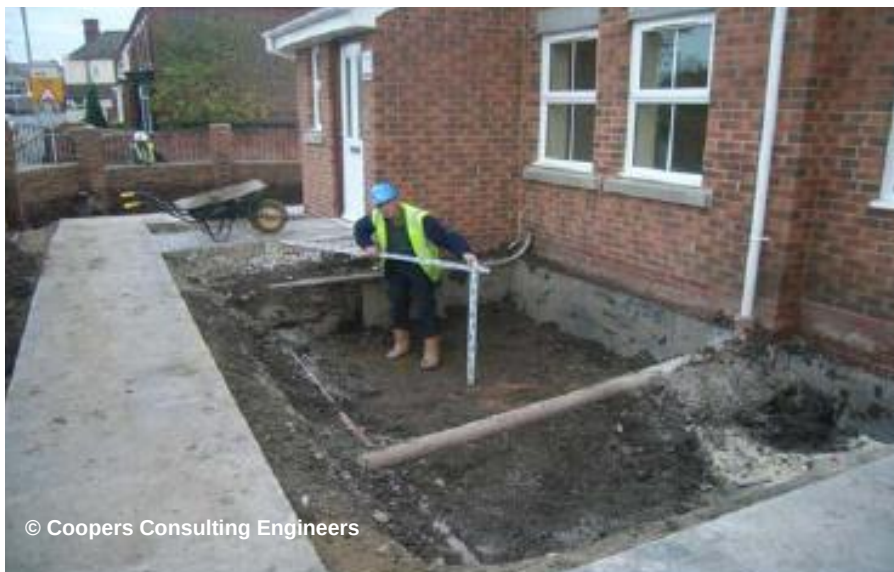
Photographs 3 & 4:  
Depth check of inert  
cover within areas of  
front gardens.

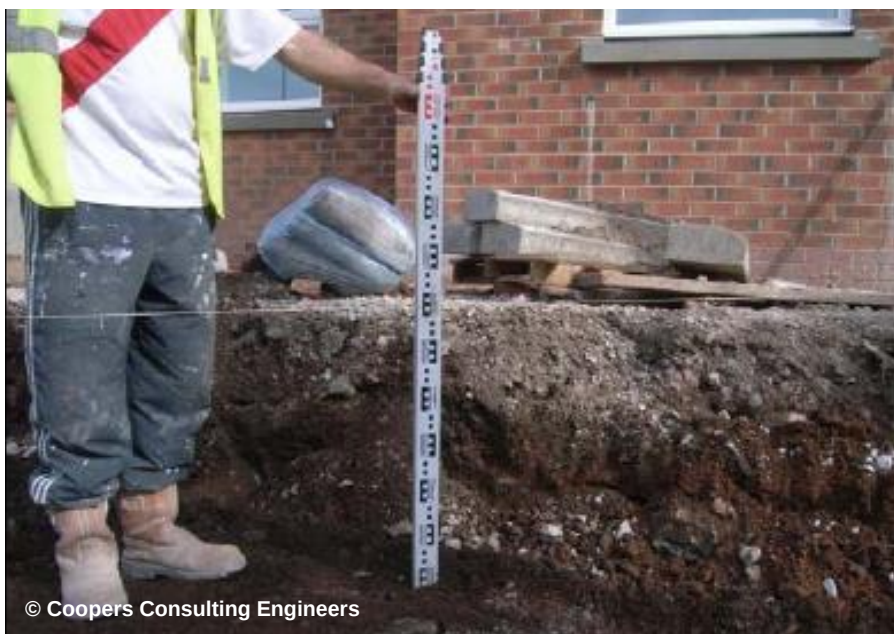
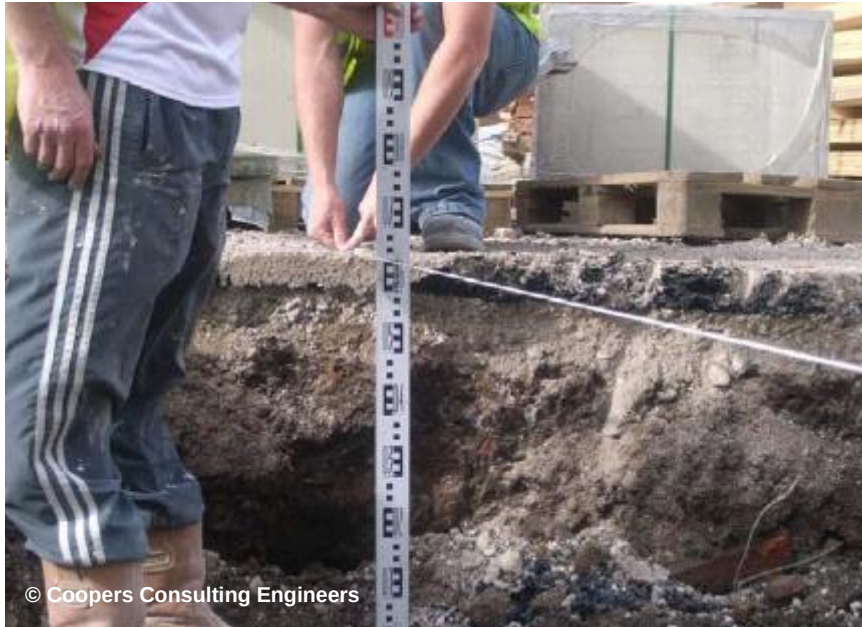
Photographs 5 and 6: Depth check of inert cover within rear gardens. Taut string line spans across excavation.

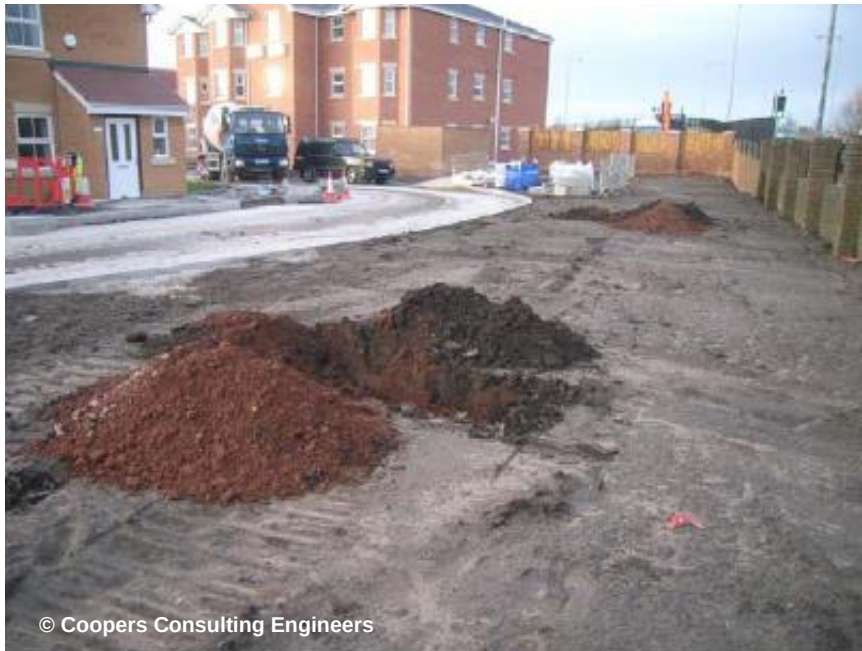
Photograph 7 shows the spatial location of the verification pit.

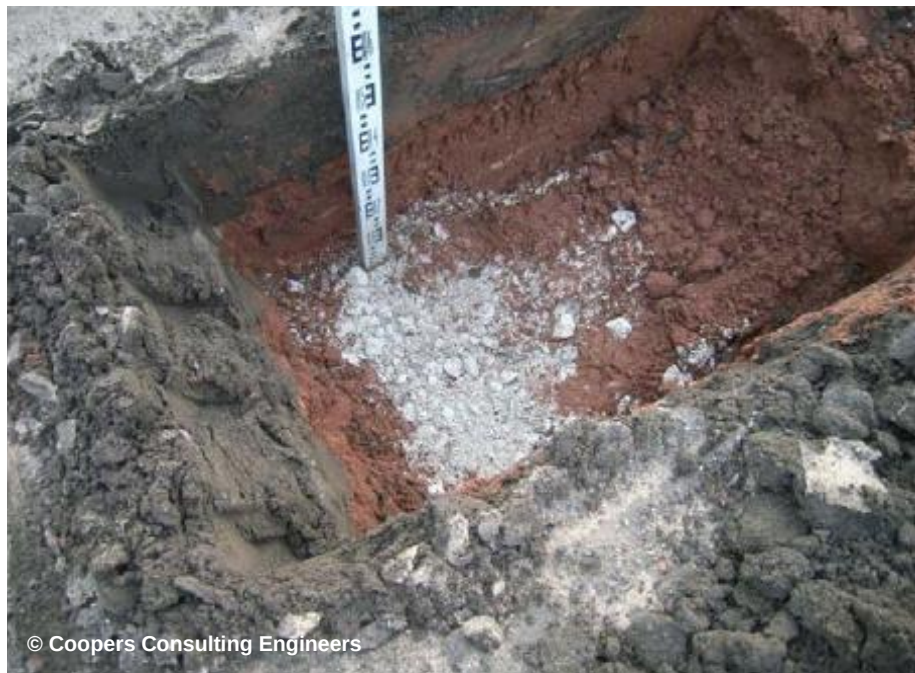
Photograph 8:  
Excavation within public open space and verification pit showing the presence of a remediation break layer at the base, a crushed sandstone inert fill overlain by topsoil.

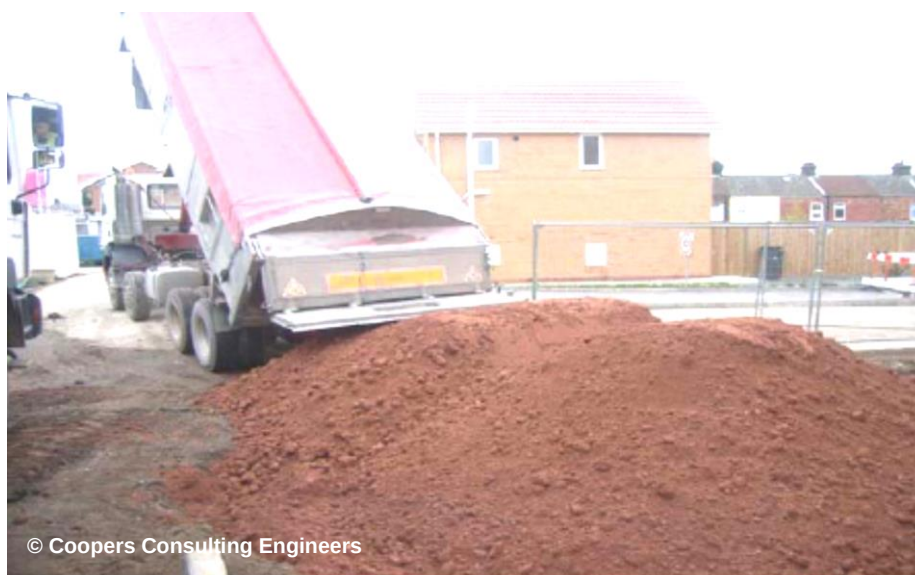
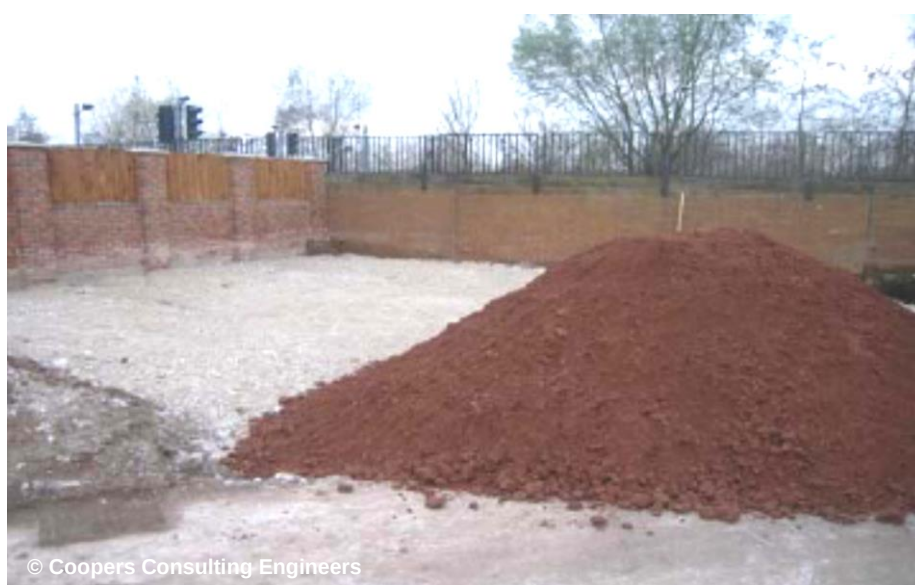
Photographs 9 and 10: Inert crushed sandstone being delivered with remediation break layer visible in Photograph 10. The spatial area of the remediation can be observed from these photographs (old terrace housing in Photograph 9 and traffic lights in photograph 10).

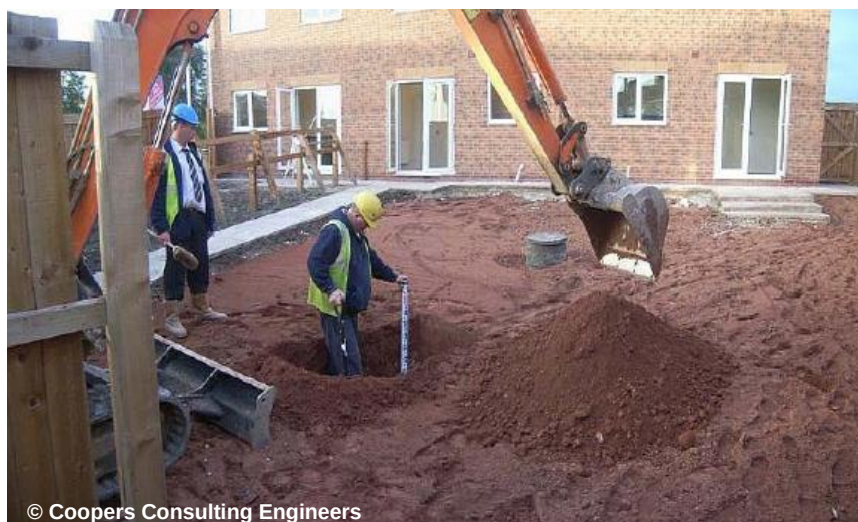
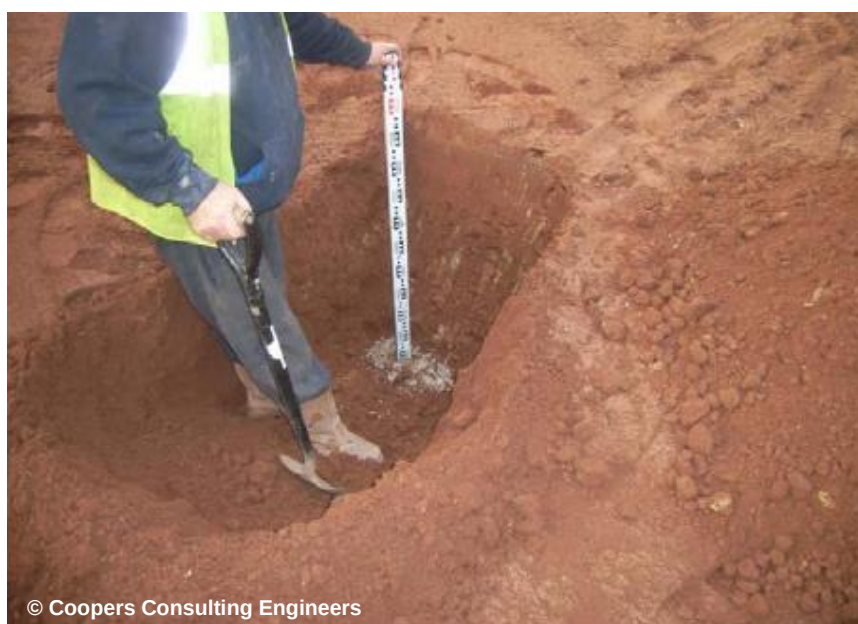
Photographs 11 and 12 show the remediation of the rear garden, with a significant depth (1.0m) of inert cover. Remediation break layer visible at the base of the excavation. Photograph 11 has been stitched to form a panoramic photograph and
