**Coal Mining Risk Assessment  
at  
4 Station Road  
Royston, Barnsley  
For  
Mr Peter Dimberline**

**Design - it**  
**Structural Solutions Ltd**

**Appendix A** Site location plan and development layout

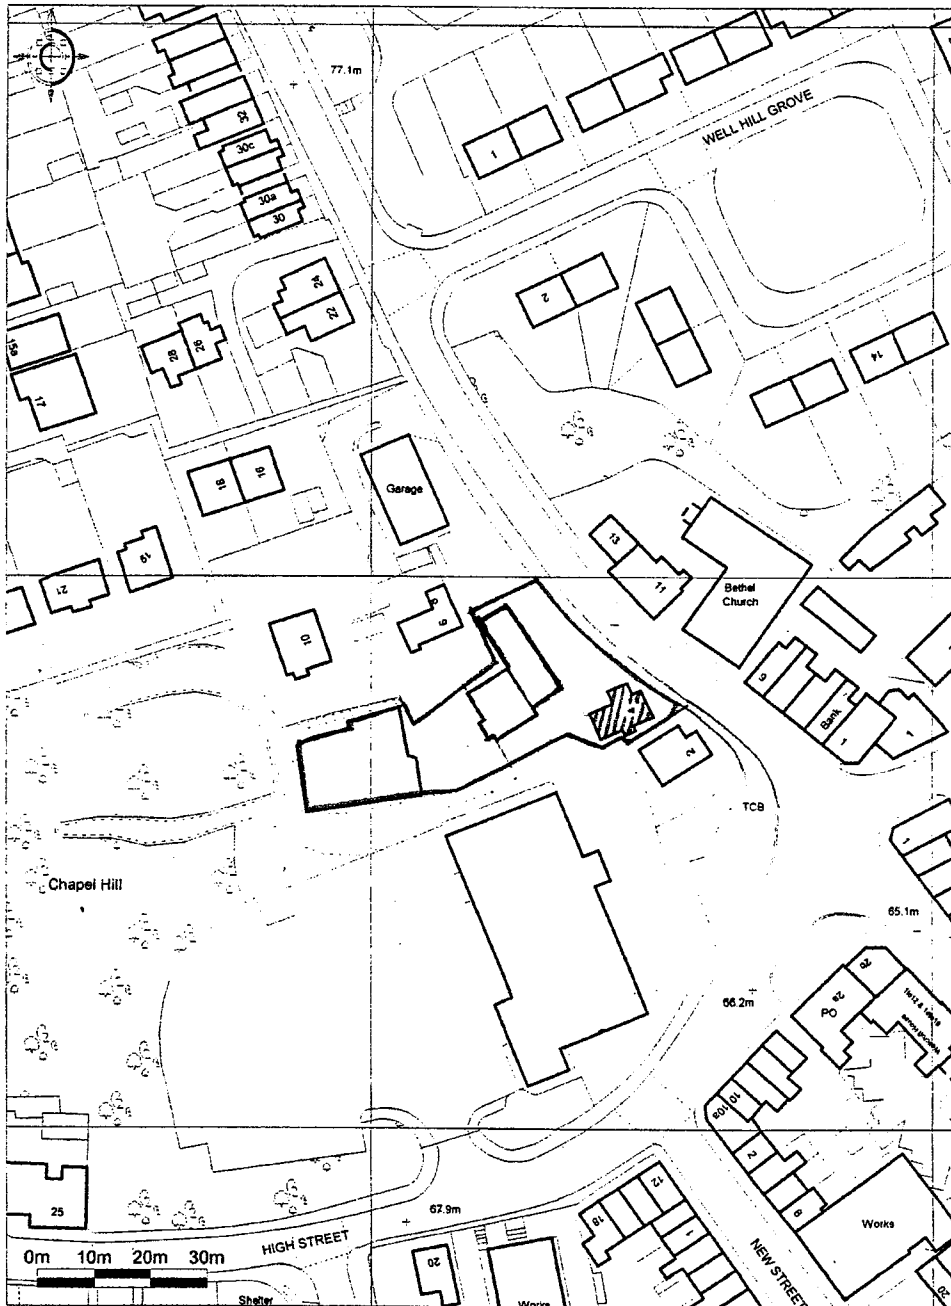
# Station Road Royston

**Appendix A**  
**Site location plan and development layout**

2.3 It is understood that it is proposed to redevelop the site with a detached 2 storey commercial office building with access directly off Station Road. The replacement building is to fully occupy the approximate footprint of the existing residential property. Details of the proposed development layout are included as **Appendix A**.
