**Penistone Grammar School, B6462  
Huddersfield Road, South Yorkshire  
Highway Condition Survey (Pre-works)**

January 2019

### Highway Condition Survey (Pre-works)

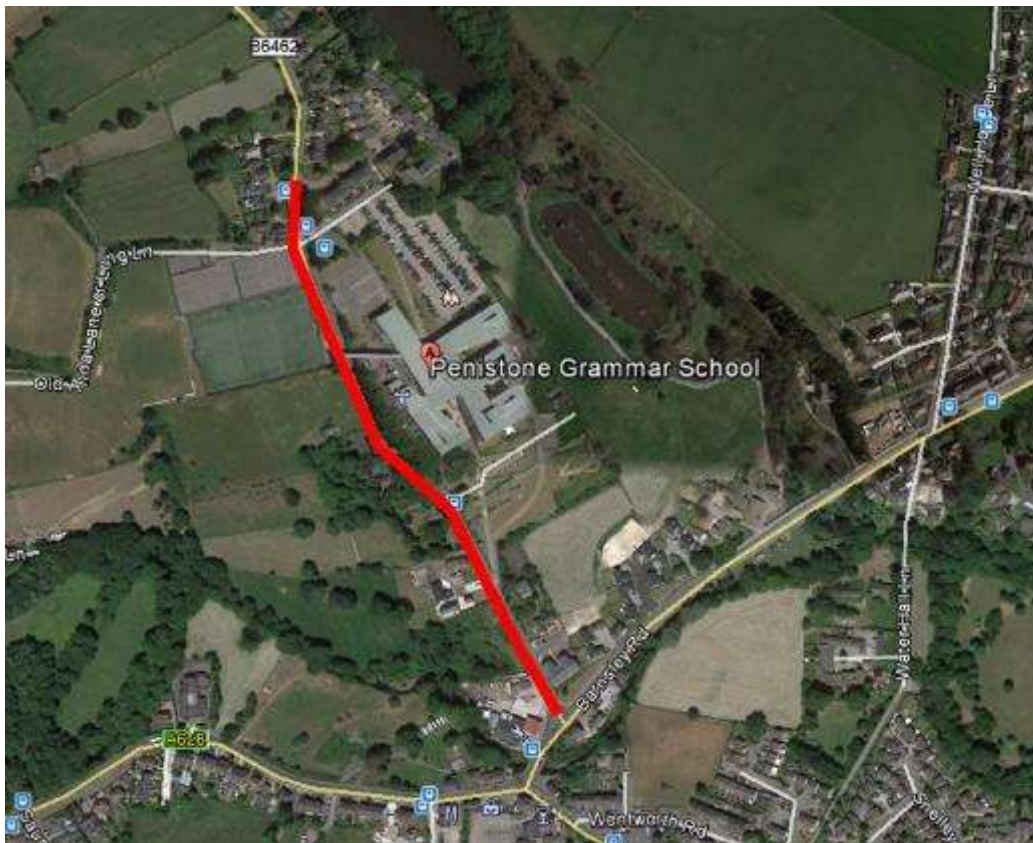
**Figure 1: Extents of survey**

- 2.1.1 The extents of the survey area on the B6462 Huddersfield Road is indicated within Figure 1 below. The length of the route is approximately 530m and extends from the centre line of the Netherfield junction in the north to the A628 Barnsley Road junction to the south. The existing vehicular access to Penistone Grammar School is located towards the northern end of the survey area, approximately 50m south of the Netherfield junction.
- 2.1.2 The B6462 Huddersfield Road is a two-lane single carriageway that is subject to a 30mph speed limit and benefits from a system of street lighting. A footway is provided throughout the route's western side, with the footway intermittent on the eastern side. Huddersfield Road is a bus route and a number of Heavy Commercial Vehicles (HCVs) were observed to use the route.
