## **Structural Inspection - Barn @ Dickroyd Farm**

**DESIGN & ACCESS STATEMENT**

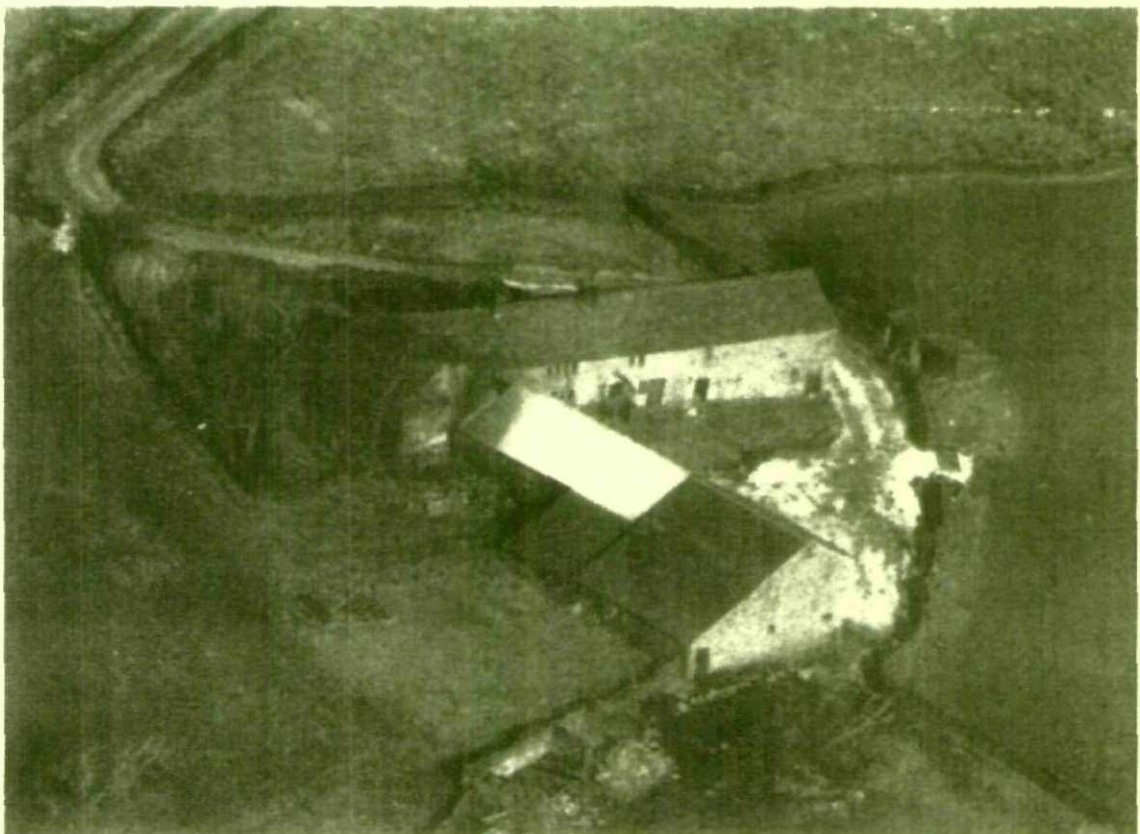
At the rear of the proposed conversion, to the west elevation, stands a modern rendered blockwork lean-to former livestock building under a sheeted roof that it is proposed, should be removed to enable the recreation of the former stone lean-to that was previously adapted to the current construction.

Aerial view of farmstead showing original lean-to.
