## Coal Mining Risk Assessment

23 Bar Lane

Staincross

Barnsley

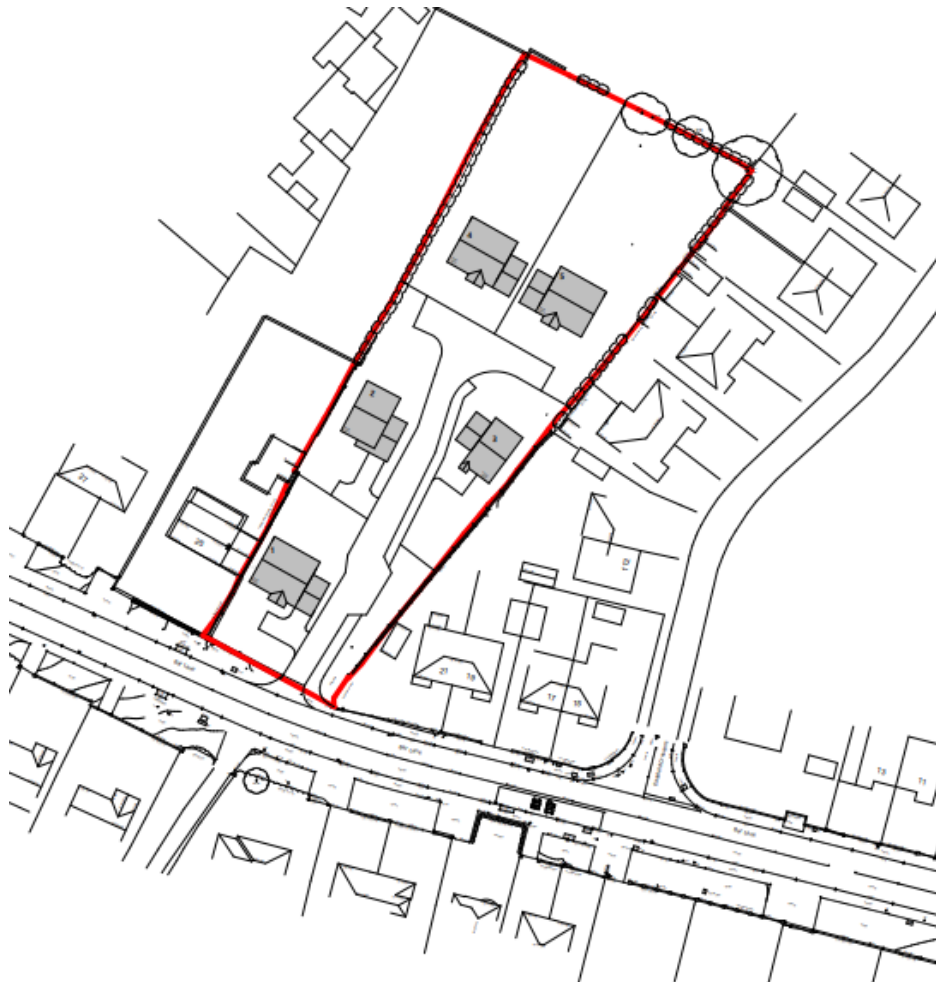
**Figure 1 Proposed Development Plan**

- 1.6 The houses are designed to use the roof spaces to decrease the footprint of the houses on the site.
- 1.7 All dwellings have a minimum of 2 parking spaces per dwelling, served by the internal unadopted road which includes a passing place.

- 1.1 Earth Environmental & Geotechnical Ltd have been commissioned by Carl Masters (the Client), to undertake a Coal Mining Risk Assessment for a development on land off 23 Bar Lane, Staincross, Barnsley.
- 1.2 A proposed development plan has been provided shown as Figure 1.
- 1.3 The site is located within a large residential area and is classed as an infill development.
- 1.4 The proposal involves the demolition of the existing property at 23 Bar Lane and the associated outbuildings. The new build section of the development includes for the construction of five detached properties with a service unadopted road which will connect all properties with Bar Lane.
- 1.5 A planning application (2023/0597) has been submitted to Barnsley Metropolitan District Council.

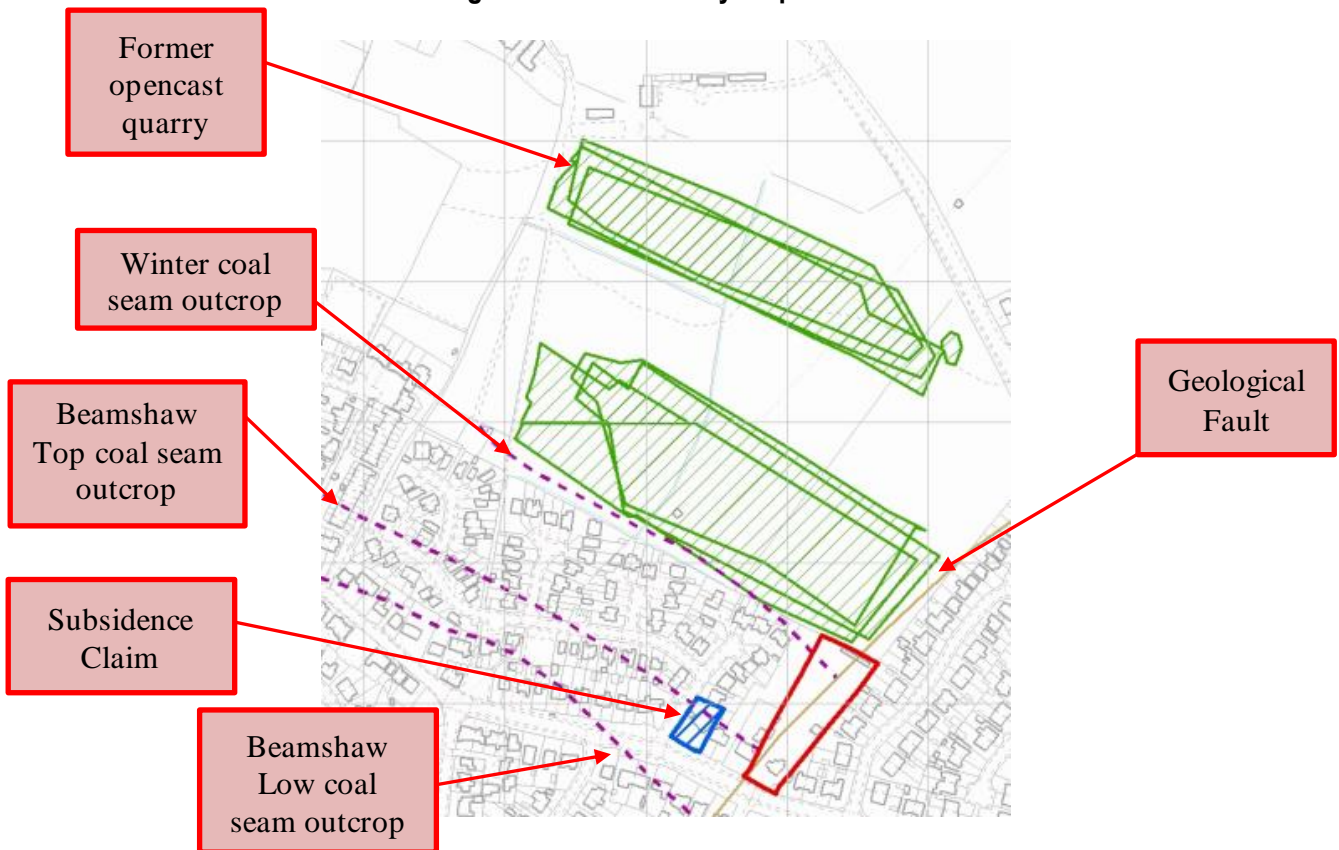
**Figure 5 Coal Authority Map Extract**

3.12 An extract from the Coal Authority report is shown in Figure 5.

3.15 A geological fault bisects the site with the coal seams terminating against it.

- 3.10 Reference to the Coal Authority Online Interactive viewer shows the site to be located within a Development High Risk Area and within an area of shallow probable mine workings.
- 3.11 A Coal Authority Mining Report has been acquired for the site and reveals that there are number of proven records of past underground mine workings beneath the site. The worked coal seams beneath the site are summarised in Table 2 overleaf.
