ARCHITECTS
HERITAGE IMPACT STATEMENT

**THURNSCOE HALL, S63 0ST
Conservatory and Garden Room**

August 2023
Job number: 5768

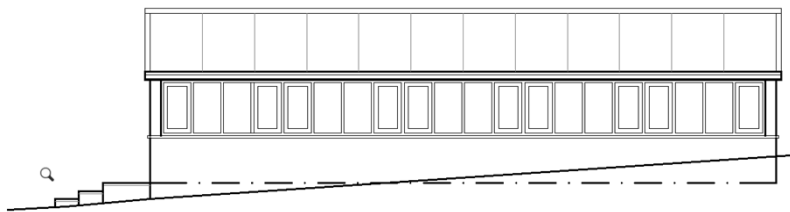
Fig 2: West Elevation, Existing

- 4.1. The proposals seek to refurbish the dilapidated building and improve the roof detailing, overcoming the faults in the existing construction.
- 4.2. The existing garden room has a stone plinth wall, inset into the rising ground to the south of the hall. The scheme seeks to rebuild the stone walls beyond the trees to the south and west. The stone wall would be extended to eaves height at the south and west elevations. This reduces the area of glazing on both facades. The wall would be constructed in coursed, squared, random-length, pitch-faced sandstone, to match the existing.

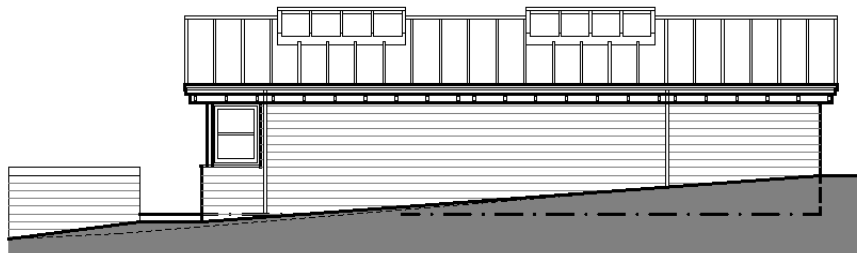
Fig 4: West Elevation Proposed

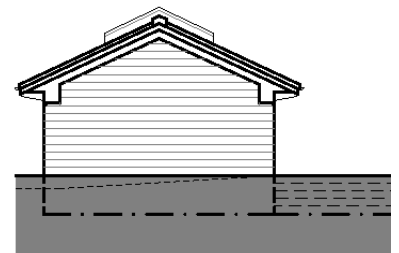
Fig 5: South Elevation

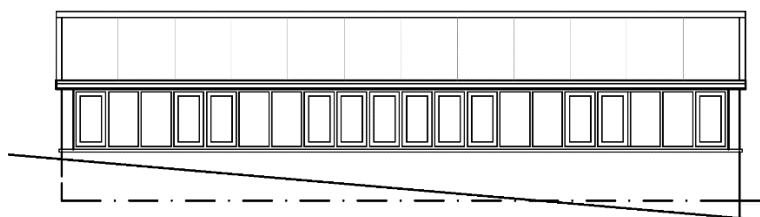
Fig 6: East Elevation, Existing

- 4.3. New bifold doors will be formed in the east elevation. The ground level immediately adjacent to the garden room would be regraded to allow level access directly onto the lawn. The vertical boarding at the north gable would be replaced with glazing up to the underside of the verge.

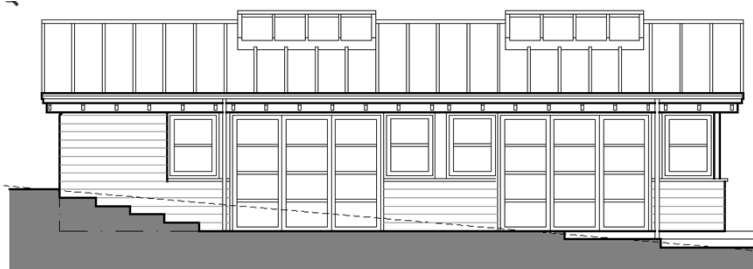
Fig 8: East Elevation, Existing

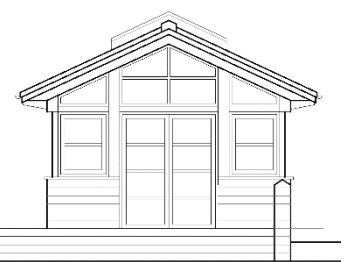
Fig 9: North Elevation

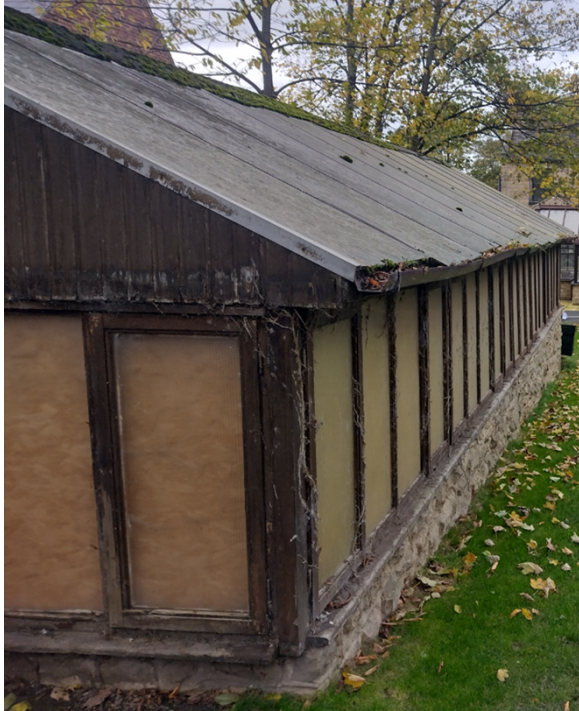
Fig 10: Slipped roof panels, and rotten corner post

- 4.4. The proposed alterations to the roof overcome issues with the existing detailing, including:
- Slipped roofing panels, owing to the materials used;
 - Insufficient projection at eaves beyond face of wall resulting in water damage to façade;
 - Water ingress to roof at ridge and along roof framing.

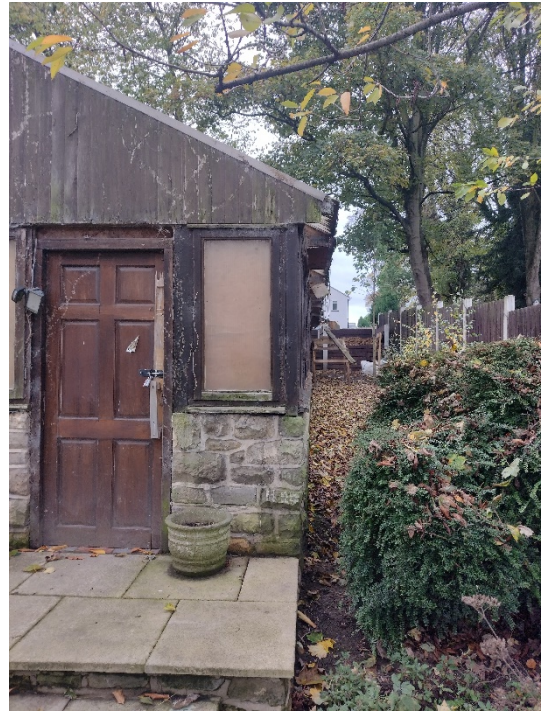
Fig 11: Inappropriate door and poor verge detail

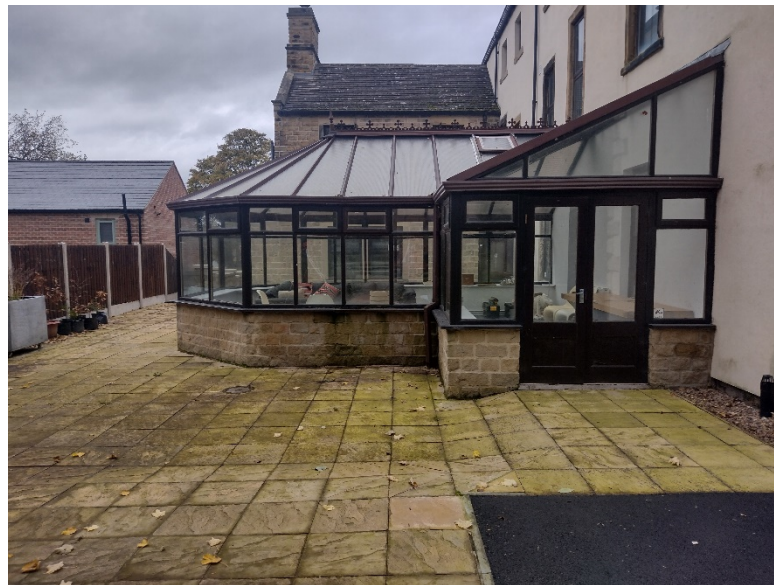
Fig 12: Existing conservatory

- 5.1. The proposals seek to replace the dilapidated building with a new conservatory, improving the relationship of the form and volume in relationship to the existing west façade and linking the conservatory design to the garden room.
- 5.2. The existing conservatory has an L-shaped plan, resulting in a long pitched valley gutter. The gutter is formed incorrectly, with a valley rafter connecting mullions for the glazed roof. This results in water ingress at the bottom edges of the panels, and along the valley rafter.
- 5.3. The conservatory is an off-the-shelf model with a splayed west end, with a hipped roof.

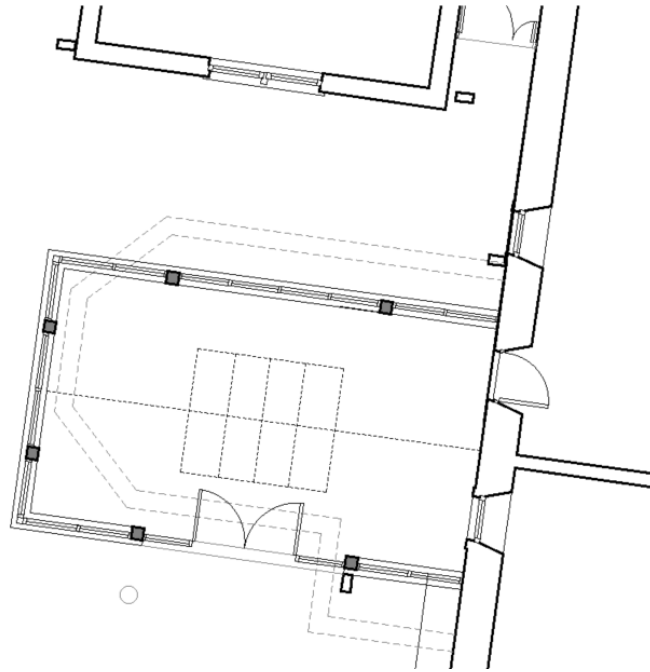
Fig 12: Proposed conservatory in relation to north wing and main house

- 5.4. The proposed footprint for the new conservatory provides a rectangular structure with broadly similar overall area to the existing conservatory. The gable end of the conservatory reflects the 2 storey, north-west wing as a subservient extension to the primary heritage asset.

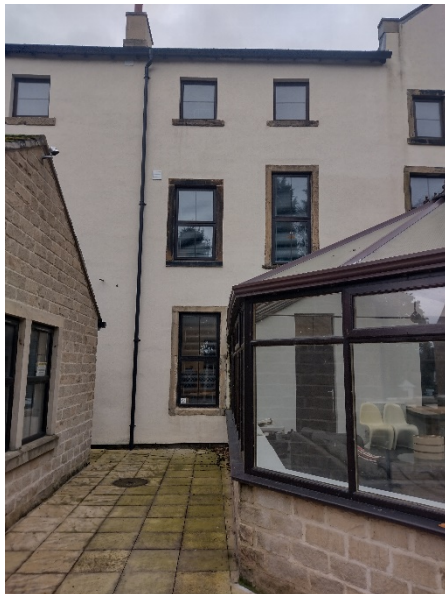
Fig 13: Ground Floor Window adjacent to conservatory

5.6. The existing window immediately north of the conservatory will be set off from the wall of the conservatory under the proposals. This allows the original window to be better read as part of the main façade.

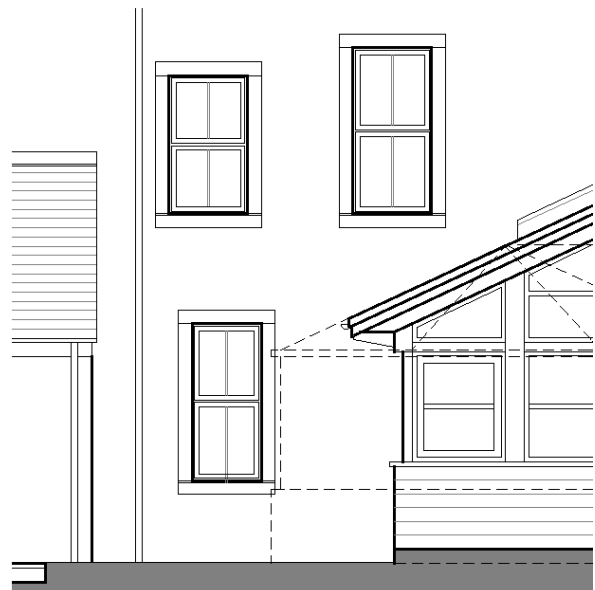
Fig 14: Proposed conservatory set off window

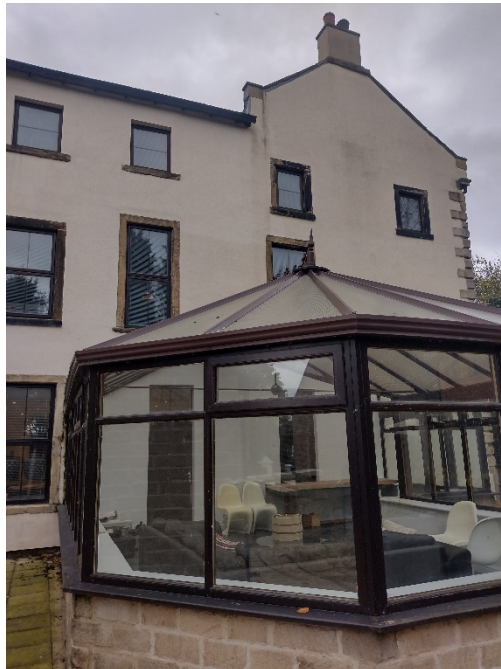
Fig 15: Existing splay ended conservatory and octagonal hipped roof incongruous against gable ends of principal heritage asset.

- 5.7. The proposed form of the new conservatory reflects the architecture of the existing house. The existing main hall to the south and the north wing both have gable ends, the conservatory adds a third gable at a former gable fronted porch position.

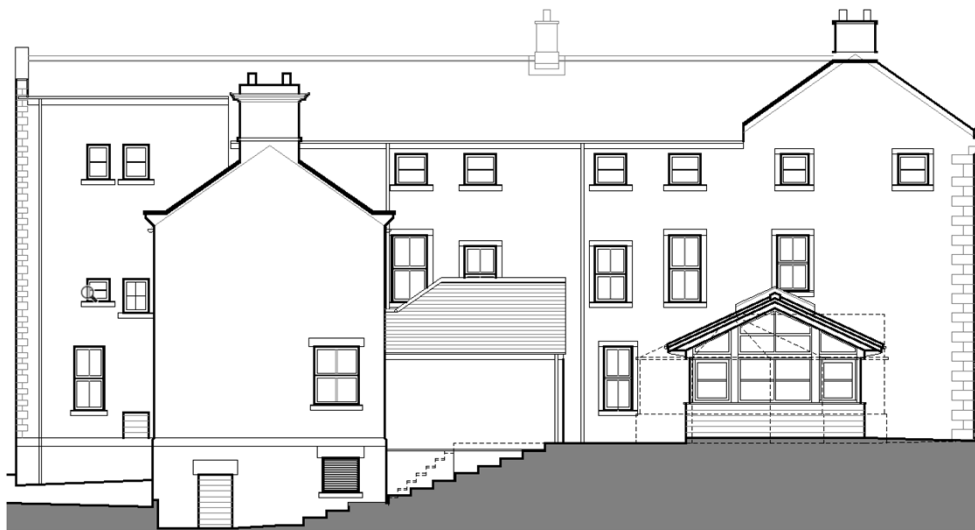
Fig 16: Proposed new conservatory roof provides balanced gable end to compliment south and north gables of existing building.

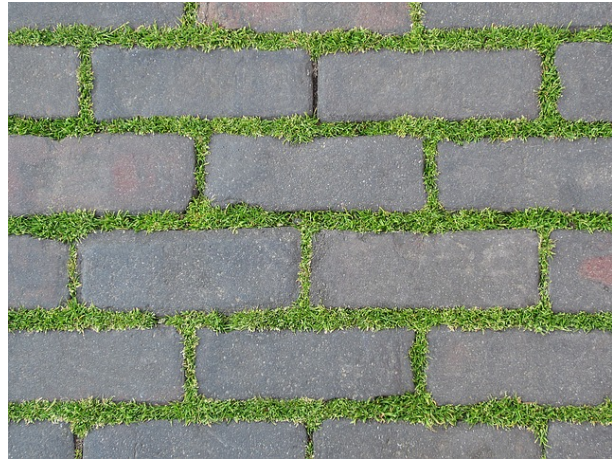
Fig 18: Spaced permeable paviours, with sown grass between.

- 6.4. In order to maintain the appearance of a lawn along to the south of the main house the patio and steps beyond the riser will be in spaced stone paviours, with grass seed to the gaps. This can be mown alongside the main lawn, whilst maintaining a level surface suitable for wheelchair access. The nosings to edges of the steps will be in close spaced, mortared paviors, to provide a consistent appearance.
- 6.5. The existing herb garden and shrubbery between the west wall of the garden room and the boundary fence will be maintained.

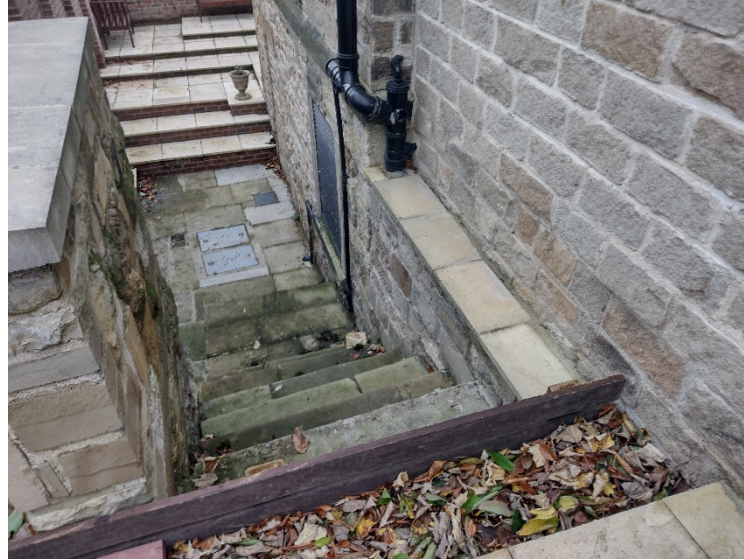
Fig 19: Existing steps between boundary and north-west wing – uneven length, height and width.

- 6.6. The existing steps to the side of the 1980s single storey extension to the north-west wing are to be re-formed. The existing steps are uneven in pitch and rise/going. There is a steep edge to the retained west side, with steps starting before the wall, to drop down to the level of the extended stone plinth.

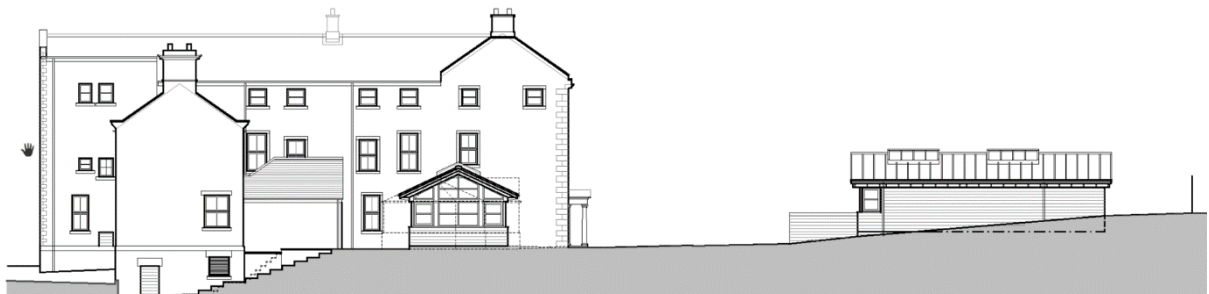
Fig 22: Relationship of Garden Room & Conservatory to main house
