Harworth Estates

Rockingham, South Yorkshire

Appraisal of Ground Conditions and Coal Mining Review

Report no. 321393-R01 (01)

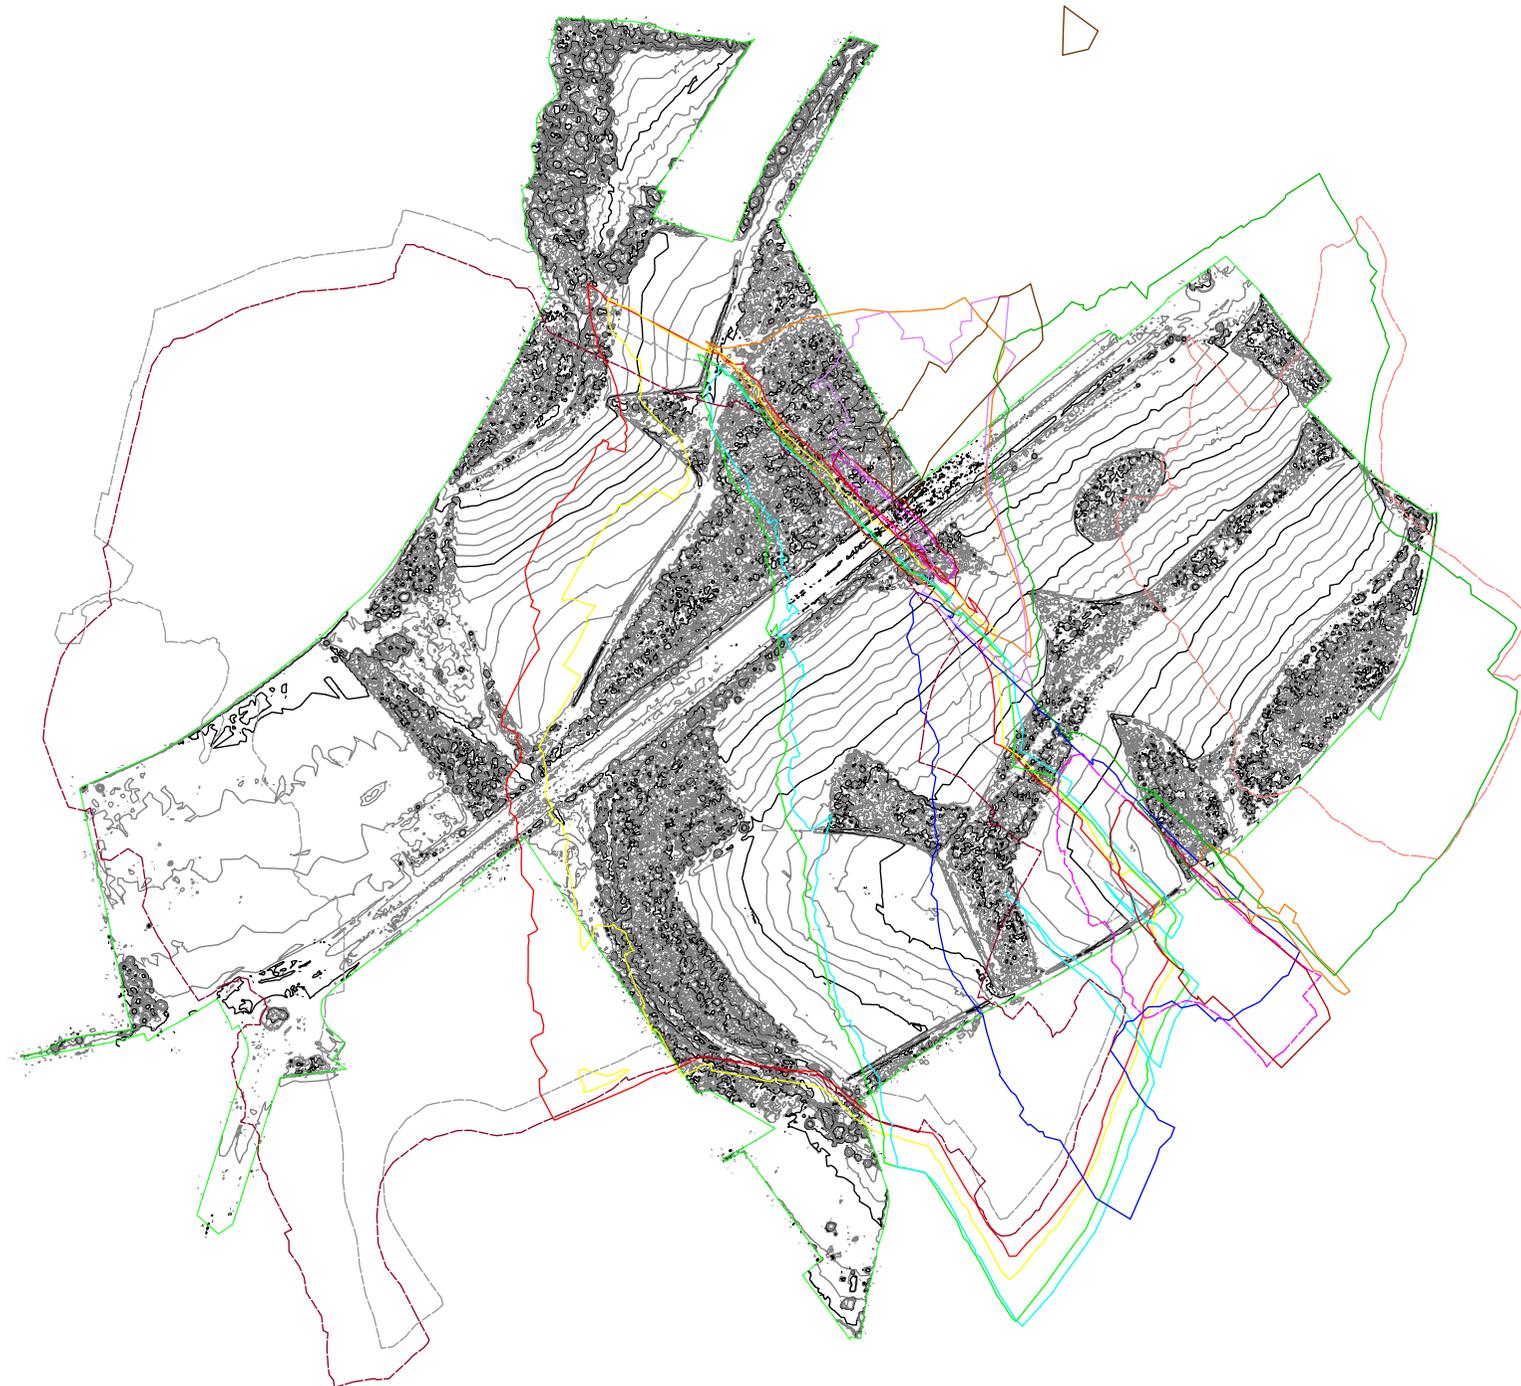
| HD | 12.07.13 | | | FIGURE 3 | A |

- Beamshaw BB
- Kents Thln BA
- Unnamed 1AZ
- Kents Thlck AZ11
- Unnamed 1AY
- Barnsley Rider Upper A
- Barnsley Rider Lower A
- Barnsley AVX
- Dunsfil Rider Upper 2AU
- Dunsfil Rider Lower 1AU
- Dunsfil AU
- Swallow Wood Rider 1AR
- Swallow Wood Ar
- Unnamed 1AQ

Figure 3 in this report shows the outlines of worked areas for all coal seams. The shallowest worked seam on site was the Beamshaw, with the base of excavation for this (within the site area) being just below 150m AOD. It is evident that this seam, along with all the others, dipped downwards towards the north-east. Due to this dip, the excavation area for each seam gradually moves westwards. The excavation for the Dunsil Rider Upper seam, for example, extended across both sides of the road, and was at its deepest around the area of the Elsecar fault, with the base here being around 110m AOD.
