Job Title:
Repairs to the Gatehouse at Monk Bretton Priory, Barnsley

Drawing Title:
Proposed Repairs to the West Wall

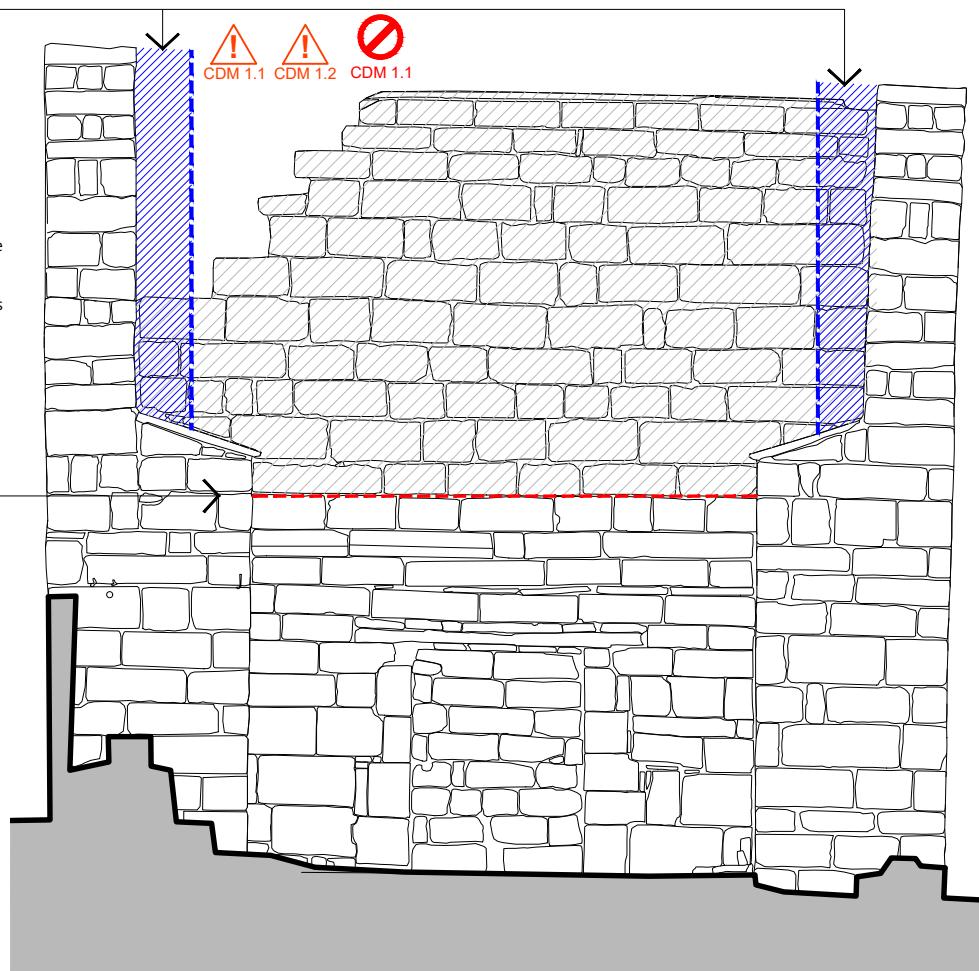
West Elevation of the West Wall of the Gatehouse 1:50

Brick pier support to be installed following deconstruction of the wall and assessment by the Structural Engineer. Reclaimed masonry from the deconstruction will be reused where possible.

Wall to be dismantled down to the course of stone above the chamfered stone on the Western face of the wall. The red dotted line indicates this position but should be confirmed with the architect on site prior to dismantling.

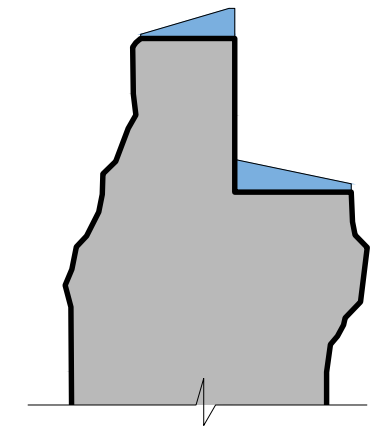
Section of the West Wall of the Gatehouse 1:100

Hatch shows the position of the loose lime putty to the wall head as temporary protection before the reconstruction process.
