COAL MINING RISK ASSESSMENT AND COAL RECOVERY REPORT

Employment Land Barnsley West

Reference	4848-JPG-Z2-XX-RP-G-1102-S2-P04
Date	August 2019
Author	JBW

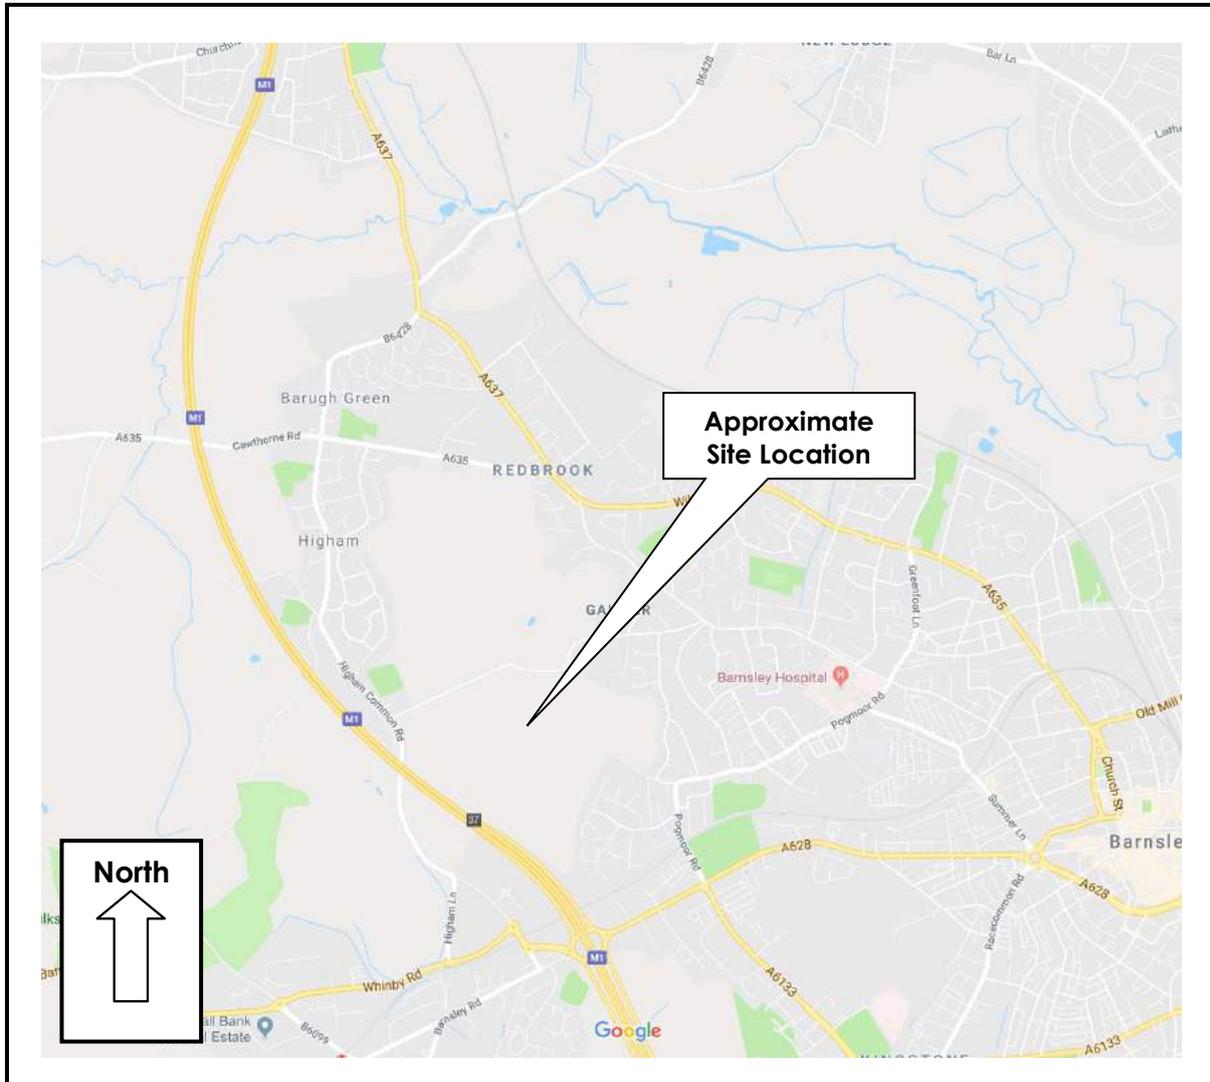
Figure 1 – Site Location Plan

Site	Employment Land, Barnsley West
Client	Strata Sterling Barnsley West Limited
Job Number	4848
Scale	NTS

The site is located to the northeast of the M1 motorway and to the south of Hermit Lane. A site location plan is presented as Figure 1 in Appendix A.

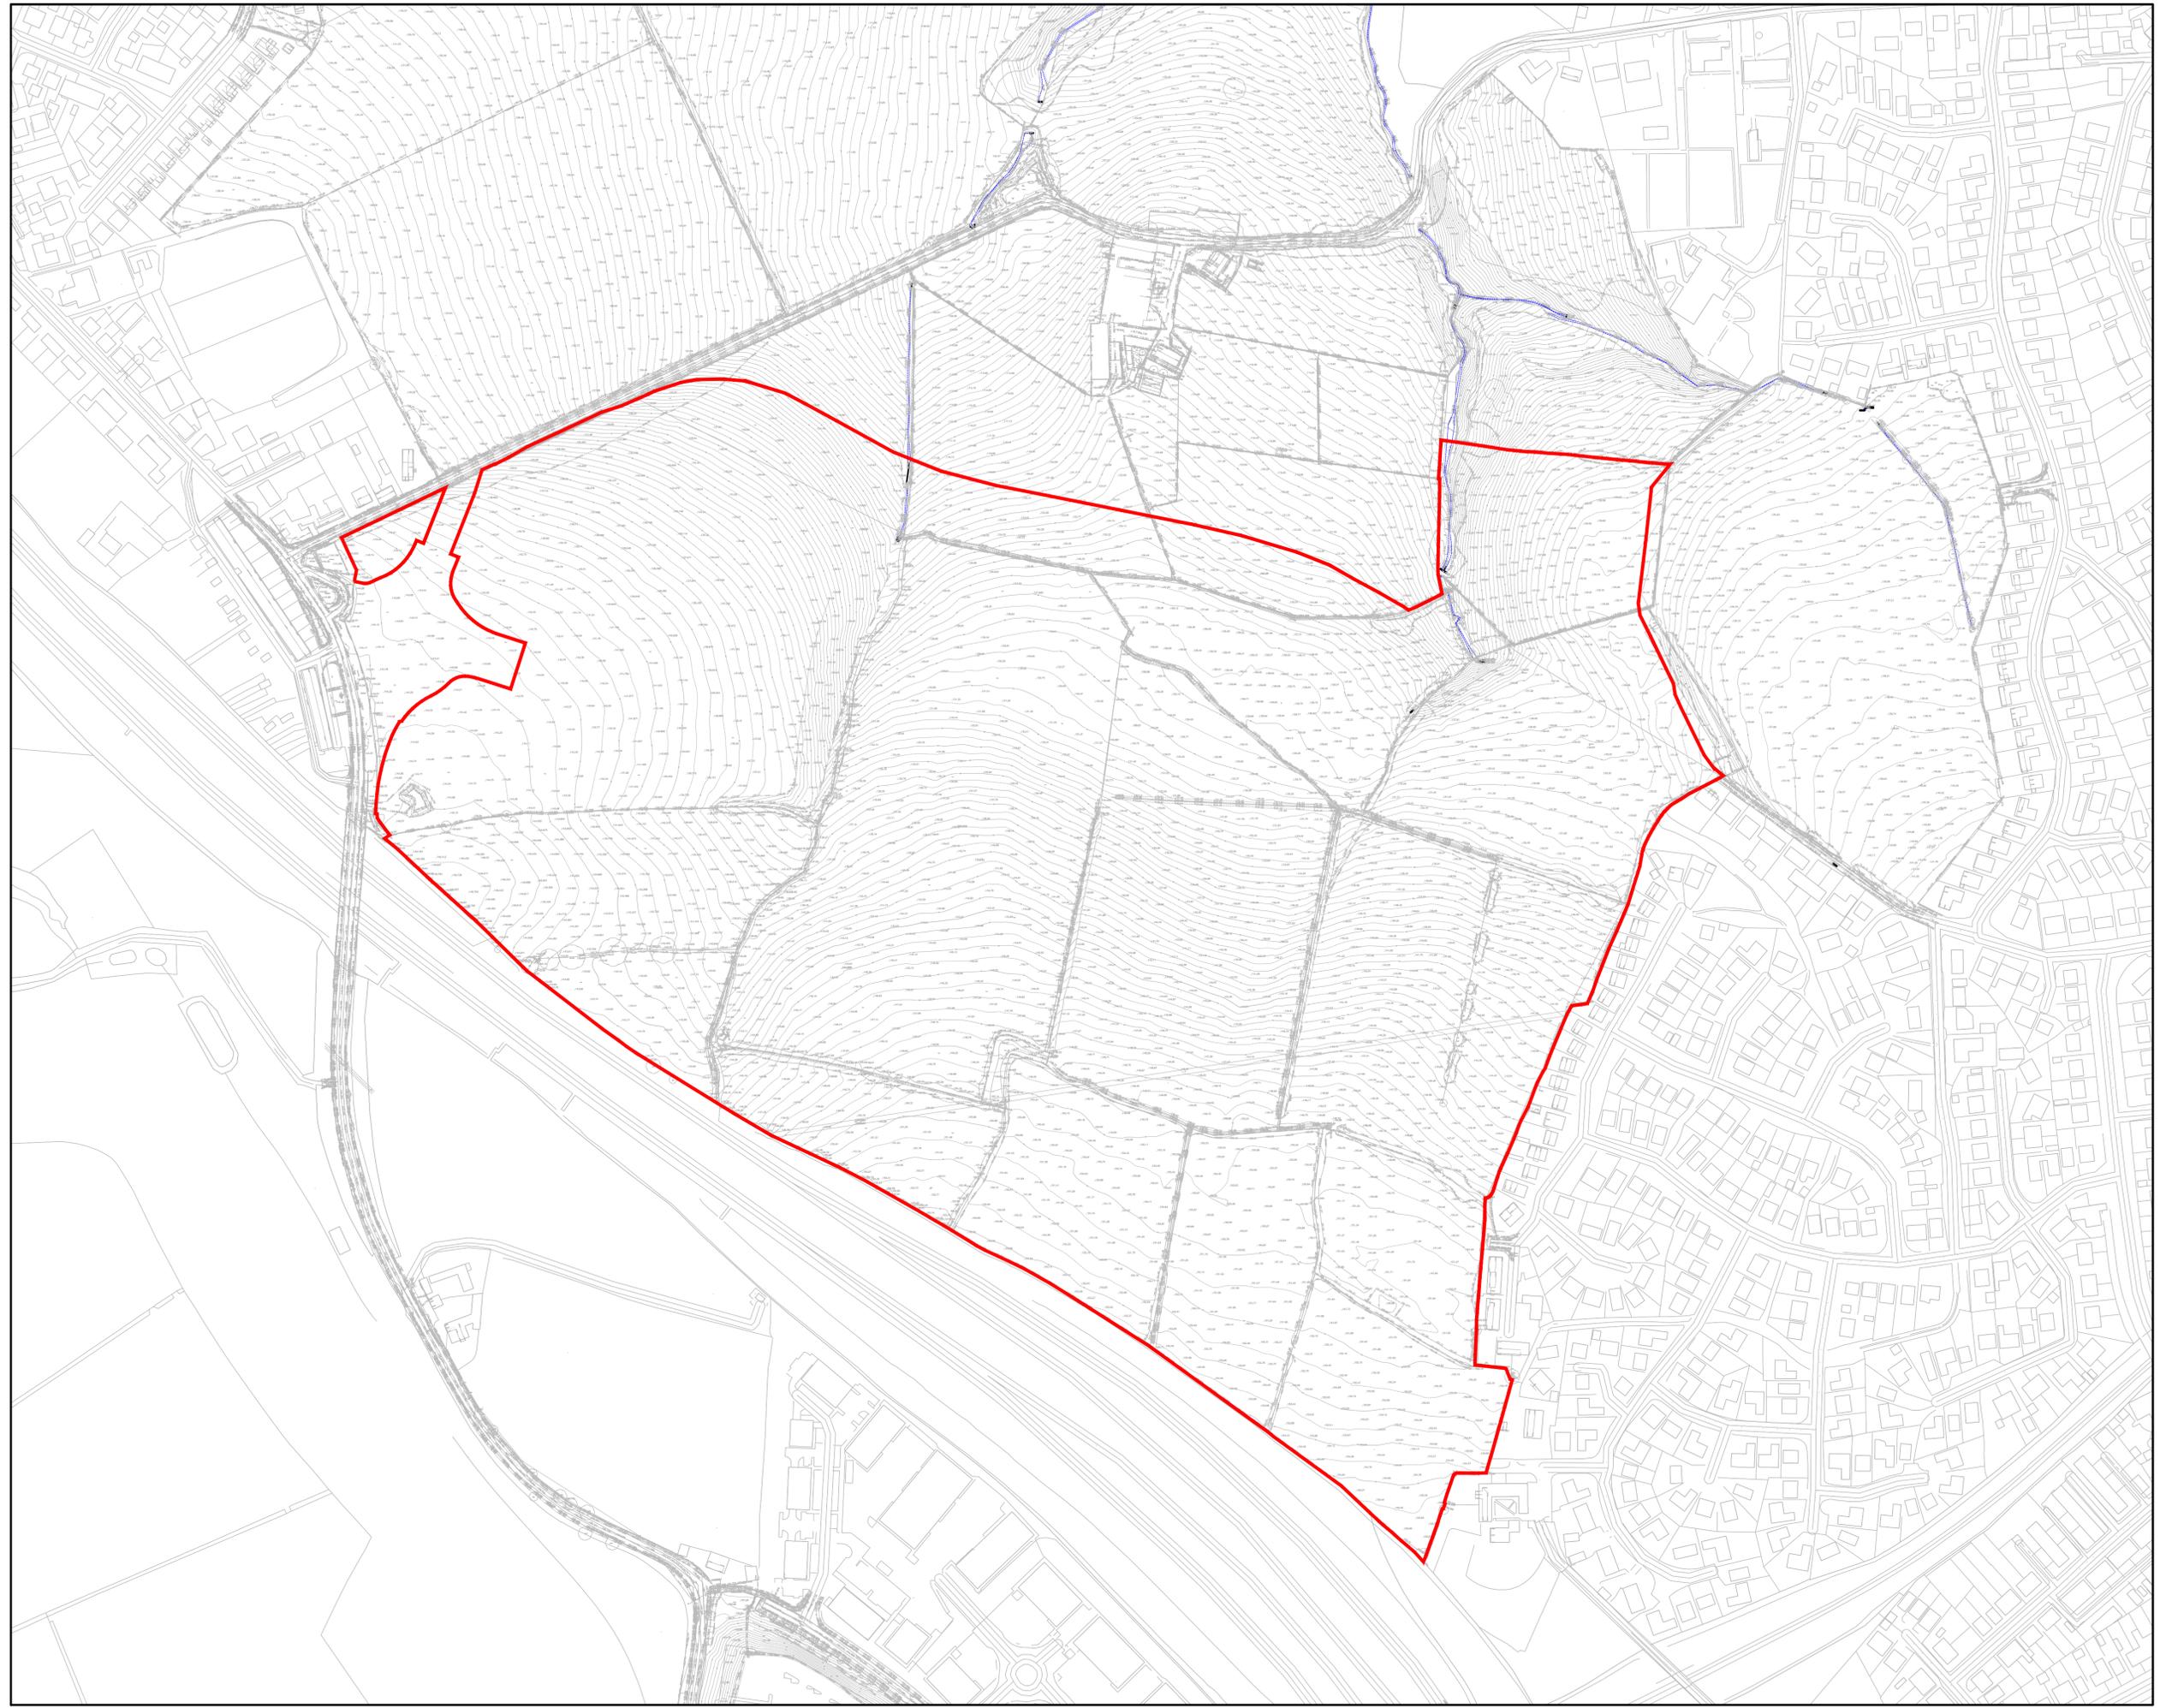
— COMMERCIAL BOUNDARY

JPG Leeds Limited. Commercial Boundary Plan. Barnsley West. Drawing Ref: 4848-JPG-ZZ-ZZ-DR-C-1001-S2-P02. Dated March 2023.

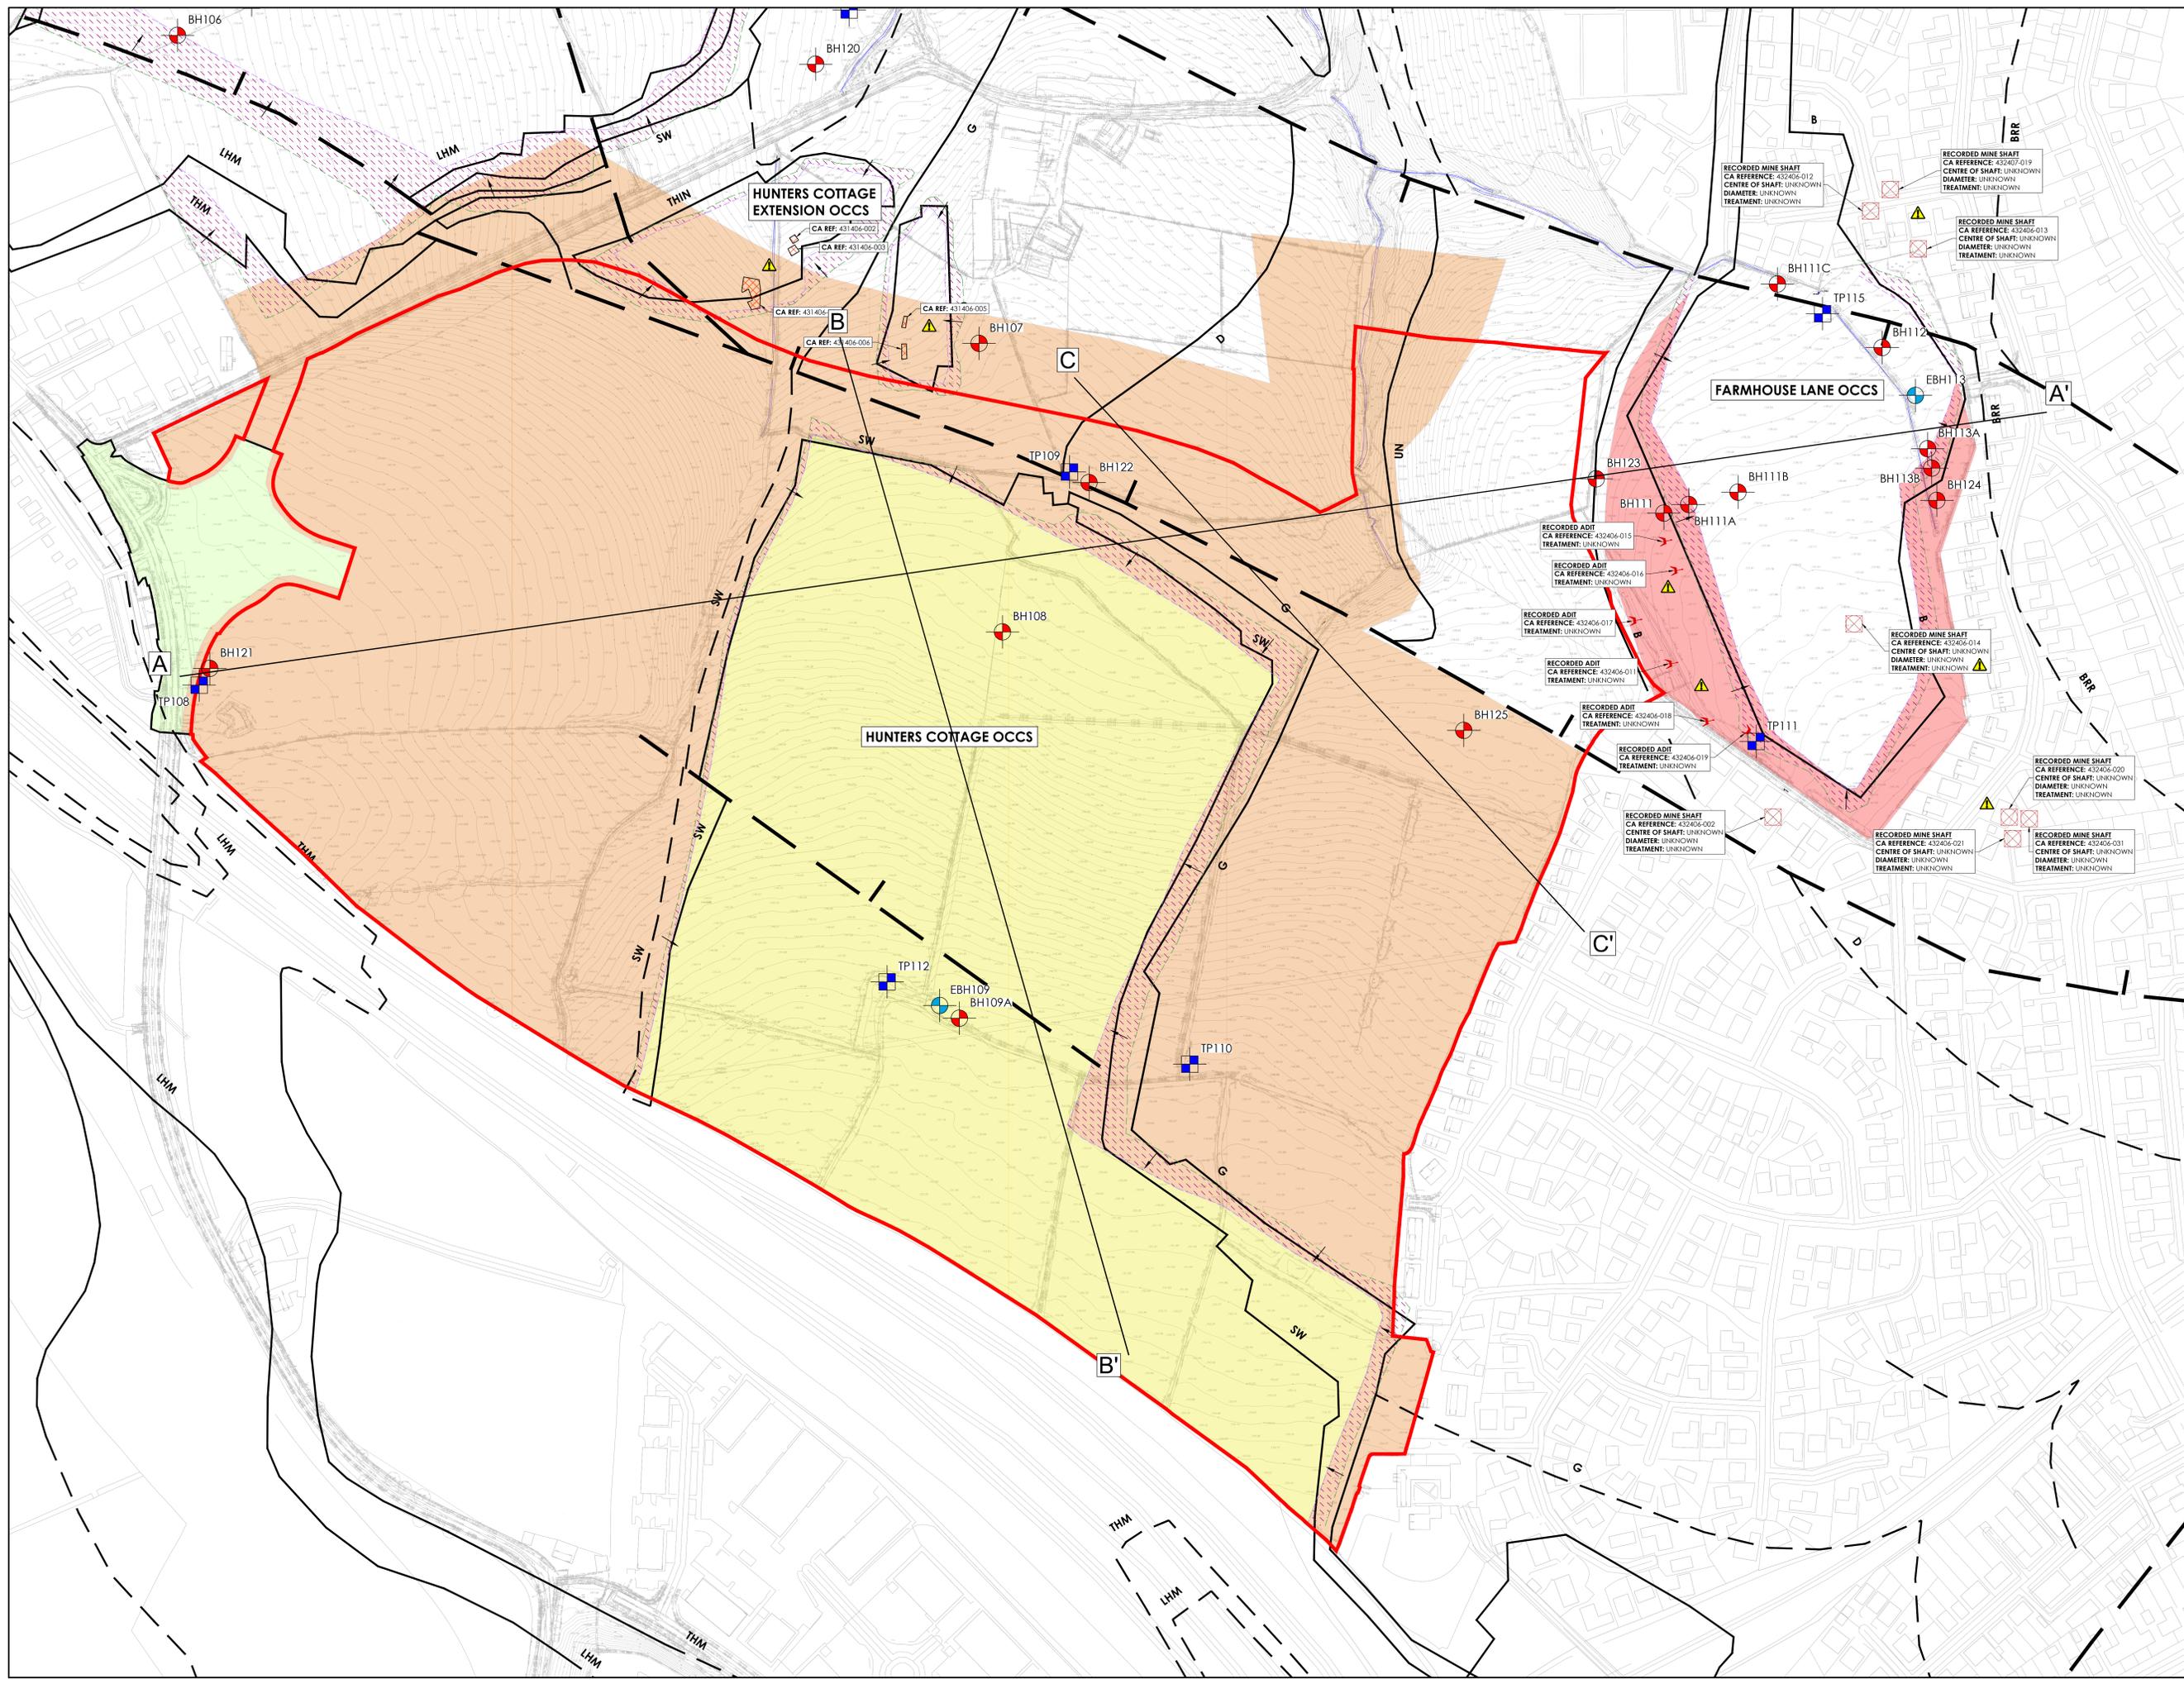
CAUTION: MINE ENTRIES & SHALLOW WORKINGS
 CAUTION TO BE OBSERVED ON SITE AT ALL TIMES DUE TO RISK OF SUFFOCATION, LOCATIONS AND COORDINATES OF SHALLOW MINE WORKINGS AND MINE ENTRIES TO BE IN APPROPRIATE GROUND INVESTIGATION.
 ALL MINE BOREHOLES LOCATED ON SITE TO BE SURVEILLED WHERE POSSIBLE AND RECORDED OFF FROM PUBLIC ACCESS UNITS. APPROPRIATE REMEDIAL ACTIONS ARE TAKEN.

JPG Leeds Limited. Barnsley West. Conceptual Ground Model - Coal Mining Risks Level Assessment. Drawing Ref: 4848-JPG-SW-XX-DR-G-1307-S2-P05. Dated July 2019.

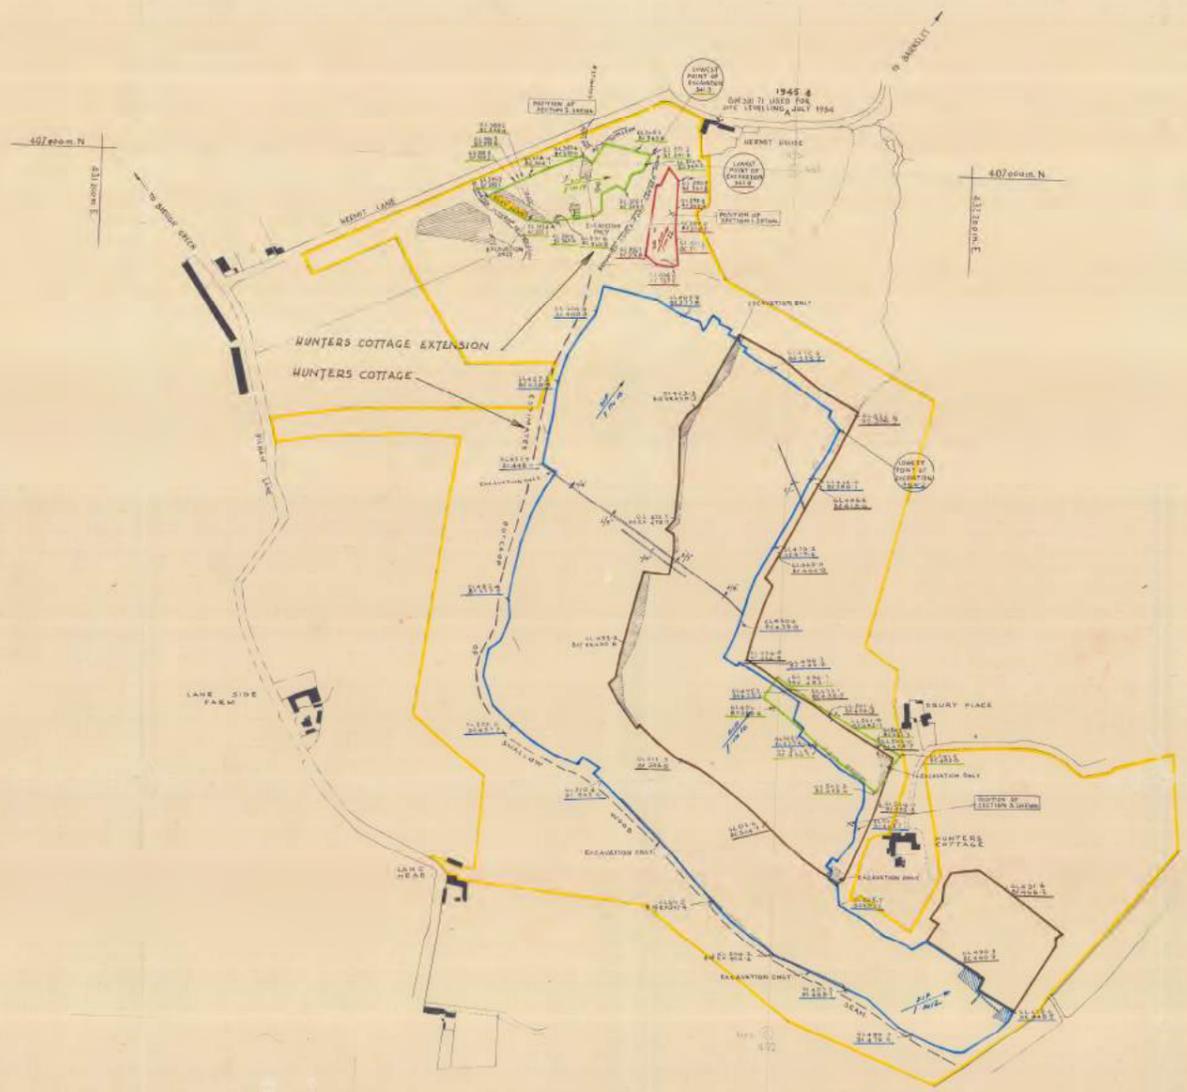
LOCATION
 1:2500 SCALE ORDNANCE SHEET REFERENCE: SE 5500, 6, 3, 10
 DATE OF ORDNANCE SHEET: 1931
 NAME OF SITE: HUNTERS COTTAGE & EXTENSION
 LOCATION OF SITE: 1 MILE WEST OF BARNESLEY
 COUNTY: YORKSHIRE
 PARISH: BARTON, BARNESLEY, OSBORTH

National Coal Board. Abandonment Plan. Hunters Cottage & Extension. Site Reference Number: 030102B. Operational Contract Number: OE/CON/3978. Drawing Number: OE/COMP/03/121. Dated December 1959.

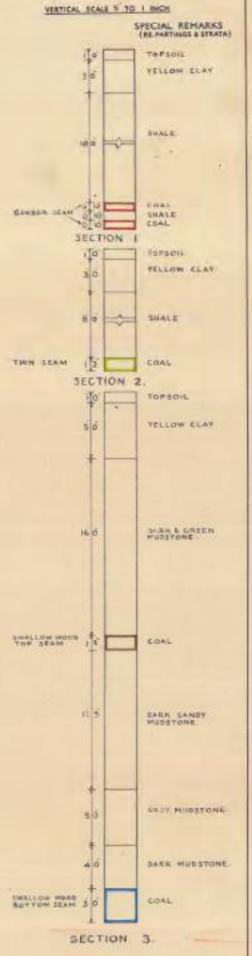
VERTICAL SECTION THROUGH ALL SEAMS

SEAM	THICKNESS	SWALLOW HOOD TOP	SWALLOW HOOD BOTTOM
BARBARA SEAM	17	75	350
THIN SEAM
