## Remediation and Validation Strategy

| <b>LOCATION</b> | Land at Fieldsend Road, Goldthorpe<br>S63 9AA |
| <b>OUR REF.</b> | G21160-REM – Rev B |

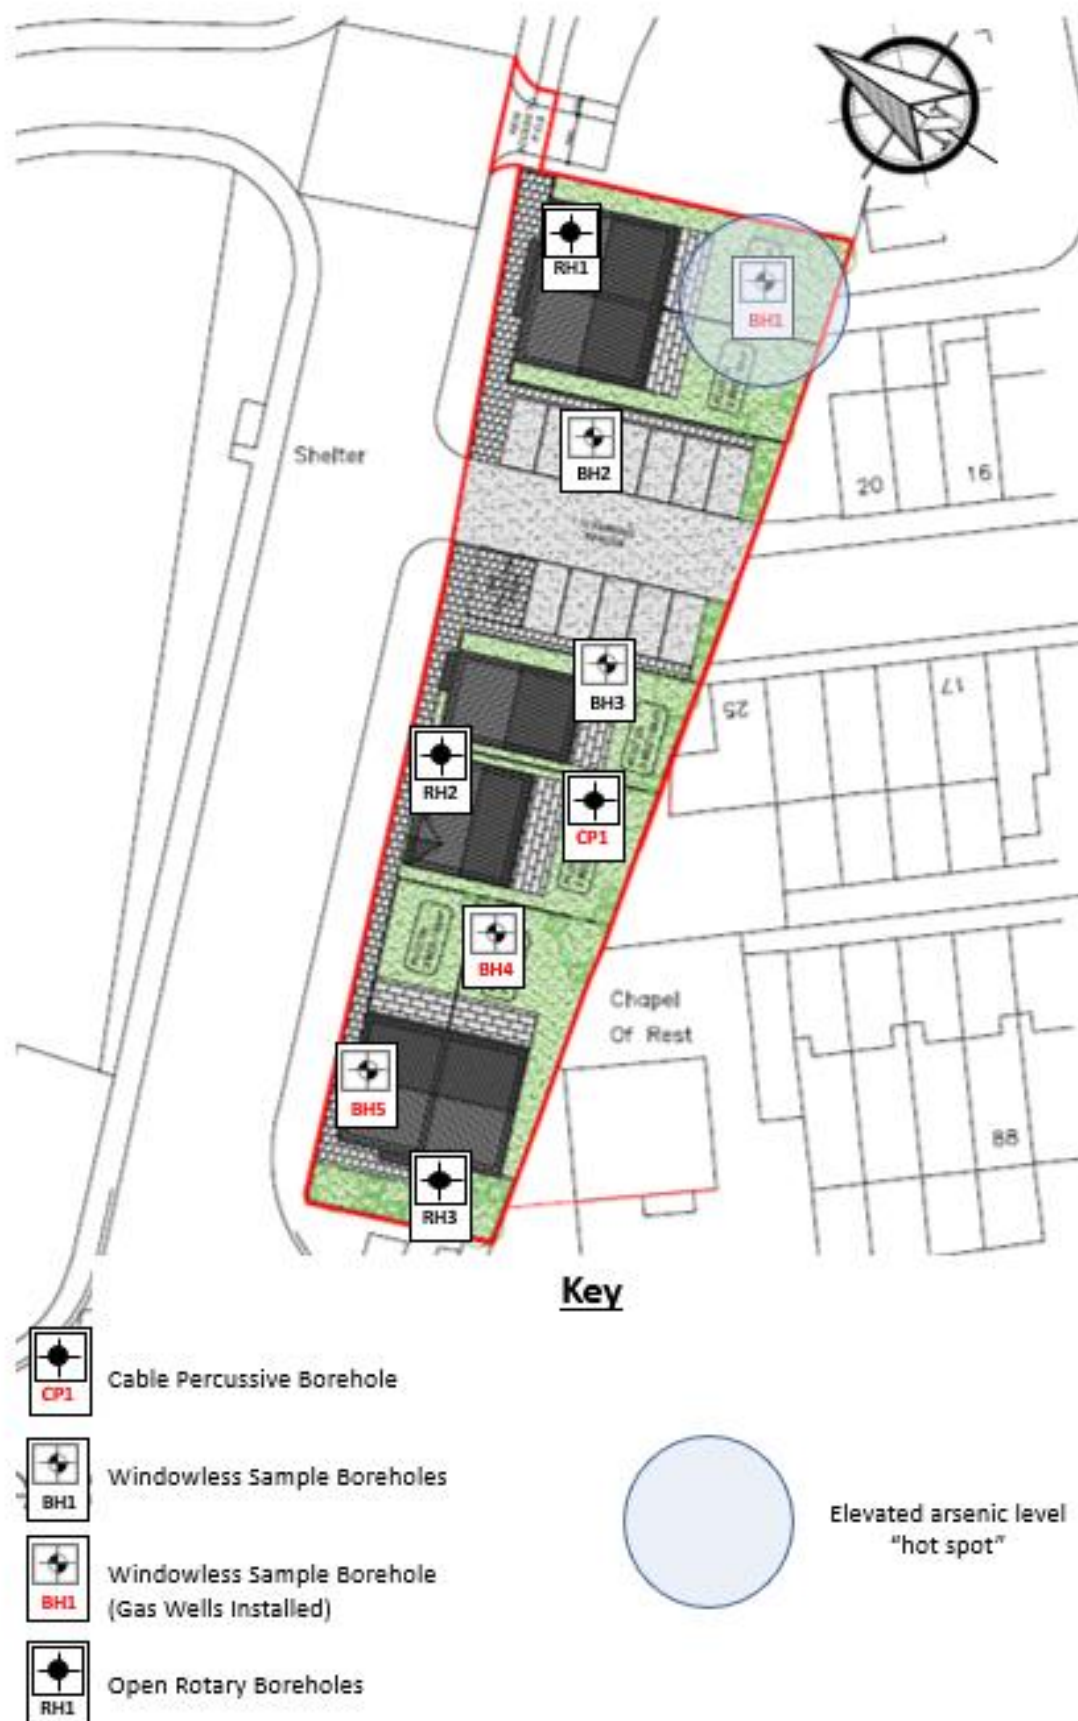
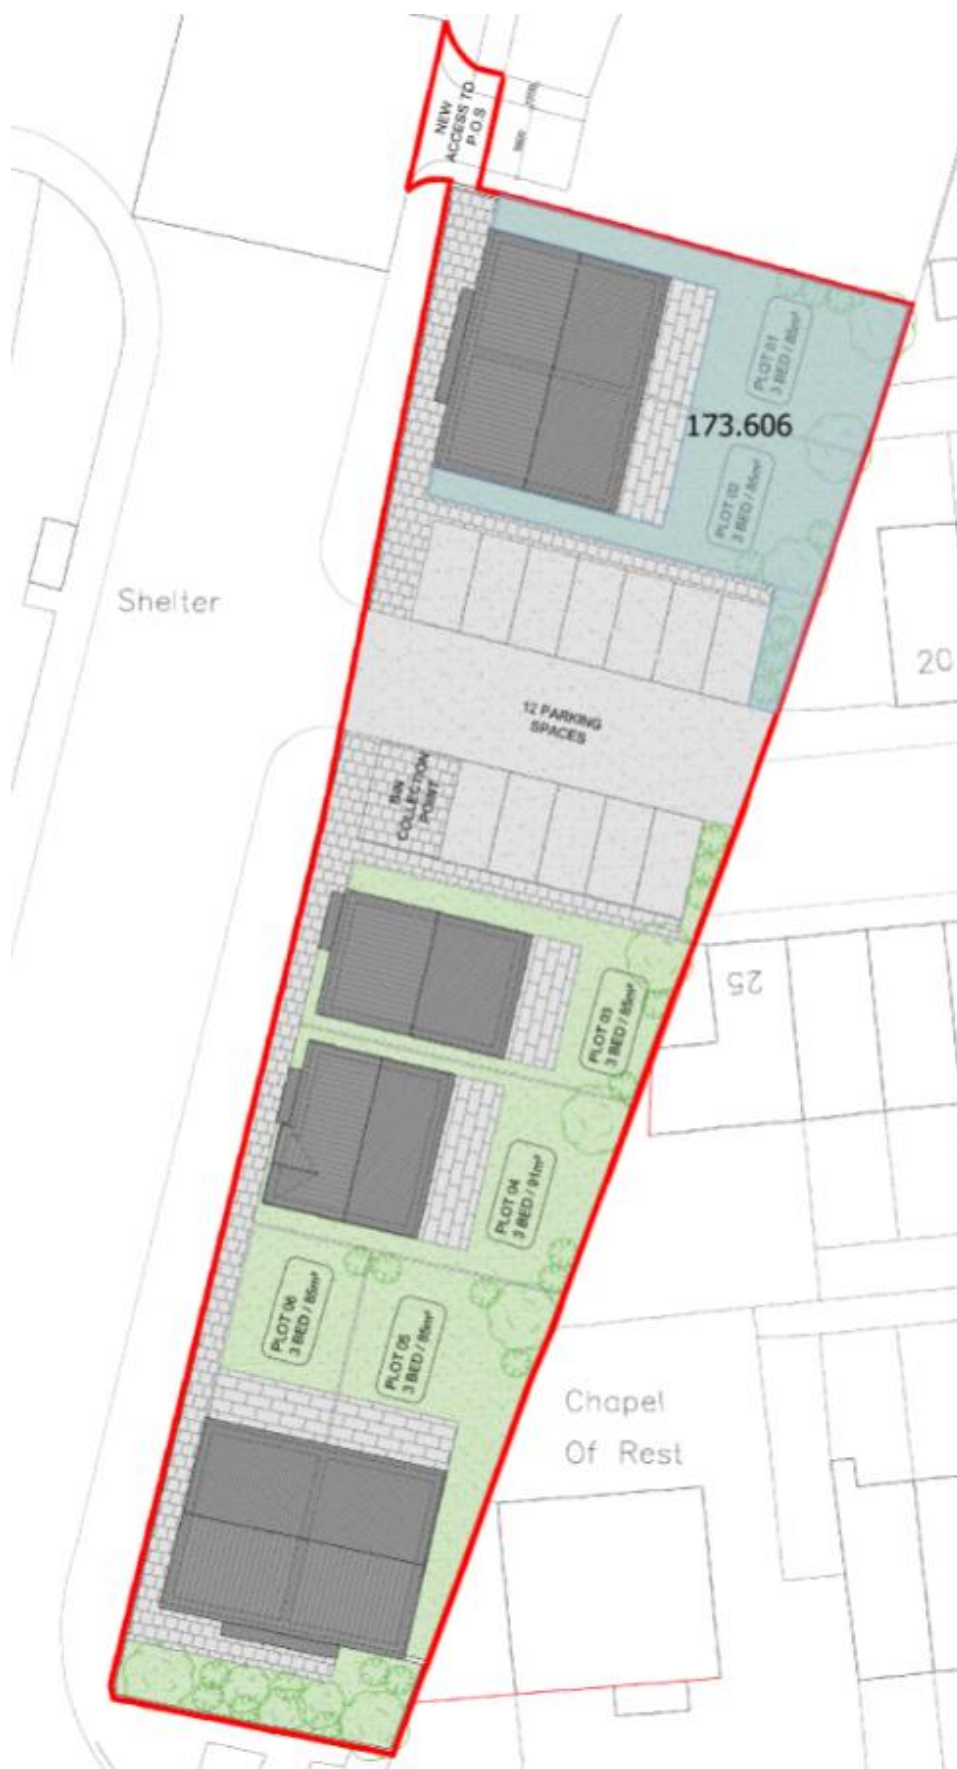
| OUR REF: G21119 | YOUR REF: | SITE PLAN (NOT TO SCALE) |

**Proposed Remediation areas highlighted in Dark Green (Plots 1 and 2), with figure indicating size of area for the proposed section.**

The site investigation report (G21119) indicates that elevated concentrations of Arsenic are present within a “hot spot” to the north of the site (Plots 1 and 2) and that a lack of suitable site won topsoil was noted. As 600mm of soil requires removal from the proposed garden areas the excavation exercise should be simple to complete successfully.
