In terms of the SPA comments, we have provided a response in red to each of the three points below:

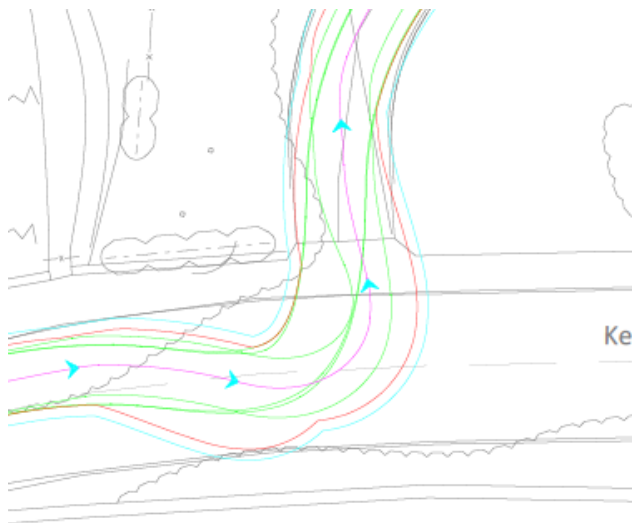
Existing Wood End Court Junction

- *A 0.5m gap from the edge of Keresforth Road is not maintained (drawing “Refuse Vehicle Entering Site”).* LTP Response: This is due to the existing alignment and carriageway width of Keresforth Road and is consistent with the movements of existing refuse vehicles travelling along Keresforth Road including those which currently serve Wood End Court. The proposed access arrangements provide a betterment to the existing situation in terms of refuse vehicle movements as vehicles are not required to encroach the opposite side of the carriageway when turning in and out of the proposed access compared to the existing Wood End Court junction.

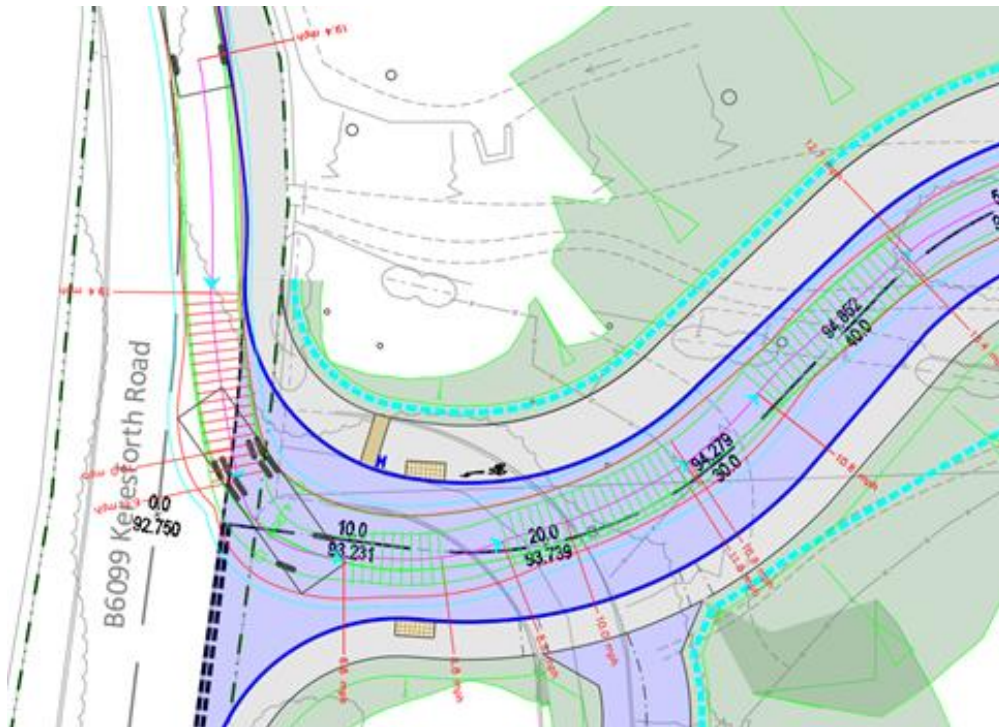
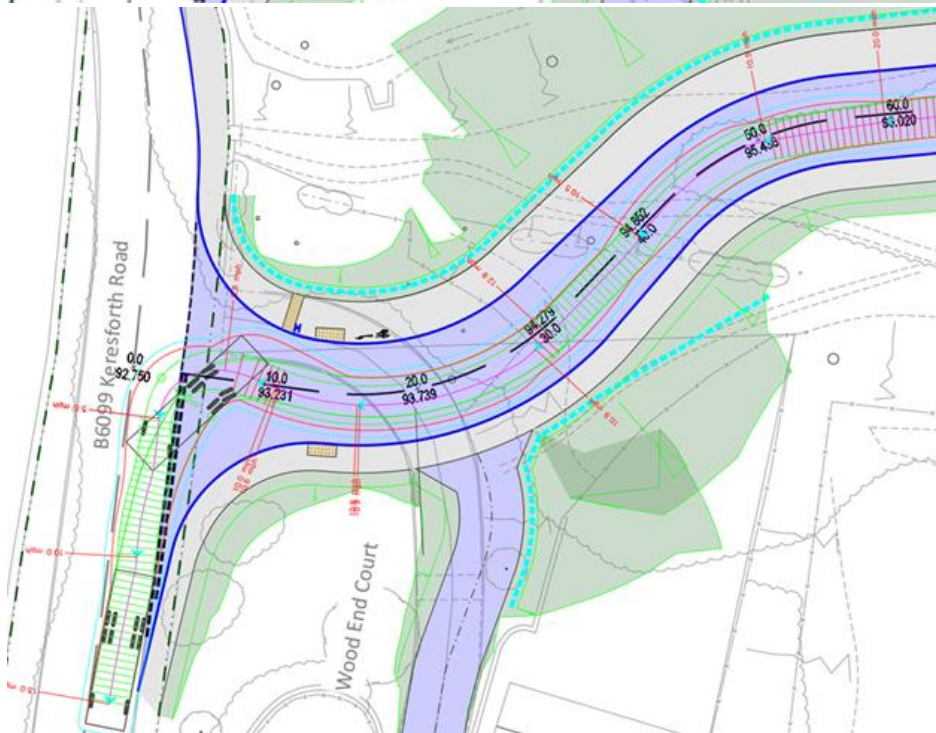
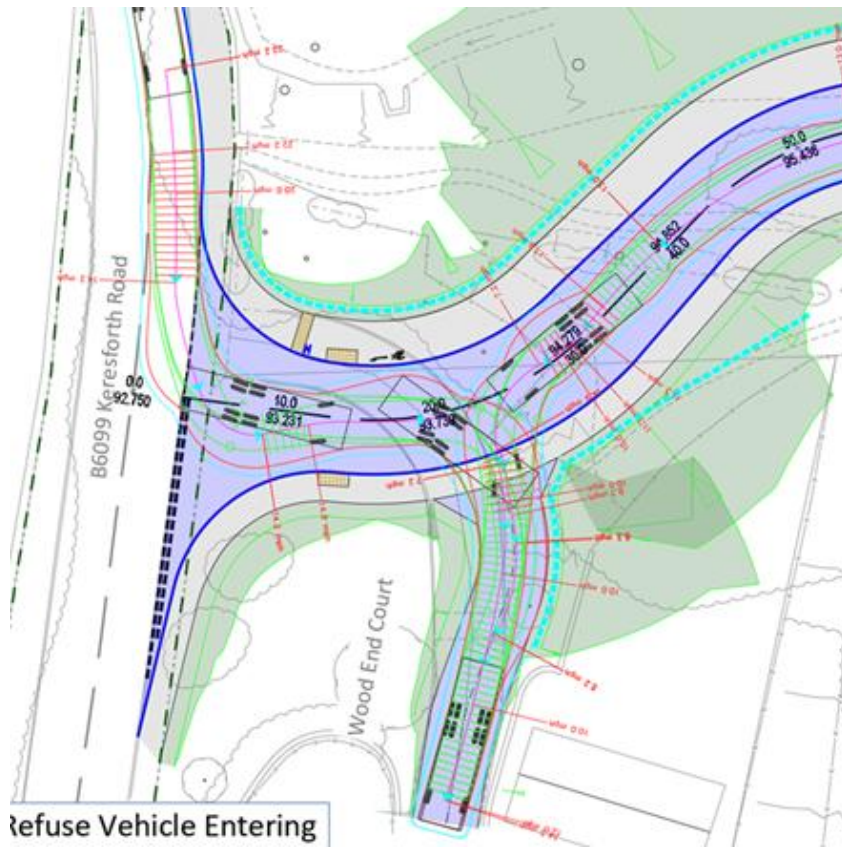
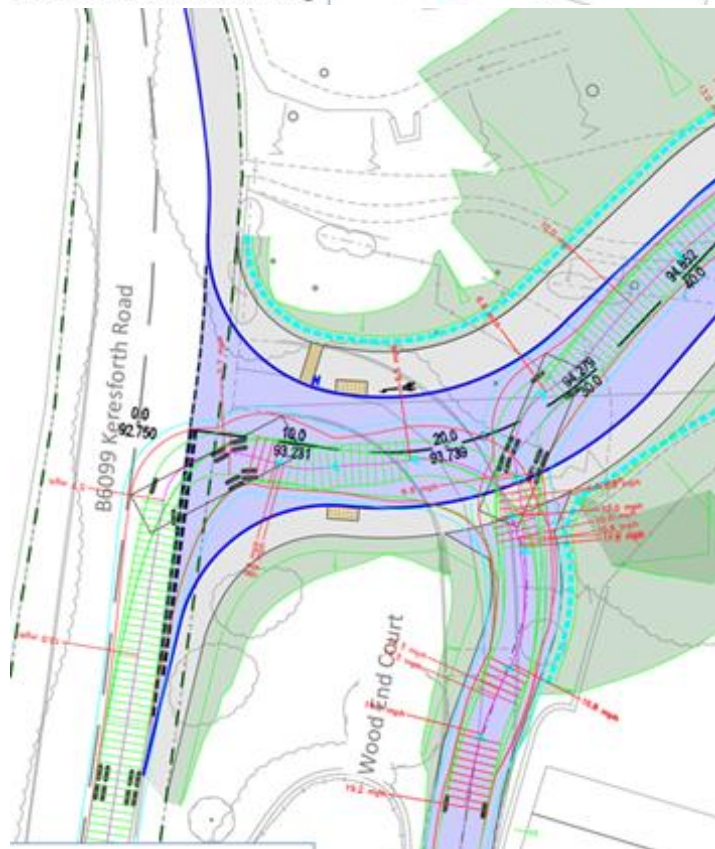
- *There are a significant number of instances where an unnatural sweep is demonstrated, presumably with wheels at full lock a 0mph. The Key states that the analysis is undertaken at “less than 5mph”, but stopping a vehicle in the highway to maintain lane discipline or prevent overrun of the footway is not acceptable as it is not a realistic method of driving (drawing “Refuse Vehicle Entering Site”, “Refuse Vehicle Exiting Site”, “Refuse Vehicle Exiting Wood End Court”, and “Refuse Vehicle Exiting Wood End Court”).* LTP Response: The refuse vehicle swept path analysis was completed with the vehicle travelling at speeds no less than 5mph with the screenshots below demonstrating that the refuse vehicle is travelling in excess of 5mph. There are no

instances of 'turn from stop' being utilised in the analysis and the unnatural sweep shown on the drawing is the swing of the vehicle body.
