**Proposed Residential Development  
321 Hough Lane, Wombwell,  
Barnsley**

**Desk Study Report**

**October 2017**

**REPORT TITLE:** Desk Study Report

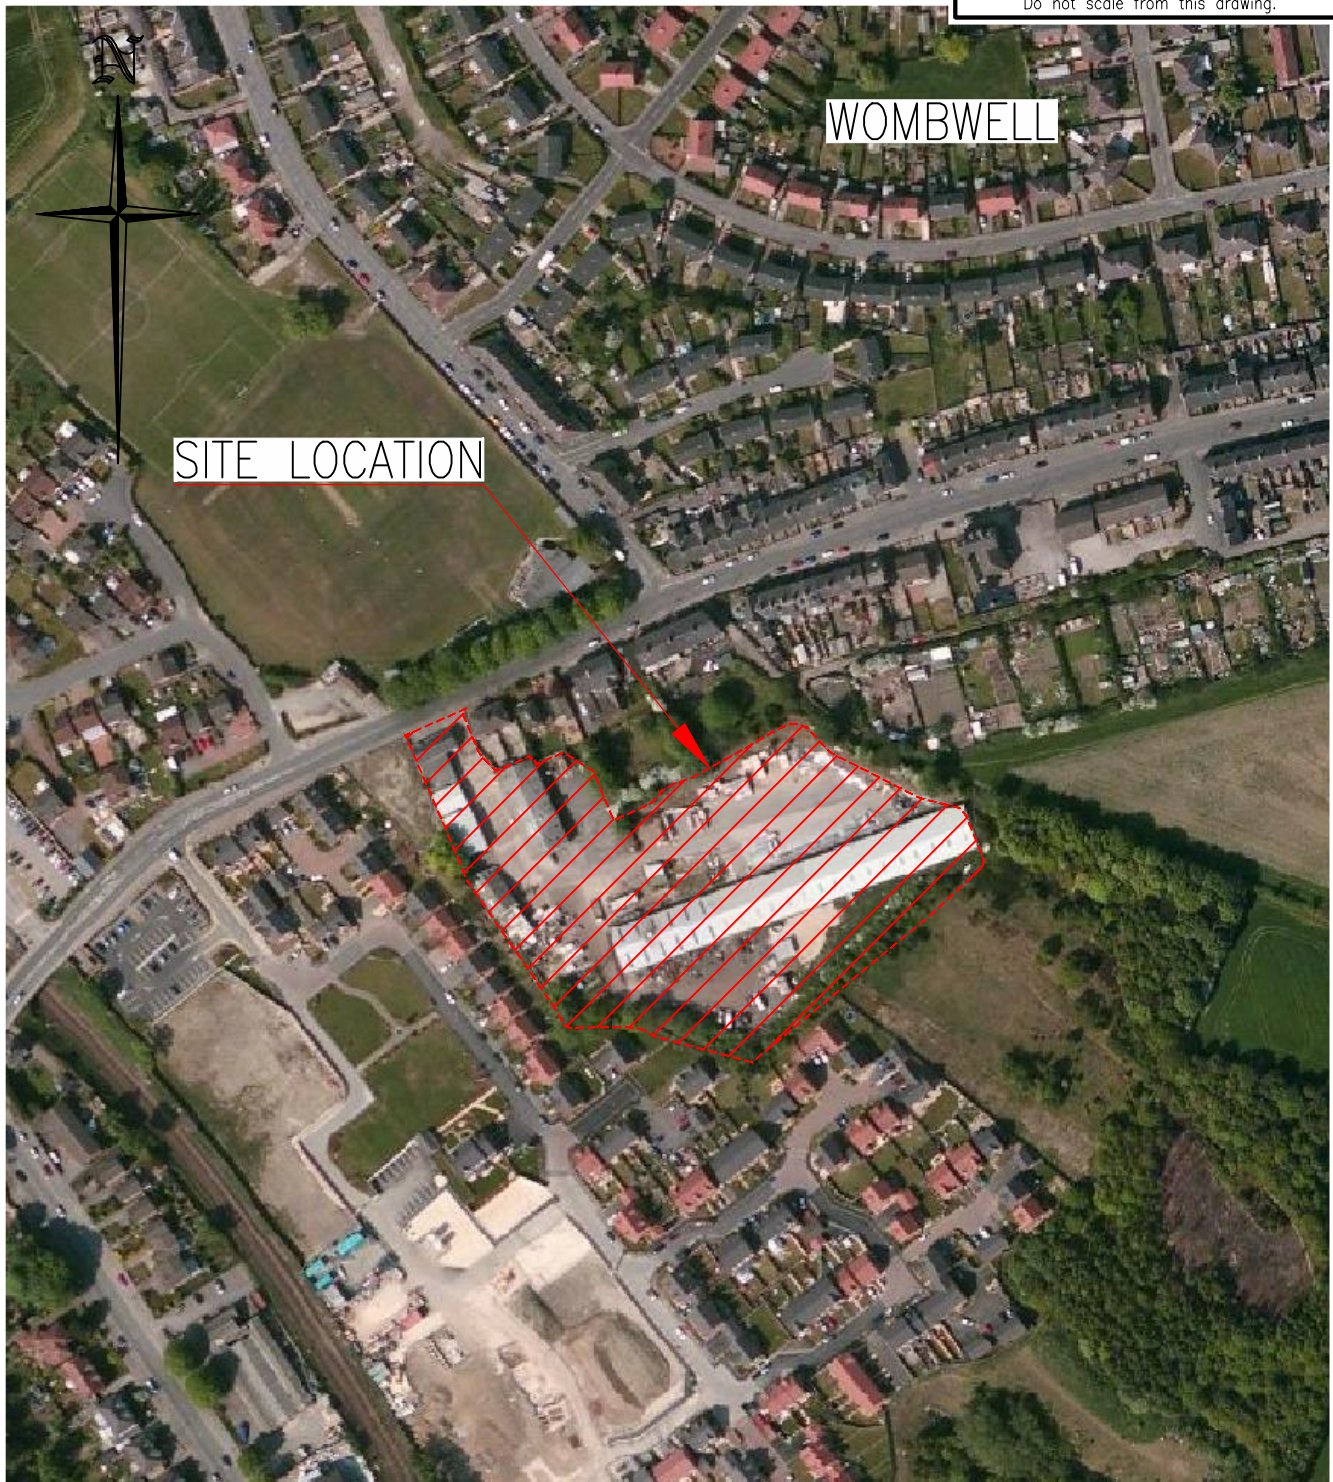
An area of the site, south of the offices and spray paint workshop, is noted to dip more steeply (Drawing 117436/9000).

A drop in level was noted along the north eastern boundary of the site, with a further drop in level beyond the south of the site (Drawing 117436/9000). This suggests cut at the northern edge of site and fill at the southern edge, indicative of a development platform.
