## Roof frame survey and repair schedule

Location : 10 Worsborough Village, Barnsley. S70 5LW

### General description.

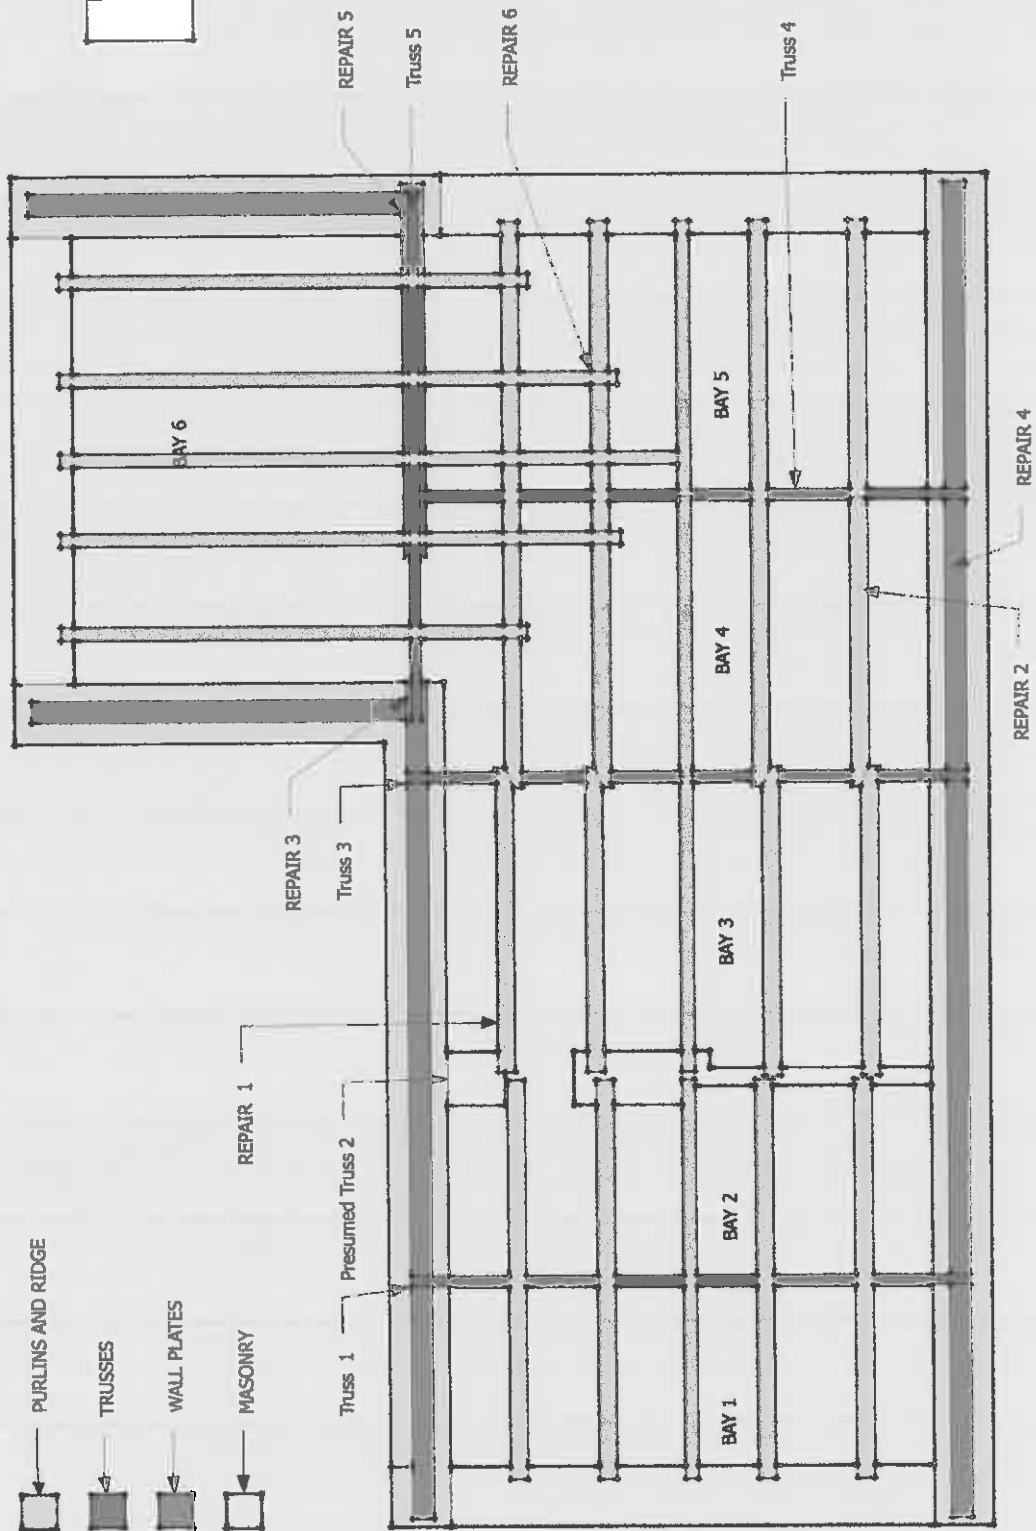
ROOF - PLAN VIEW

The roof frame follows a fairly standard layout, consisting of 5 Bays and 4 simple oak trusses (referred to as Trusses 1- 4 from South West to North East), with large section tie beams and an upper and lower purlin run on each pitch of the roof. The tie beams are coggled over an oak wall plate, sitting directly on top of the masonry wall, and a carved oak corbel sits within the wall, coggled around the underside of the wall plate. The corbel projects into the roof space and would have provided a small amount of cantilevered support and additional bearing for the tie beam. There are no gable trusses, with the purlin ends resting in the masonry walls. All the original common rafters have been replaced with new timbers.

At the north eastern end of the building a gabled extension has been built, extending to the north west. An additional truss for this roof (Truss 5) sits on top of an internal oak top plate in line with the north western wall plate (but separated at one end by a framed doorway) with similar upper and lower purlins extending back from the stone gable, to connect with the purlins of the main roof. The internal top plate is supported by a number of small oak posts, and a large carved jowl post directly below Truss 4, the northern most truss of the main roof.
