**ARBORICULTURAL  
METHOD STATEMENT  
to BS 5837:2005  
at  
A629  
Ingbirchworth WwTW  
Penistone  
South Yorkshire**

**JCA Ref:**

10156/AB

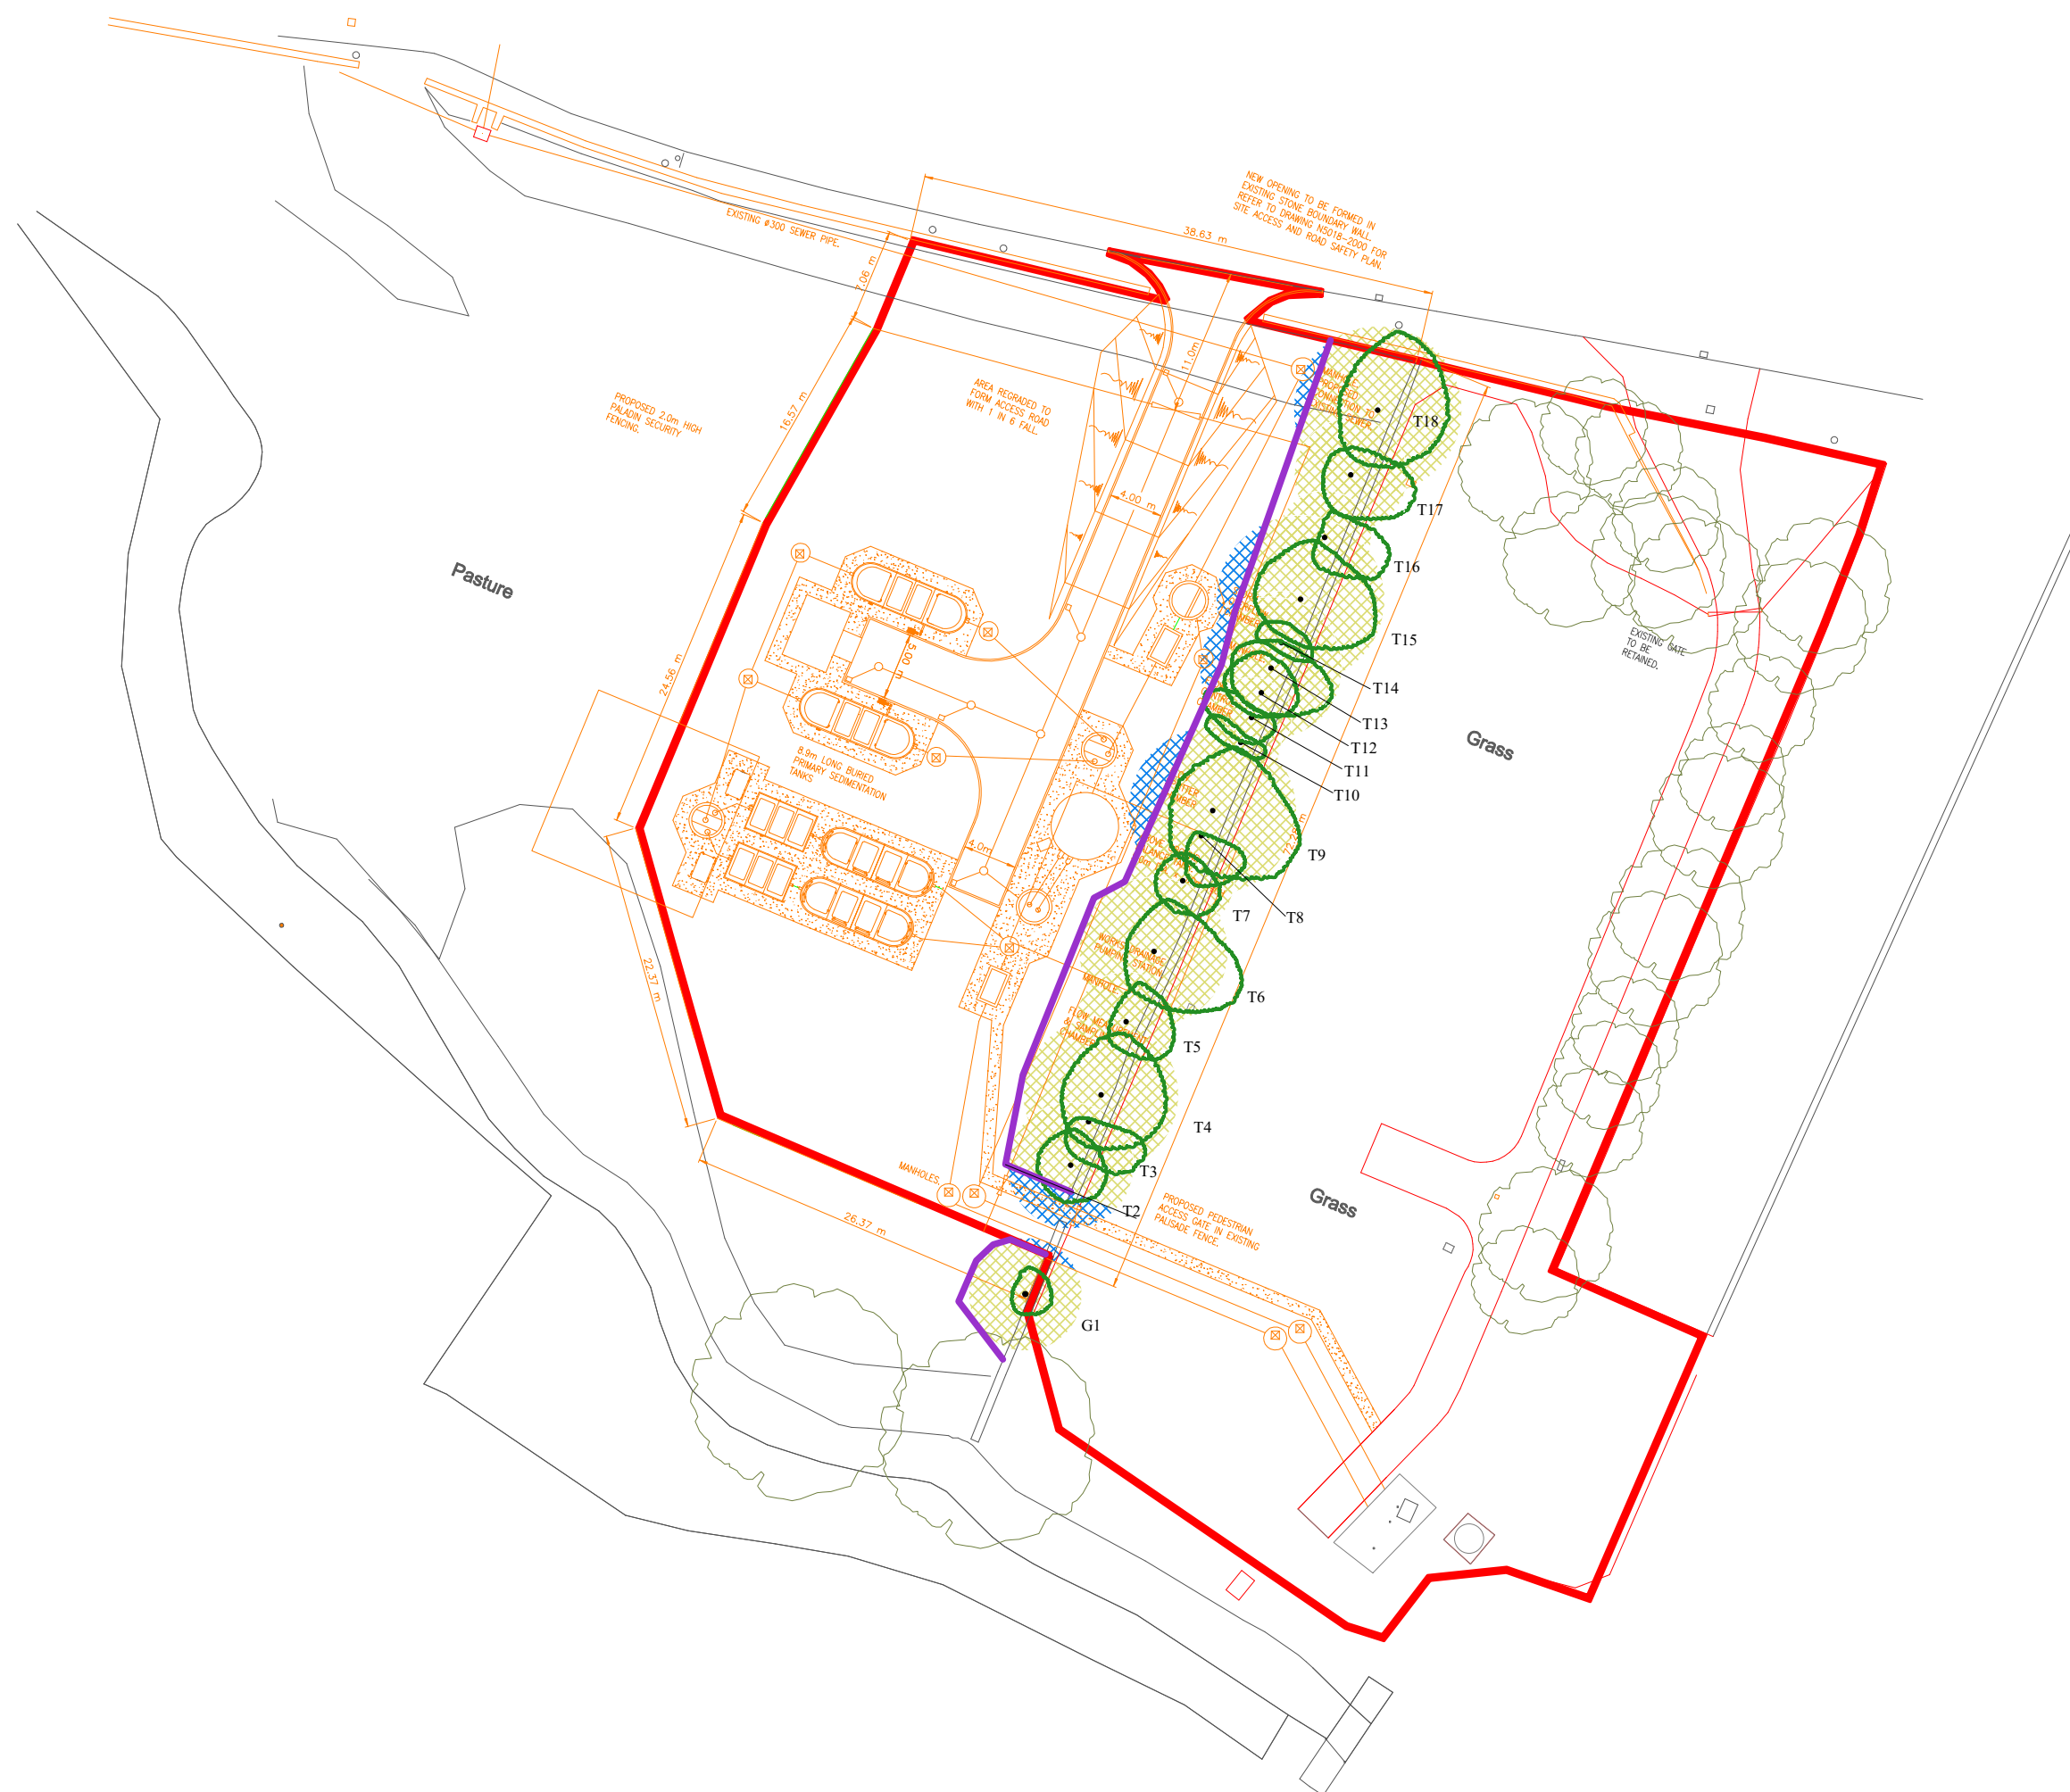
Platform level at first lift of brickwork

Area of construction activity

| <b>TITLE:</b> A629 Huddersfield Road WwtW,<br>Ingbirchworth, Penistone,<br>South Yorkshire.<br>JCA Ref: 10156/AB | | |
