Design and Access; Flood Risk and Heritage Statements

Dean Head Farm Cottage
Snowden Hill
Oxspring
SHEFFIELD
S36 8YR

Kit fletcher (Kit Building Design)

12th October 2022
(revised 18th May 2023)

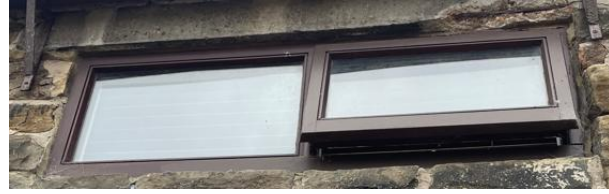
Dining Lounge Window to Westerly Elevation

- Replacing timber windows with narrow profile coated aluminum frames casements.
Most windows will be a double casement type with one opener (See appendix 1). Windows with coursed stone at cill level and no stone cills will have aluminium cills.

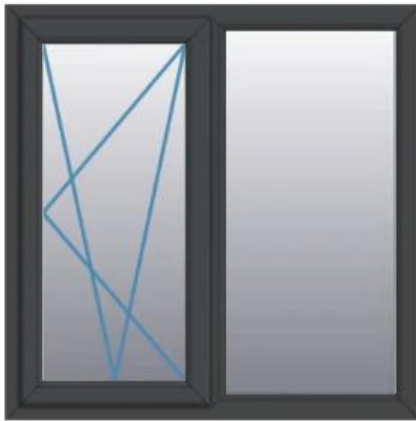
Proposed Window - Example

Inward opening style windows (to west elevation)

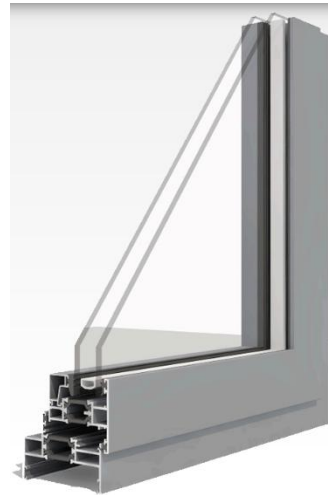
Flat Thin Profile Opener Section

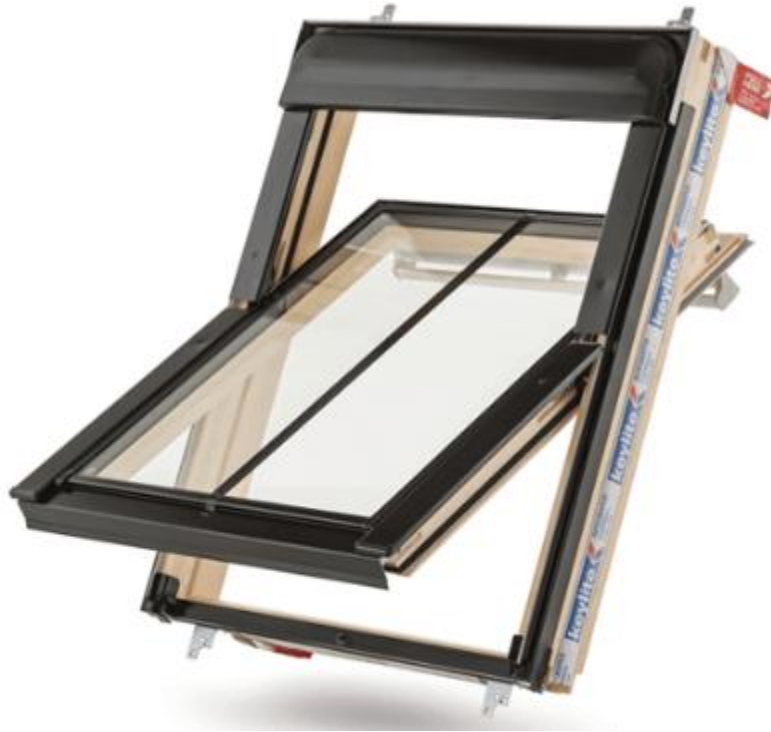
Appendix 2

Keylite Conservation Roof Windows

- The addition of a new roof window (conservation type) to let more natural light into the new bedroom which is facing east and to the rear of the property out of view from the highway.
The addition of a 780x1180mm Keylite Conservation style roof window with wooden frame cannot be seen from the highway and has little impact on the appearance overall. (See appendix 2)

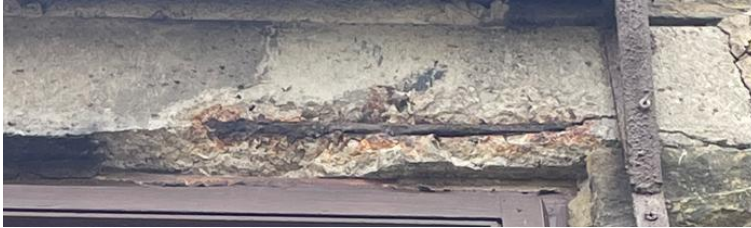
Bedroom window lintel concrete perishing to northerly elevation.

- The replacement of cracked and degraded Jambs, cills and lintel (heads).
Unfortunately, Over time one jamb and two cills have fully cracked and one jamb is badly damaged (splitting along the grain), all of which let water enter the premises and over time will be detrimental to the longevity of the property. Also one reinforced concrete lintel (head) is failing and requires replacement. (see appendix 3)

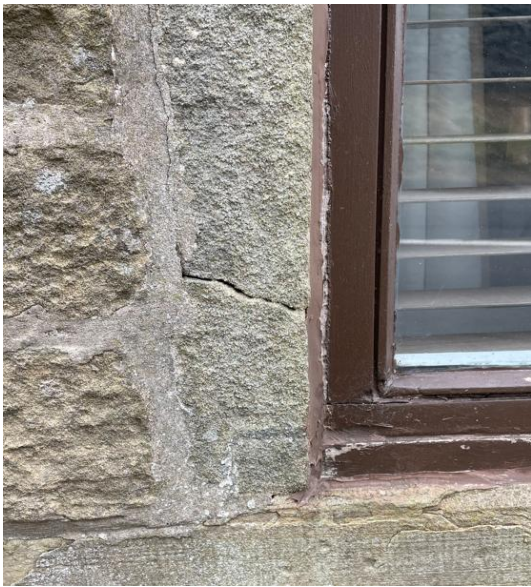
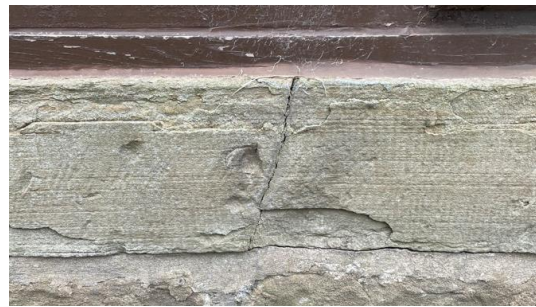
Left ground floor window to westerly elevation - cracked left side jamb and cracked cill.

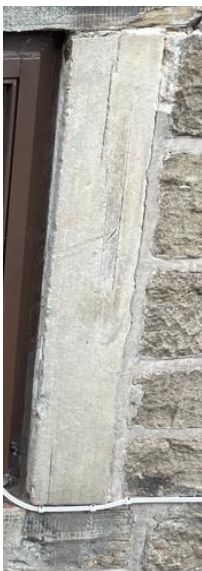
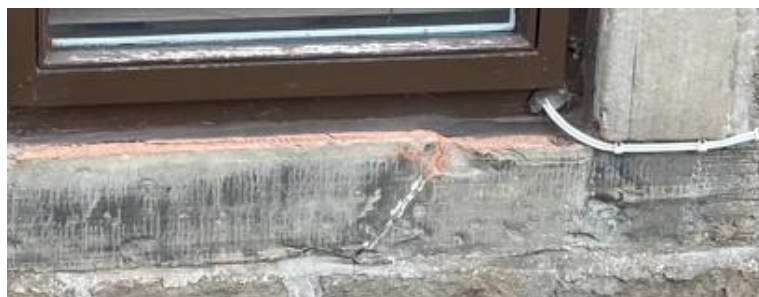
Right, ground floor window to westerly elevation - splitting to right side jamb and cracked cill.

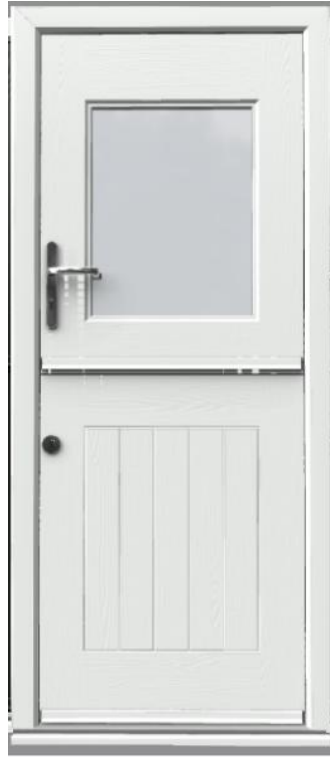
Appendix 4

Proposed style for rear door

- Existing front door to be retained and painted to colour match the new windows. The rear stable door may need to be replaced with the new window next to it if this is the case then a replacement composite stable door will be used (see appendix 4).

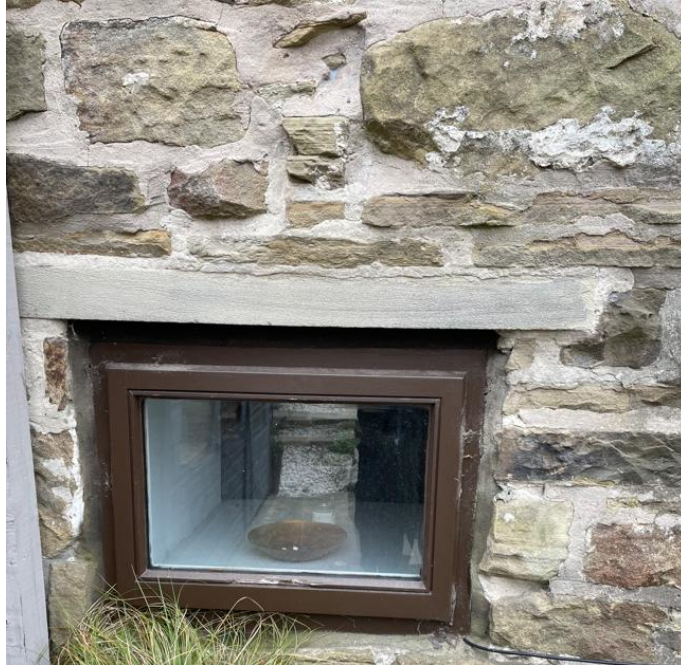
As it currently is with hard cement mortar

The property is appears to be largely a lime mortar pointed but does have areas that have hard Portland cement mortar. The property hasn't been seriously maintained since the 1990's and is overdue for maintenance of its pointing. At the same time as renewing the lime mortar areas the removal of the Portland cement pointing will not only be more in keeping but will prevent longer term damage to the stonework, enabling the building to breath and prevent erosion of stone round 'hard' pointing. It is therefore proposed that the whole building has the pointing raked out using hand tools and re-pointed in a lime / aggregate in ratio 1:3 (where 1 part NHL 3.5 is added to 3 parts well graded aggregate or river sand). Brushed or stippled back before curing to compact and form a gently recessed joint. (See appendix 6)

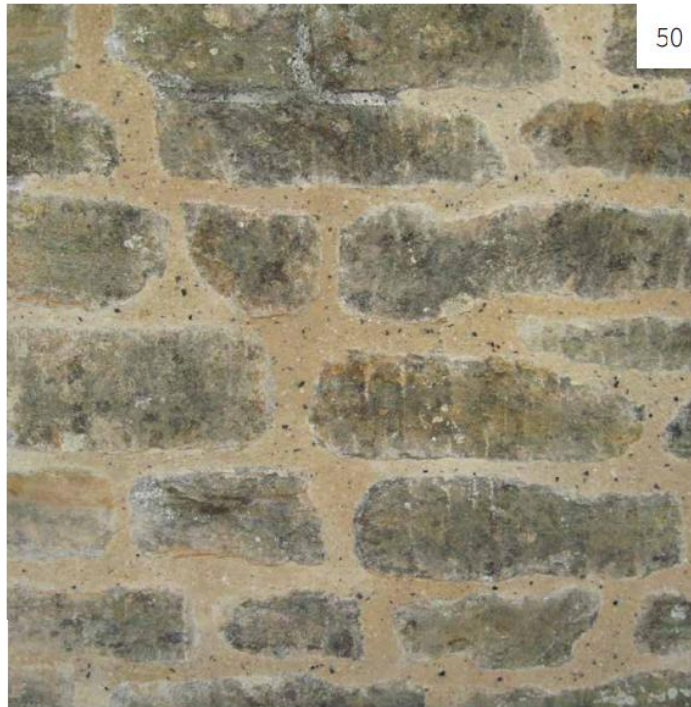
As it will be with lime based mortar
