# Arboricultural Assessment Report

## Detailed Report on Trees

| | <b>Risk Address:</b> | Stonecroft, Hall Royd Lane, Barnsley, South<br>Yorks, S75 4PP |
| <b>Refs:</b> | <b>OCA Ref:</b> | 52145 |

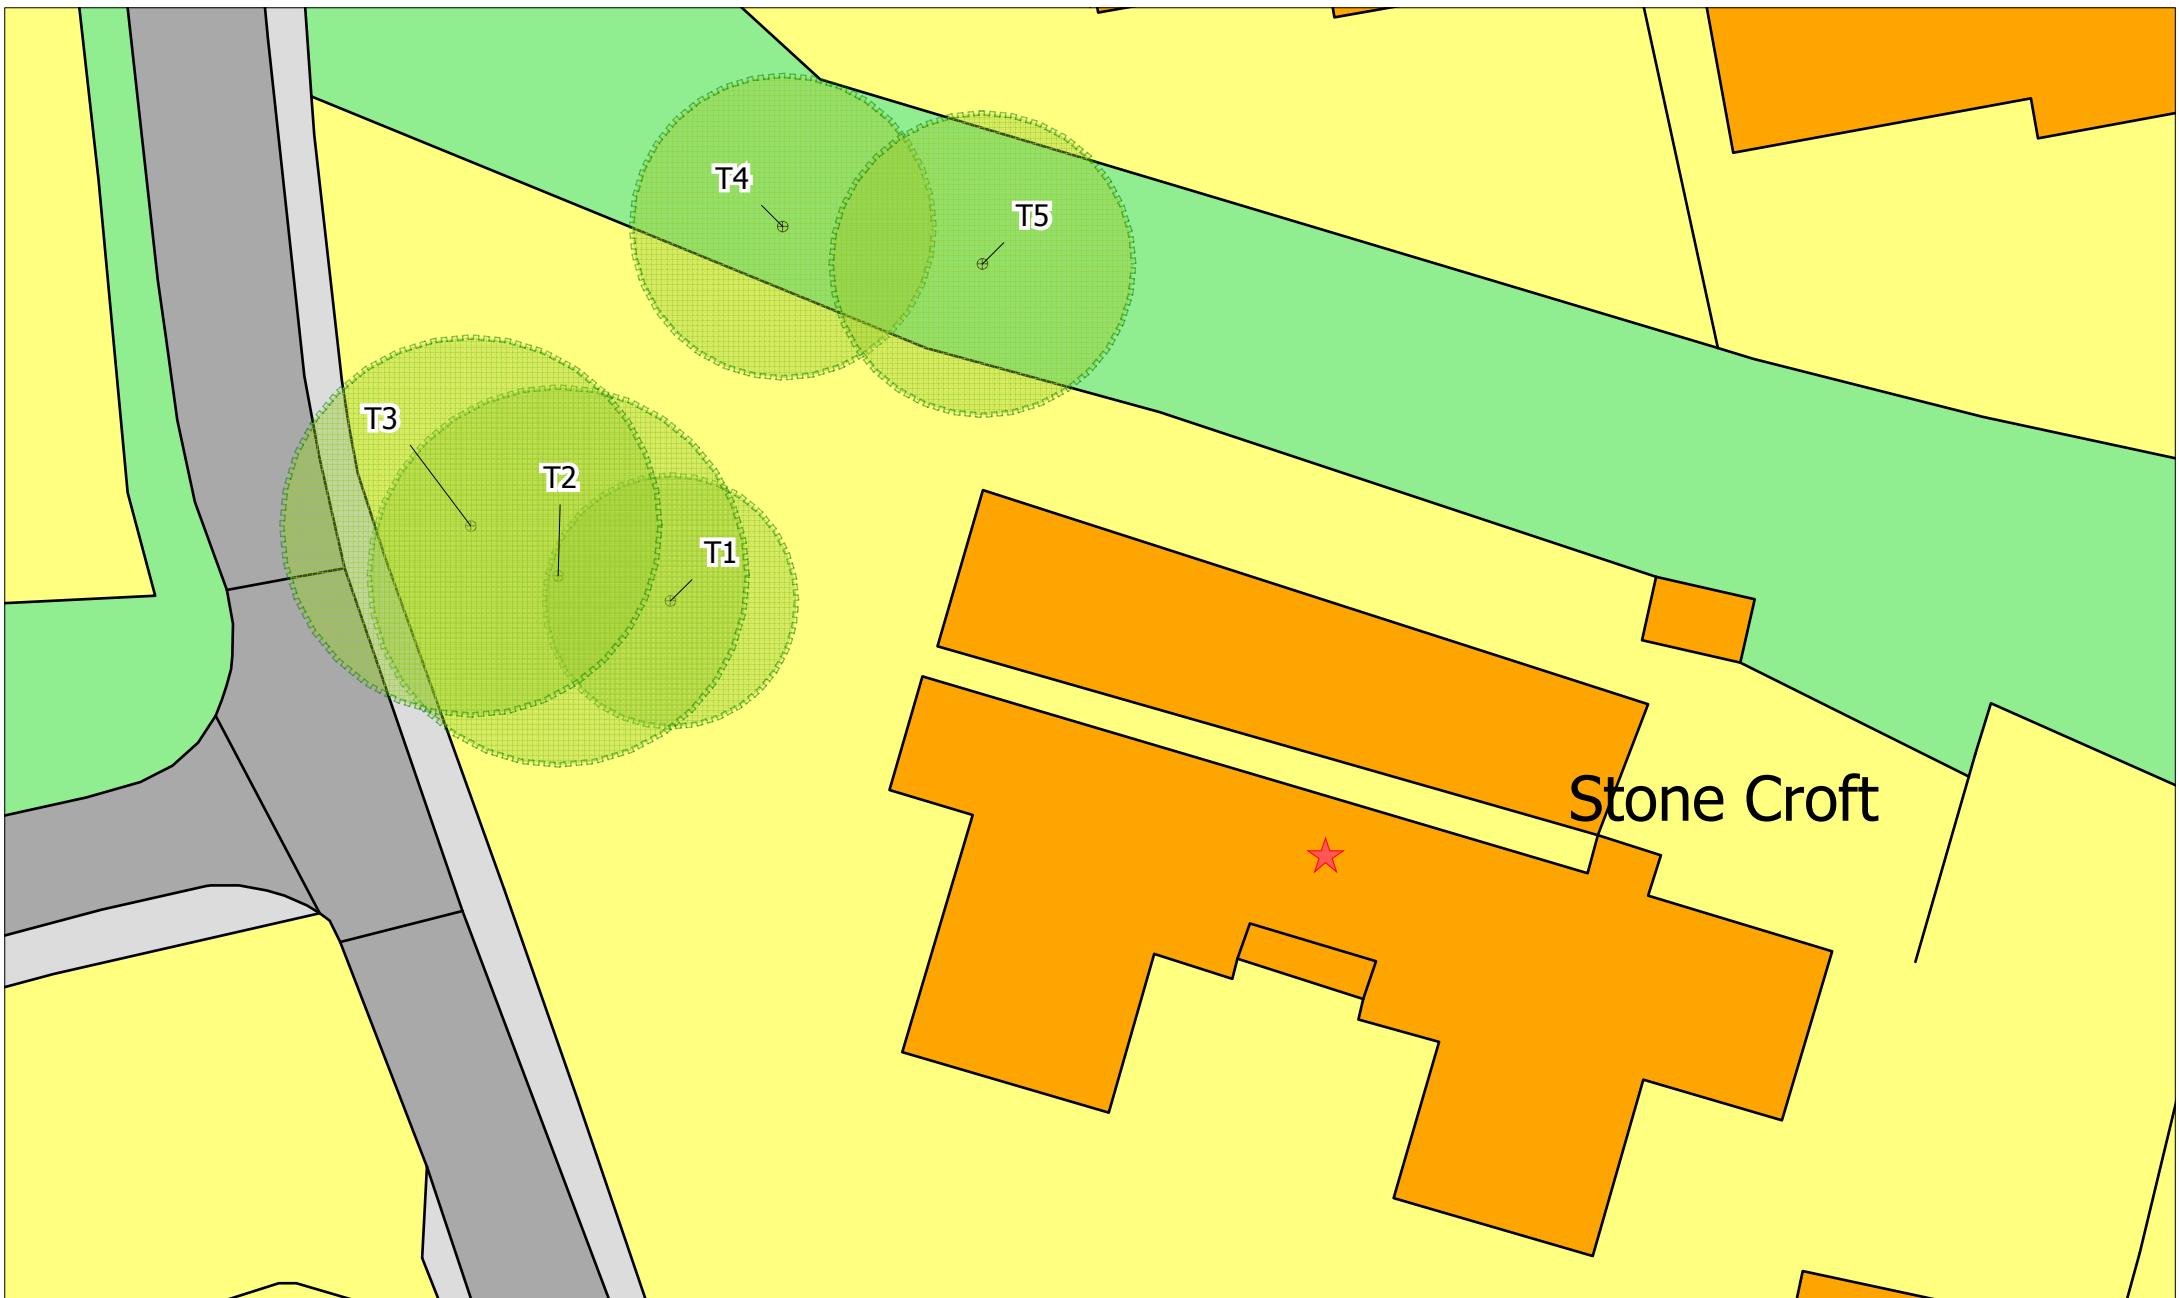
| Location: | STONECROFT, HALL ROYD LANE, SILKSTONE COMMON, BARNLEY, S75 4PP |

- 1 Introduction & Brief
- 2 Limitations
- 3 Evidential Assessment
- 4 Conclusions
- 5 Recommendations for Vegetation Management
- 6 Vegetation Survey
- 7 Site Plan

| Tree No | Common Name | Age Class | Condition | Height (m) | Crown Spread (m) | Stem diam. (mm) | Dist to bldg (m) | Pruning history | Recommendation | Tree work constraints | Notes | Owner address | Owner |
|---|---|---|---|---|---|---|---|---|---|---|---|---|---|
| T4 | Sessile Oak | EM | G | 18 | 12 | 540 | 15 | No significant past tree works | Fell and grind stump. | Located on a bank on far side of lawn | | Stonecroft, Hall Royd Lane, Silkstone Common, Barnsley, S75 4PP | PH |
| T5 | Sessile Oak | SM | F | 17 | 12 | 520 | 8 | No significant past tree works | Fell and grind stump. | Located on a bank on far side of lawn | | Stonecroft, Hall Royd Lane, Silkstone Common, Barnsley, S75 4PP | PH |
