# South Facing Elevation As Proposed

ISSUED FOR PLANNING

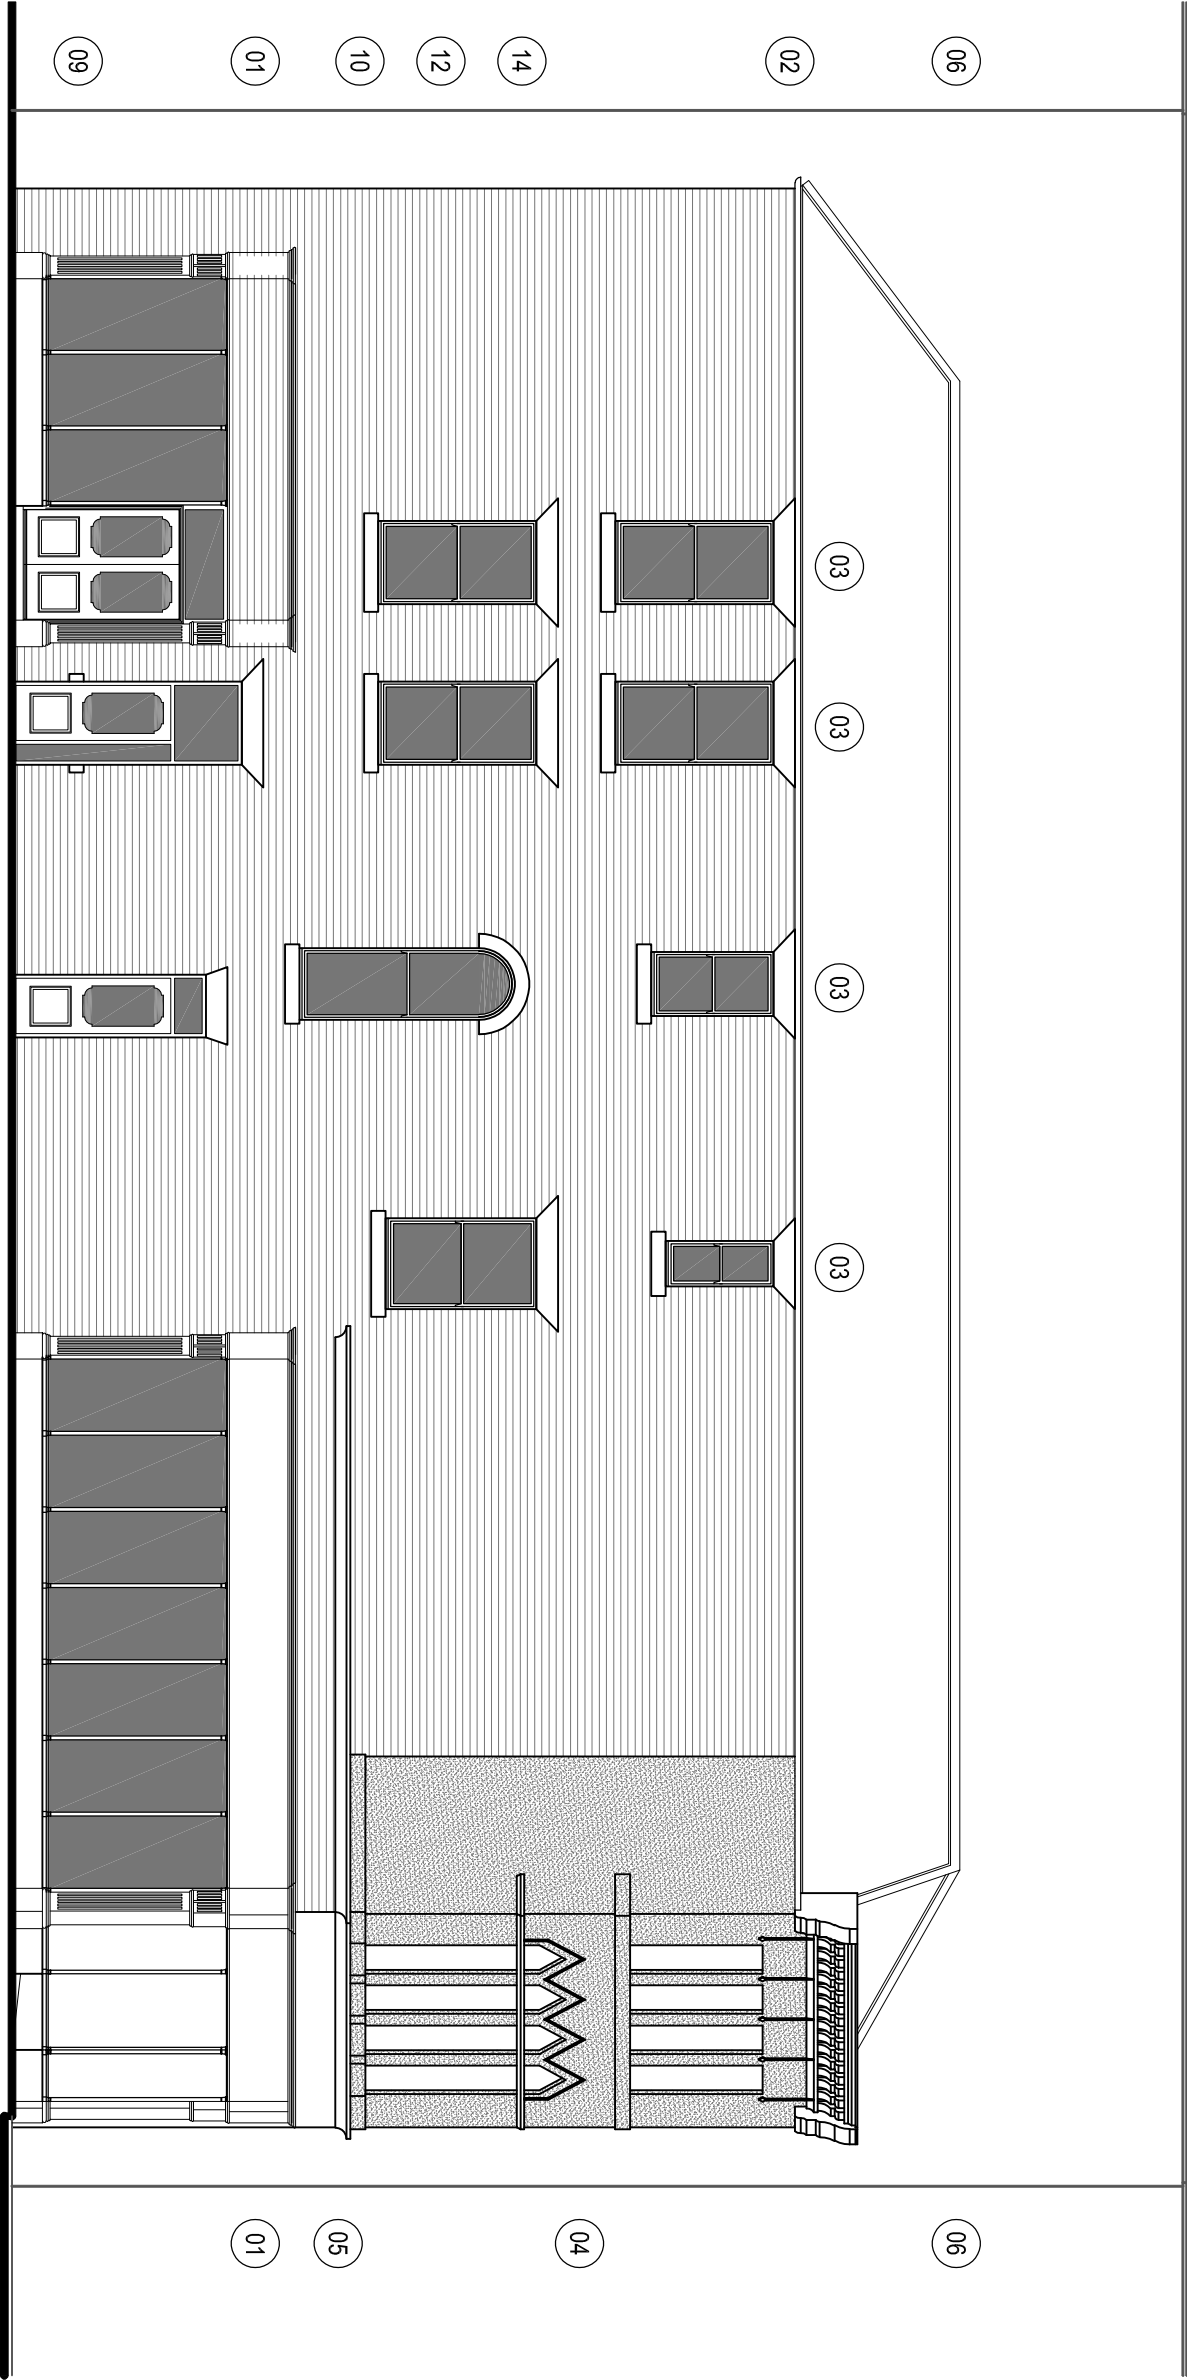
- Carefully remove existing modern shop fascia, signage, walling, entrance doors and glazed windows and dispose of from site, replace with new masonry stallriser as shown on drawing 208, traditional shop frontage windows and relocated recessed door entry as shown on drawings 201 - 207 & 208 - 210

- Carefully strip out existing plastic gutters and rainwater downpipes and install new 'ogee' profile cast metal gutters and 68mm cast metal rain water pipes and connect into the existing drainage

- Existing timber windows to first and second floor to be carefully renovated/overhauled and install new painted timber vertical sliding sash windows to existing opened up window openings as identified on drawings 201 - 203.  
NOTE retain all instances of existing historic glass

- Carefully remove existing failing render system to the front and sides and render to all existing areas with breathable lime roughcast render and paint with breathable paint, colour to be confirmed, for details refer t the specification

- Existing lead flashings above existing water table to be carefully removed and allow for installing new Code 5 Lead flashing to be chased into existiong wall, include for removing existing paint to water table and redecorate with breathable paint to match that of the render above

- Existing roof, flashings and support beneath to be carefully removed and set to one side, battens etc to be disposed of, existing roof structure to be inspected by the CA, include for 15% timber spliced repair and 15% timber replacement, reinstall existing roof tiles allowing for 20% replacement to match the existing on SW timber battens and counterbattens on Tyvek Supro breathable membrane on existing SW timber rafters and with 100mm Kingspan Kooltherm K7 rigid roof board insulation laid between rafters and 62.5mm Kingspan Kooltherm K18 Insulated Dry-Lining fixed to the underside all to achieve a U-Value of 0.13W/m<sup>2</sup>K

- Carefully remove the existing failed canopy between the 2 buidlings and dispose of from site, make good the existing walls
- Existing brickwork walling to rear and main side elevations to be repaired and repointed fully with NHL 3.5 Lime mortar - allow for removal of previous repairs using cementitious mortar
