BUILDING 20B

ELSECAR FORGING AHEAD

DESIGN, ACCESS AND HERITAGE STATEMENT

29/08/2024

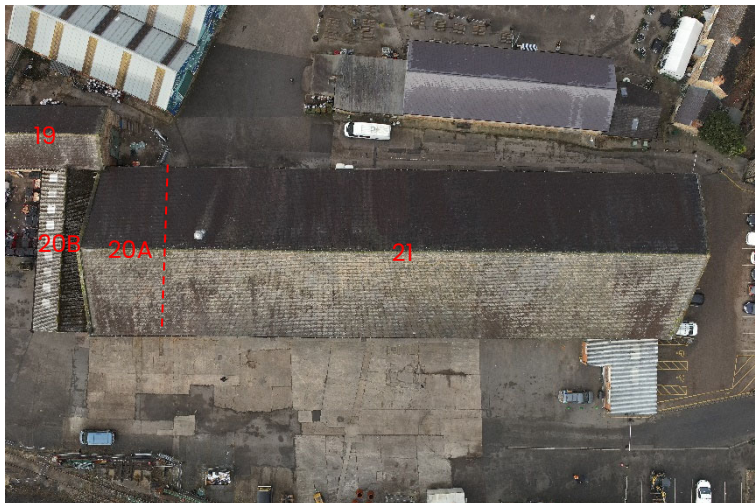
Building 20B – roof in context

Building 20B is a single storey rectangular brick shed abutted to both the south elevation of Building 20A and part of the east elevation of Building 19. It has a corrugated asbestos roof which is in poor condition. The roof is pitched with a back gutter alongside the gable to building 20A. The back gutter, which is also of asbestos and therefore not maintainable is leaking, causing water ingress into the south of the adjacent listed building 20A. The building is currently vacant. It has most recently been used as a store however this use has ceased due to the condition of the roof.

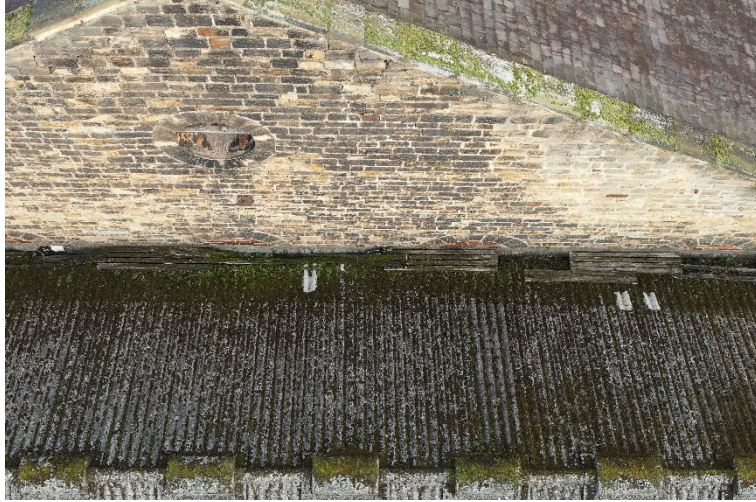
Building 20B – roof and back gutter to Building 20A

The existing roof covering to Building 20B has been identified in the asbestos report as Chrysolite asbestos, with a low level of damage in parts. The back gutter, also of asbestos, is the cause of water ingress into Building 20, indicating that the gutter and/or flashings are defective. It is not possible to maintain the roof and rainwater goods given that it is asbestos. Encapsulating the roof is not deemed appropriate given that more extensive alterations would be required to the roof of Building 19. Removal of the hazardous material not only removes the risks associated with asbestos but will also facilitate ongoing maintenance.

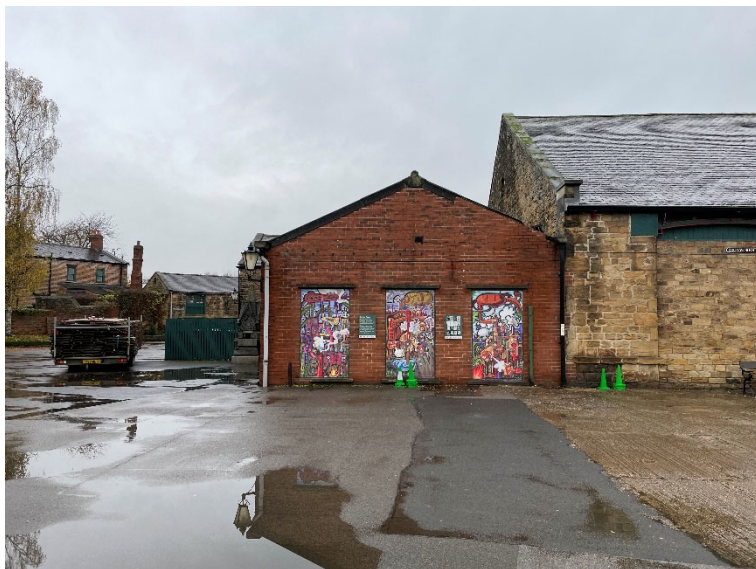
Building 20B – east elevation

The existing gutters are asbestos and will be removed together with the roof. The downpipes on the east elevation are PVC. It is proposed that all rainwater goods will be replaced in steel to match the new roof covering (refer to Drawing 3430 Proposed Details).

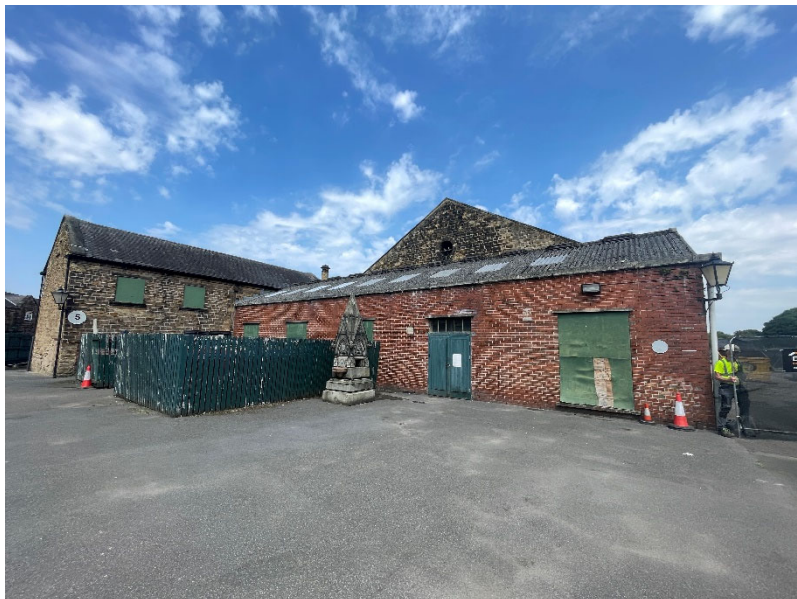
Building 20B – south elevation

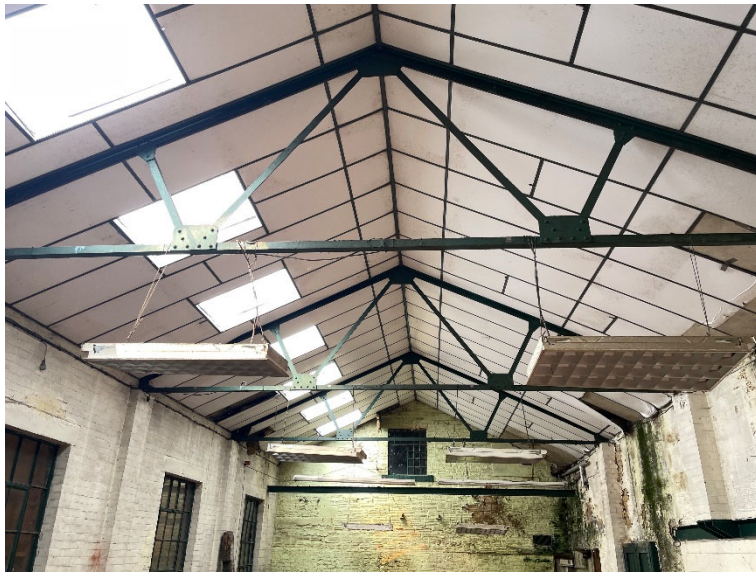
Building 20B – interior

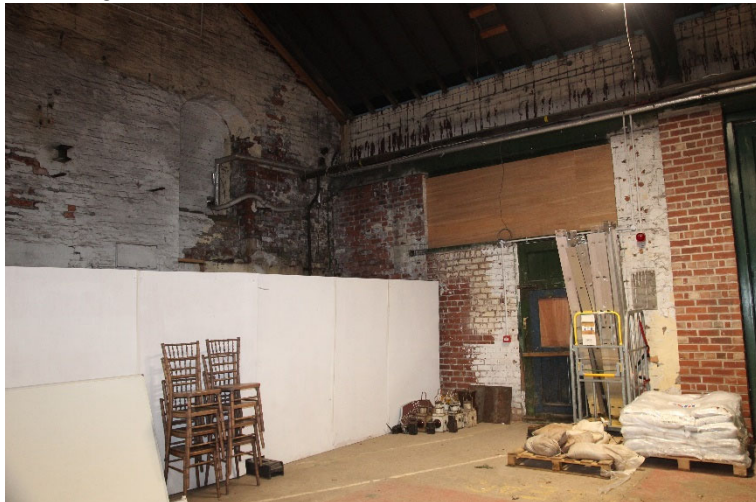
Building 20A – Interior – Water ingress into listed building caused by defective roof covering to Building 20B
