### **Highway Condition Survey**

**Lancaster Street, Brunswick Street, Briton Street, Cromwell Street,  
Windsor Street, Grange Crescent, Stuart Street Thurnscoe**

**2039/HCS/MI**

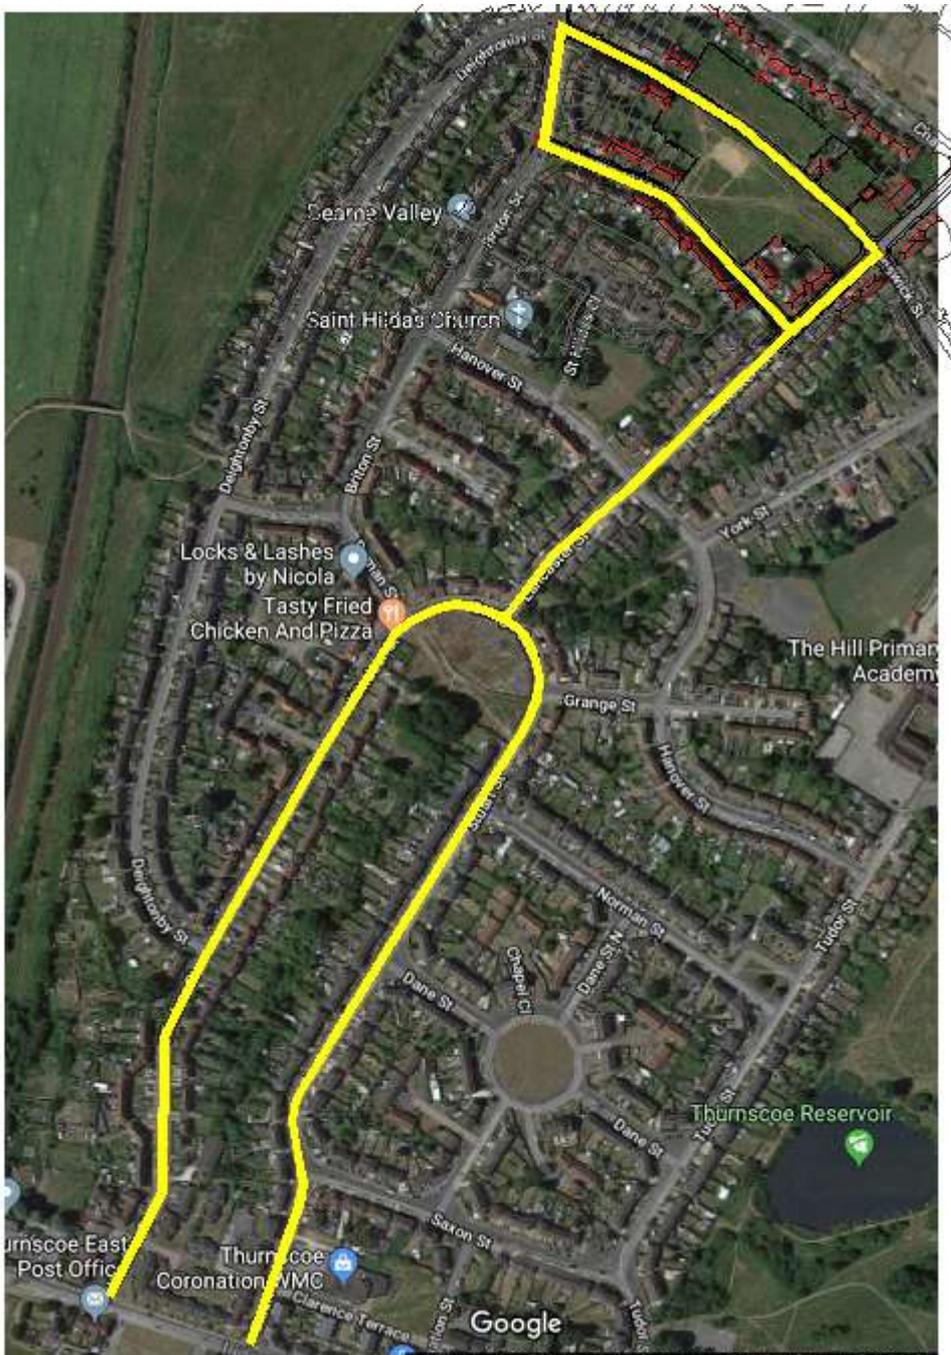
Fig 1. Extent of highway condition survey

The extents of the survey are shown on Fig 1.
