## Combined Phase I and Phase II Geoenvironmental

**Premier Inn, West Bromwich New Gas Street, West Bromwich B70 0NP**

CRM.1483.095.GE.R.001.A

Project:	Premier Inn, West Bromwich, New Gas Street, West Bromwich B70 ONP
For:	Whitbread PLC
Ref:	CRM.1483.095.GE. R.001.A
Status:	Draft
Date:	May 2025
Author:	Richard Hamilton <b>Director of Geoenvironmental</b>
Reviewer:	Steve Rhodes <b>Director</b>

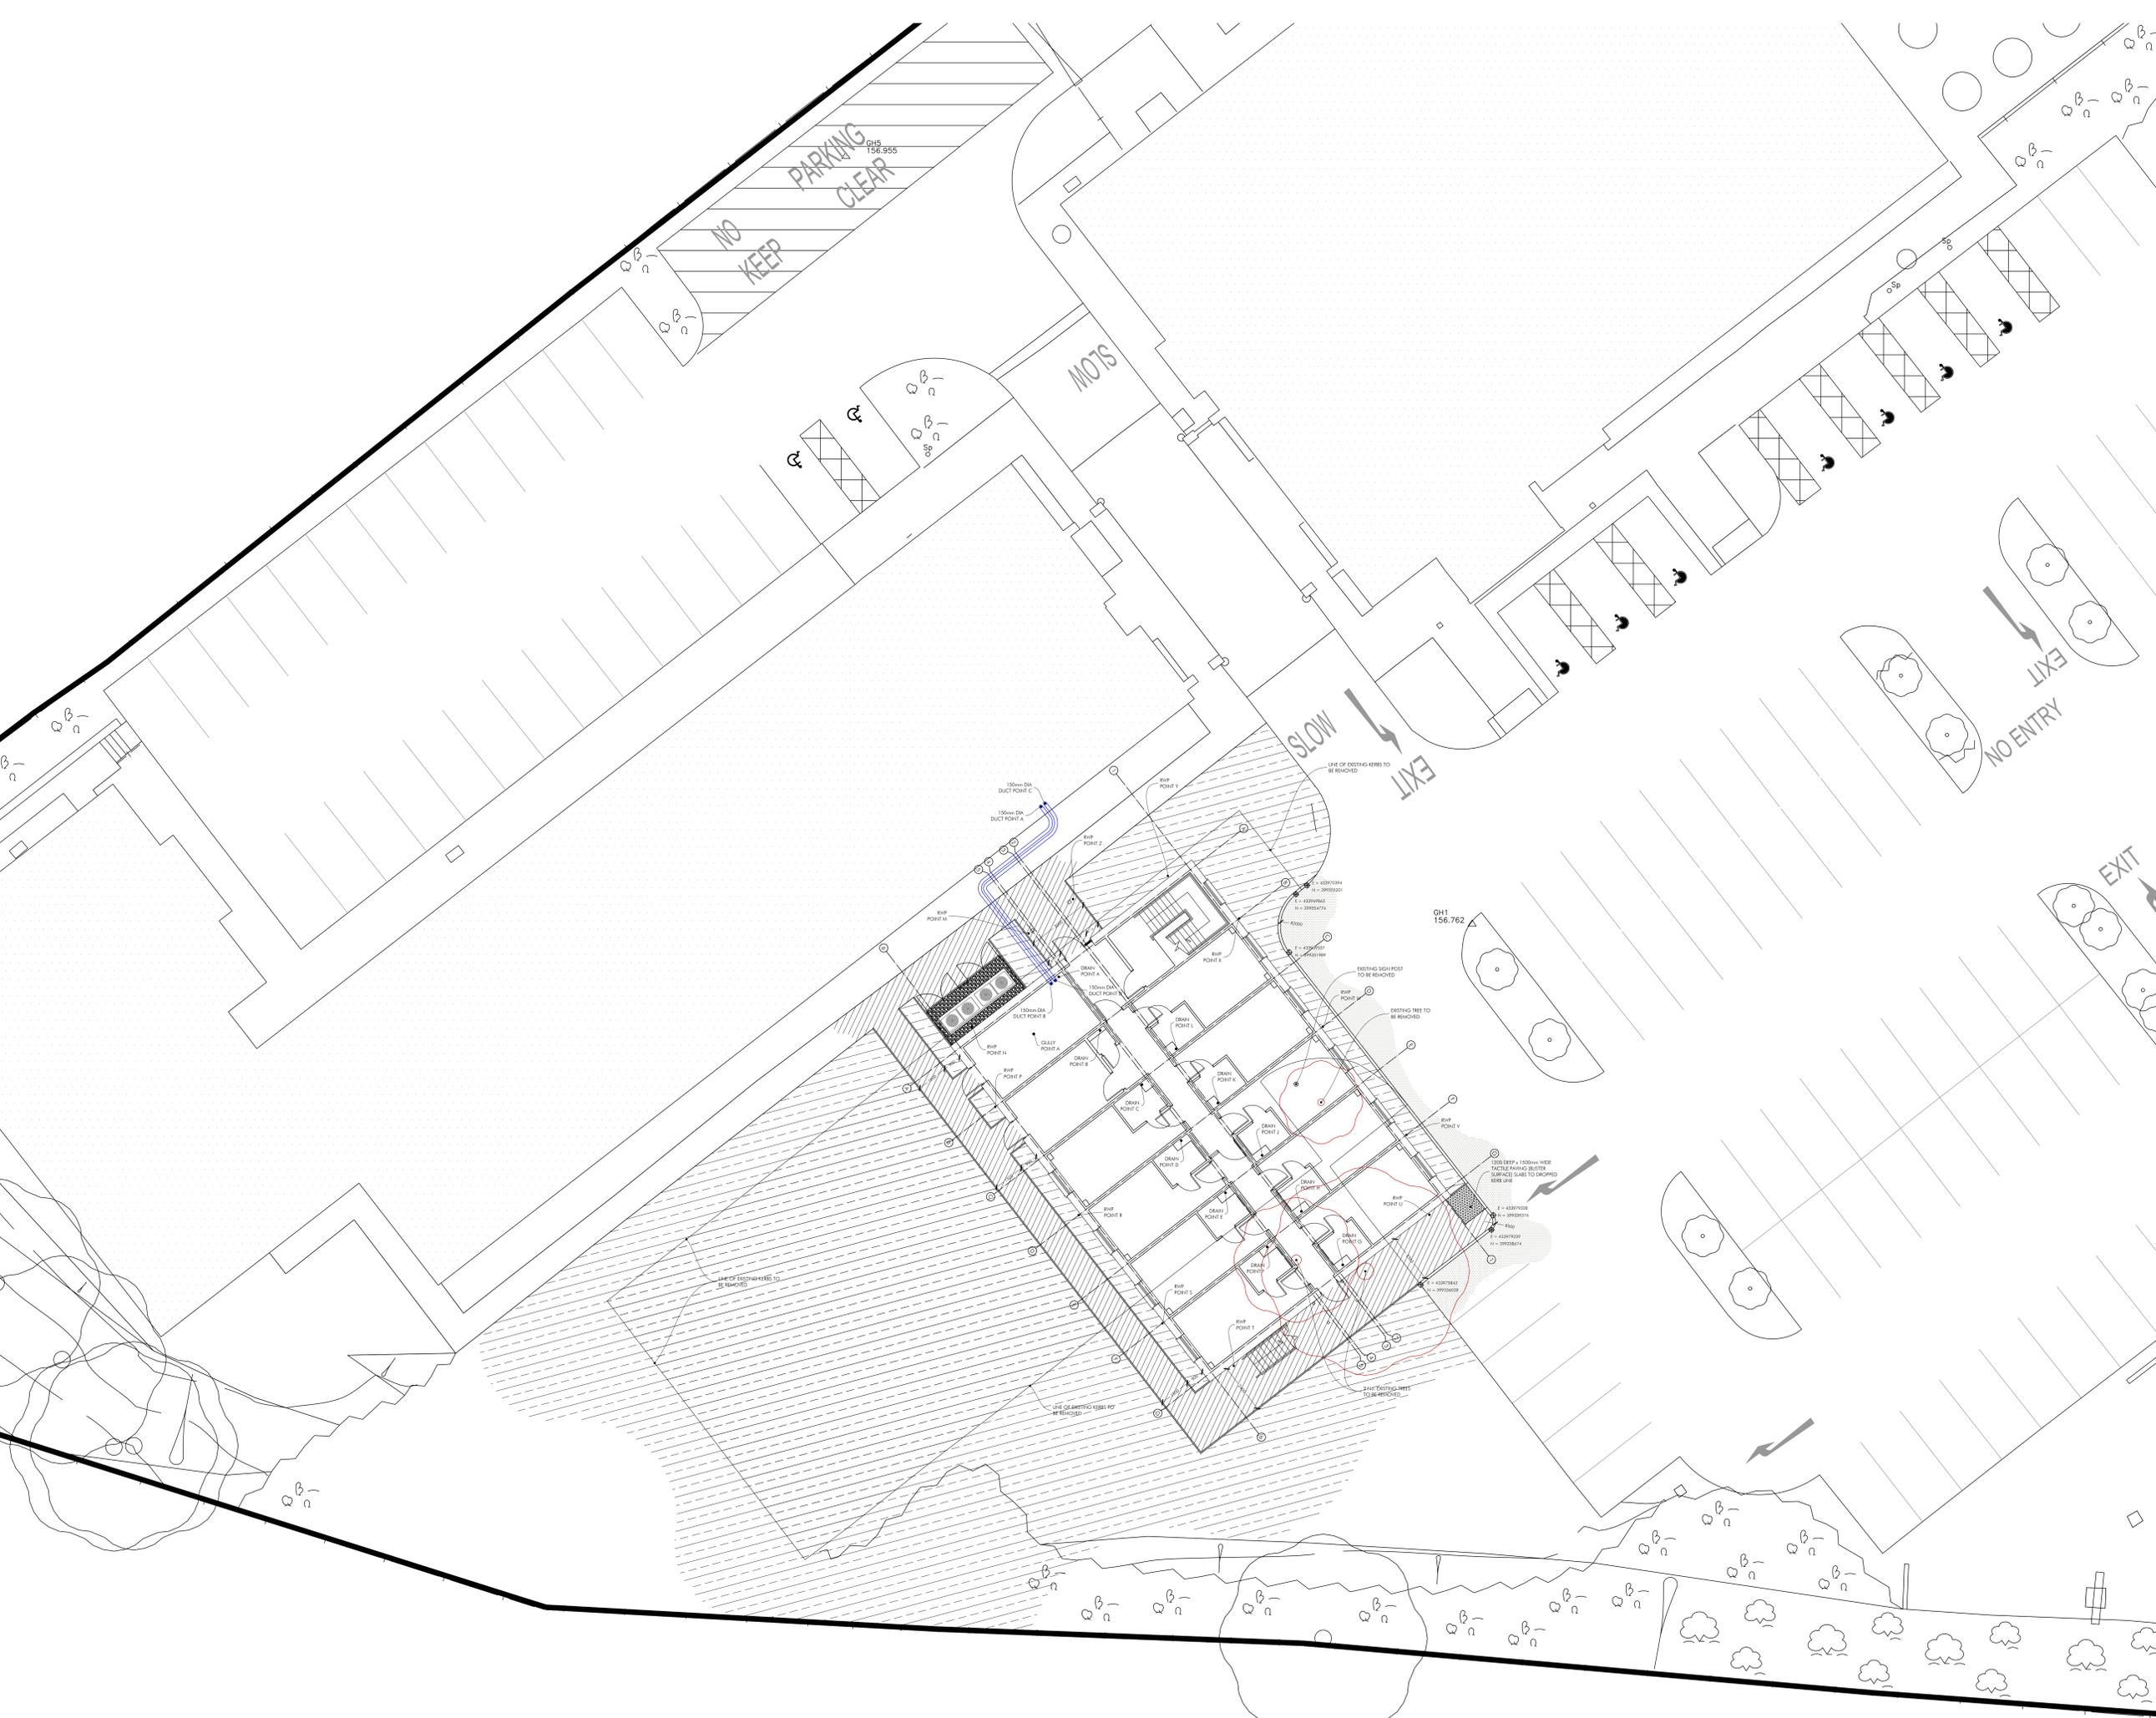
NOTE: GROUND FLOOR EXTERNAL DOOR THRESHOLDS TO BE SET LEVEL WITH INTERNAL FLOOR LEVEL UNLESS STATED DIFFERENT

POINT	EASTING	NORTHING
DUCT A	439957.623	399358.984
DUCT B	439958.118	399350.489
DUCT C	439957.821	399356.137
DUCT D	439958.316	399350.642

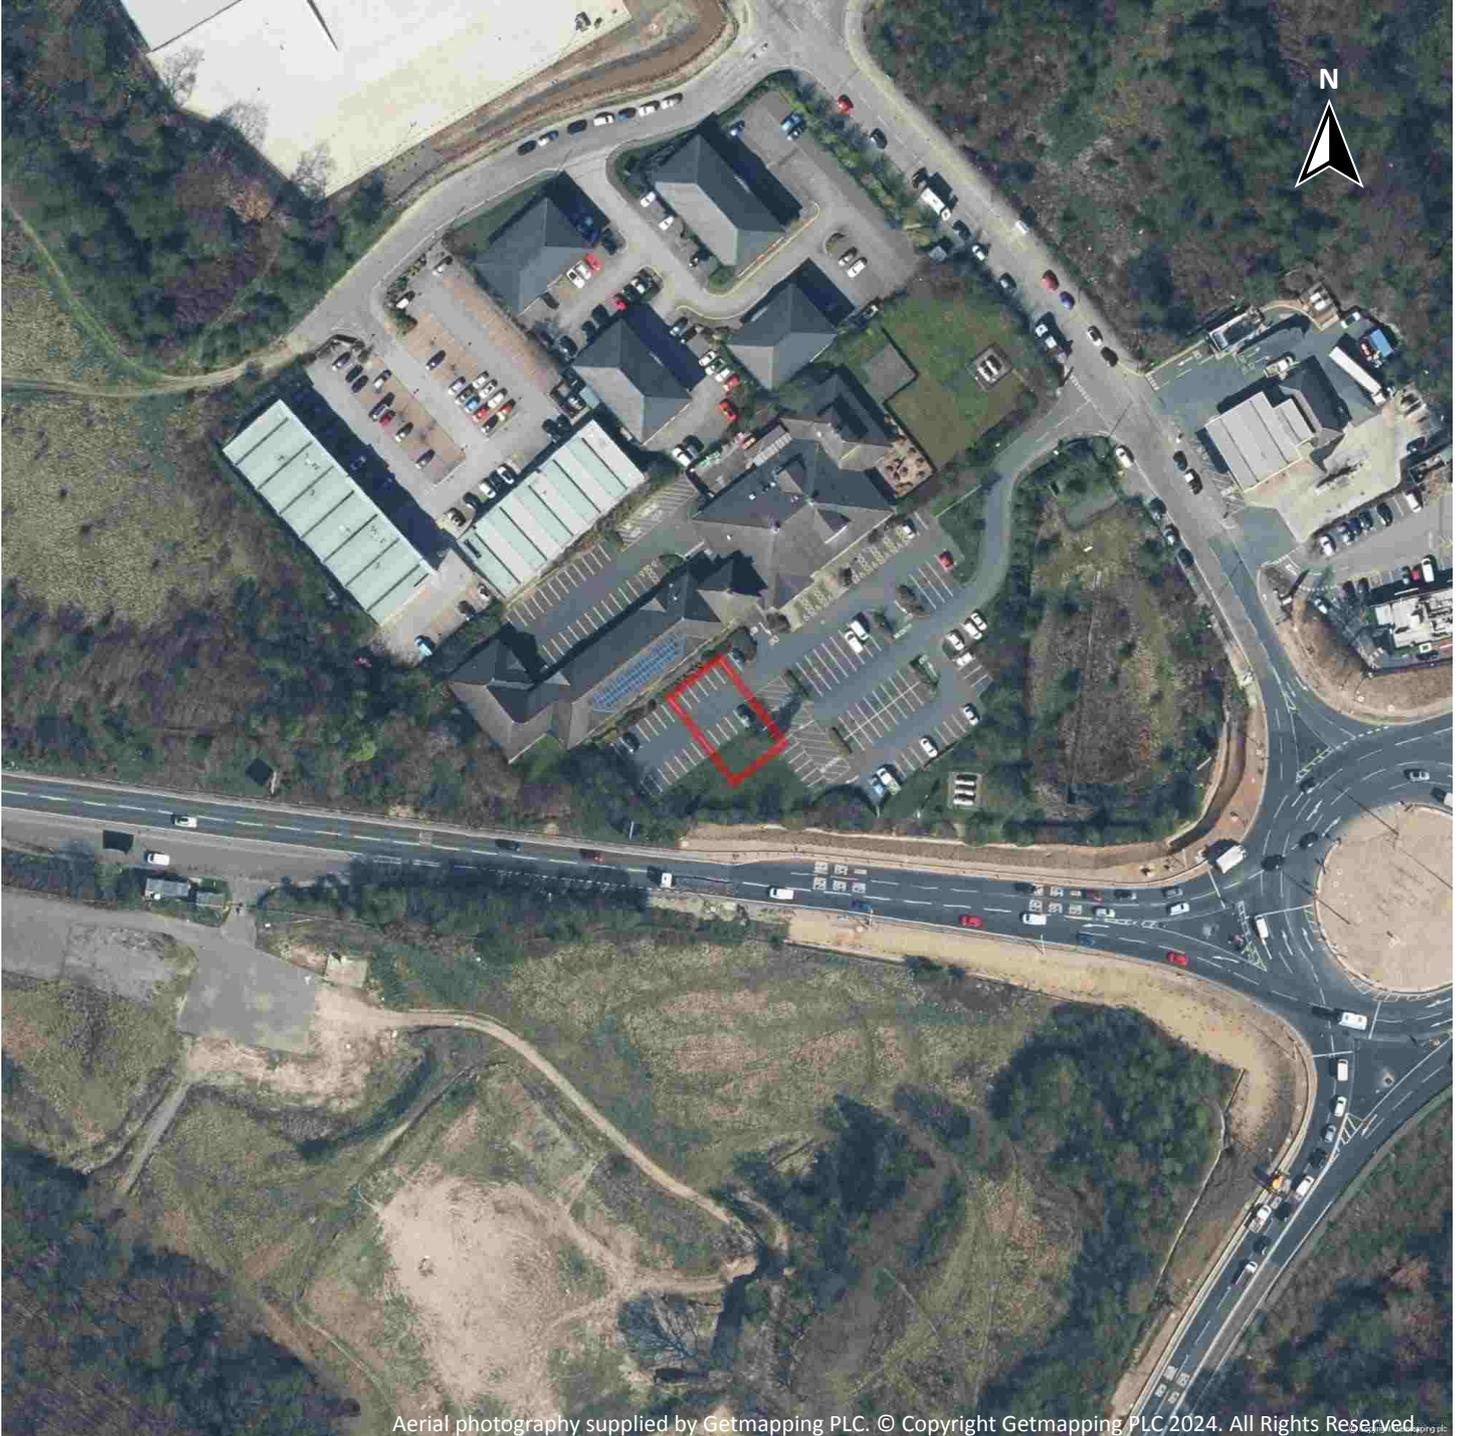
## Recent aerial photograph

Capture Date: 19/04/2021

Site Area: 0.04ha

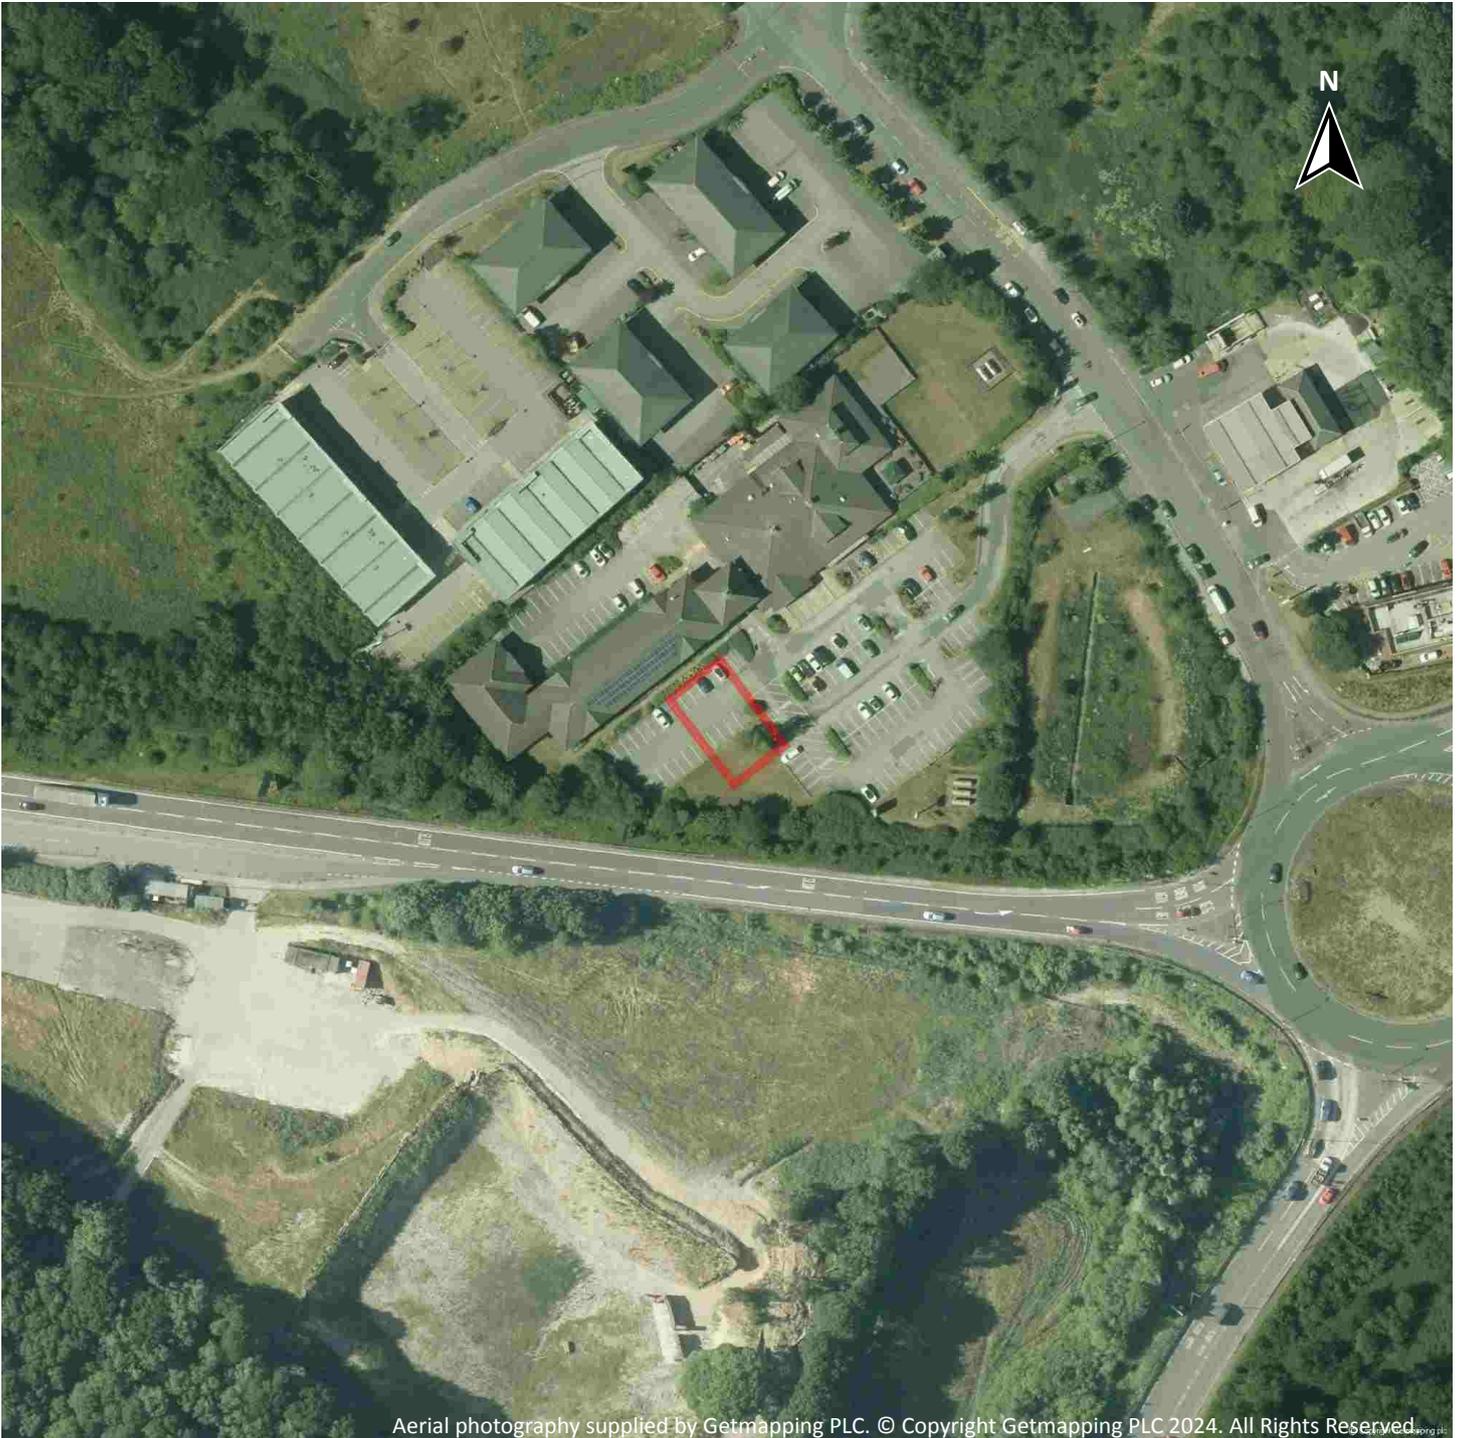
## Recent site history - 2018 aerial photograph

Capture Date: 27/06/2018

Site Area: 0.04ha

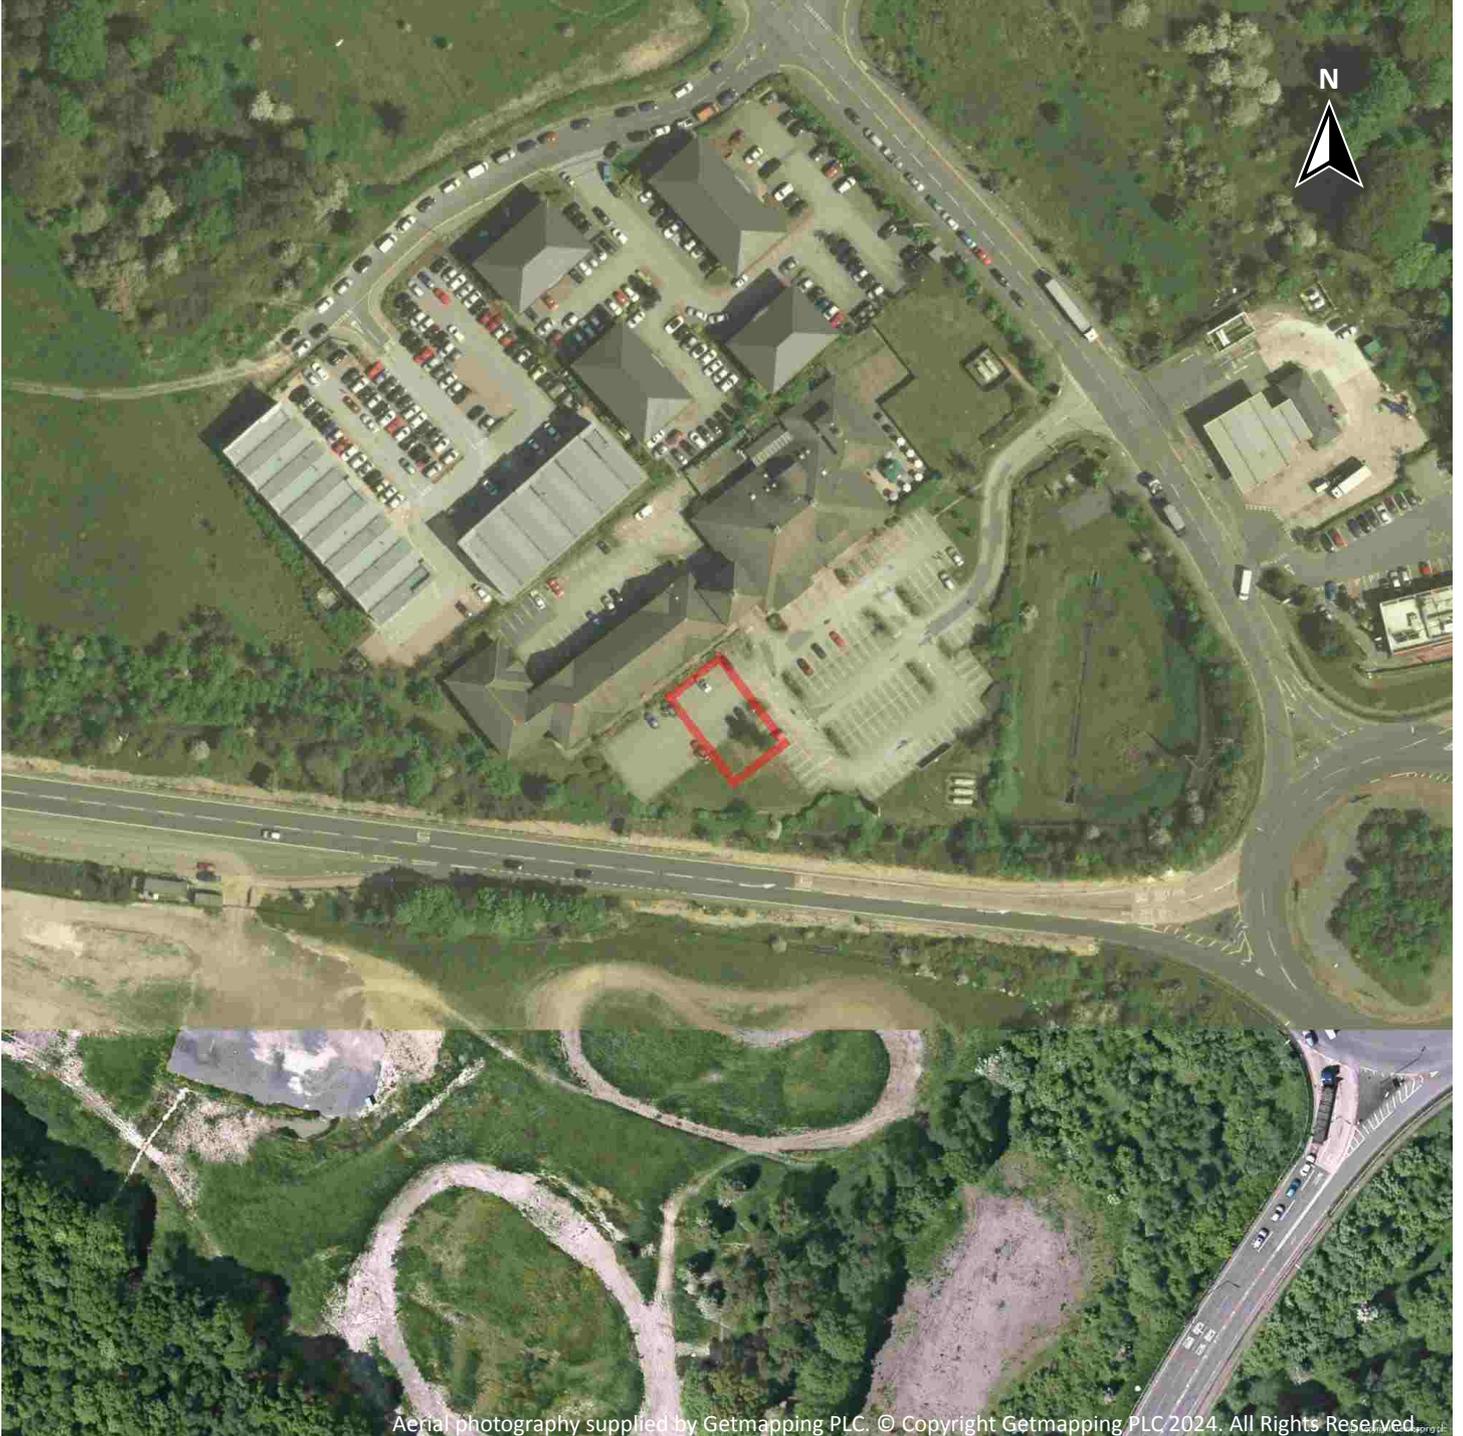
## Recent site history - 2012 aerial photograph

Capture Date: 28/05/2012

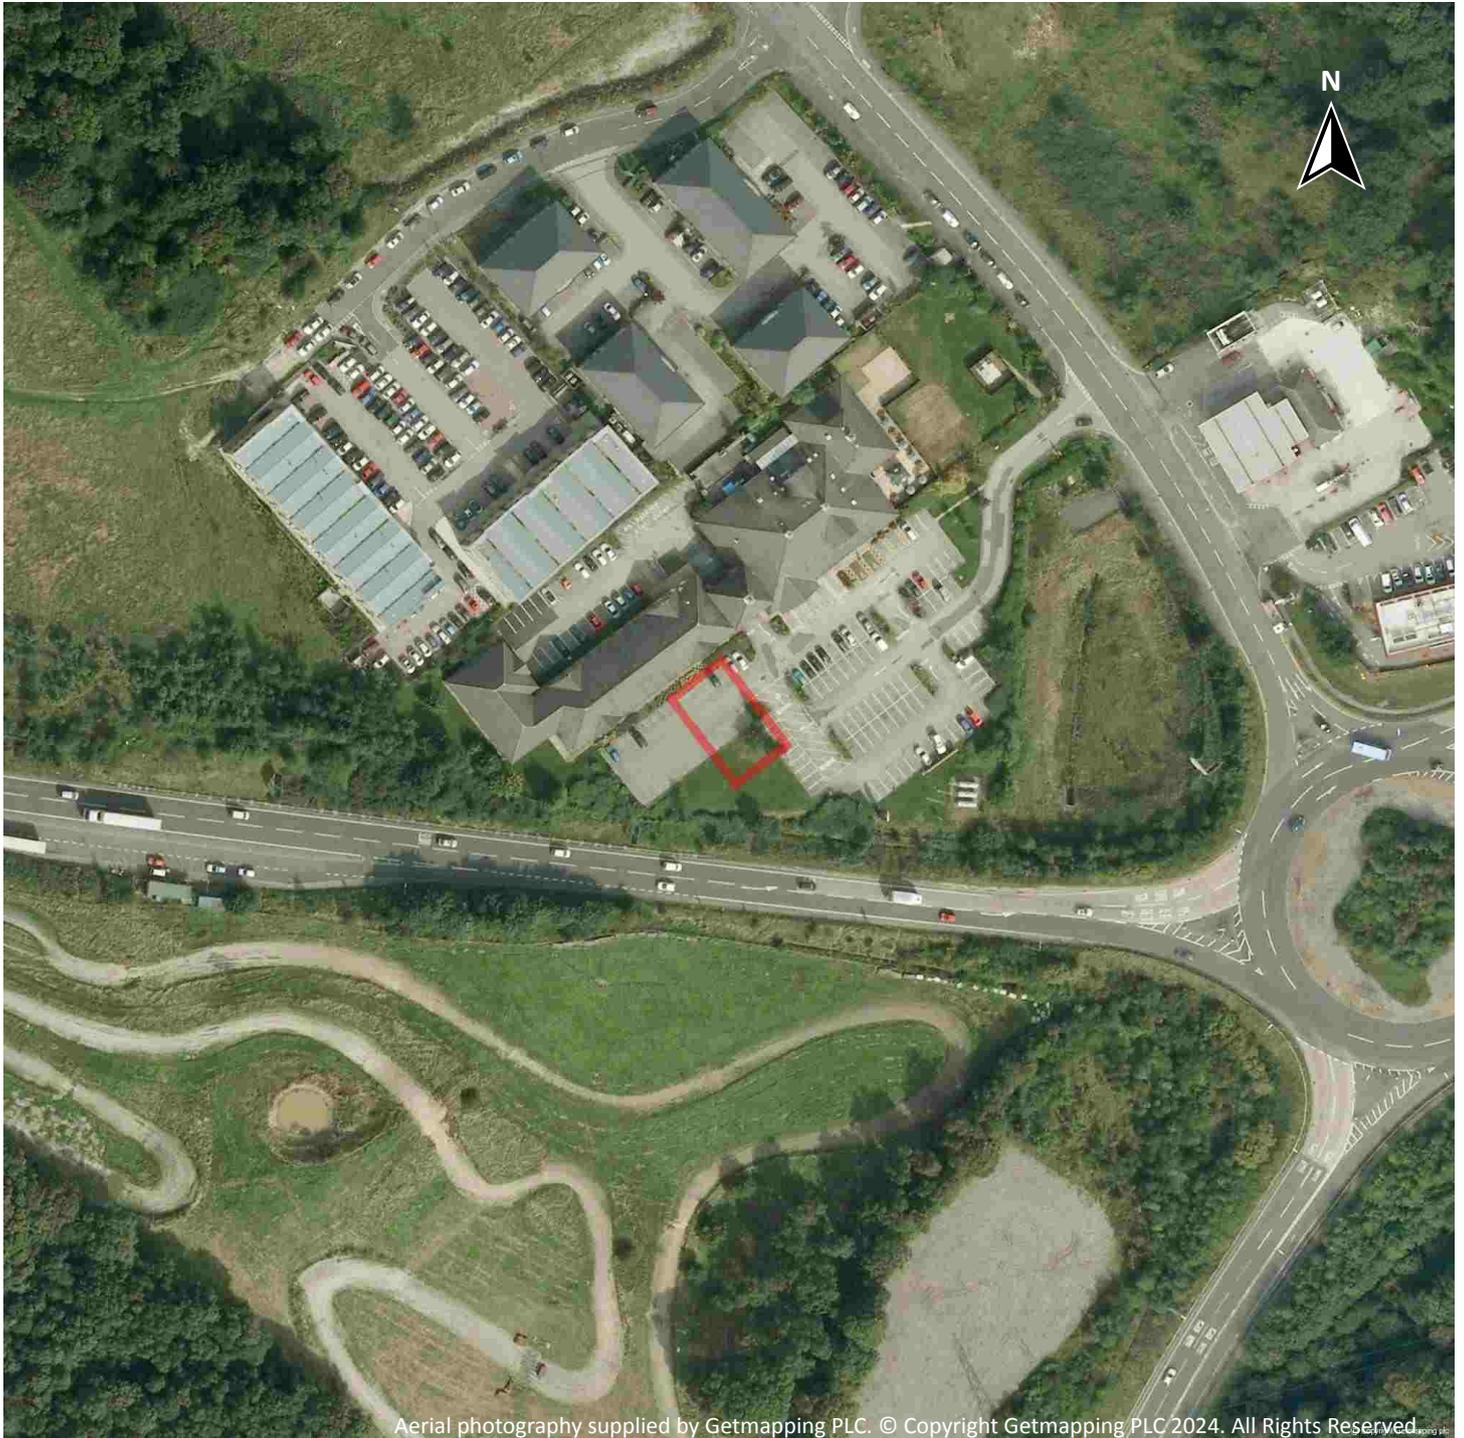
## Recent site history - 2009 aerial photograph

Capture Date: 11/09/2009

Site Area: 0.04ha

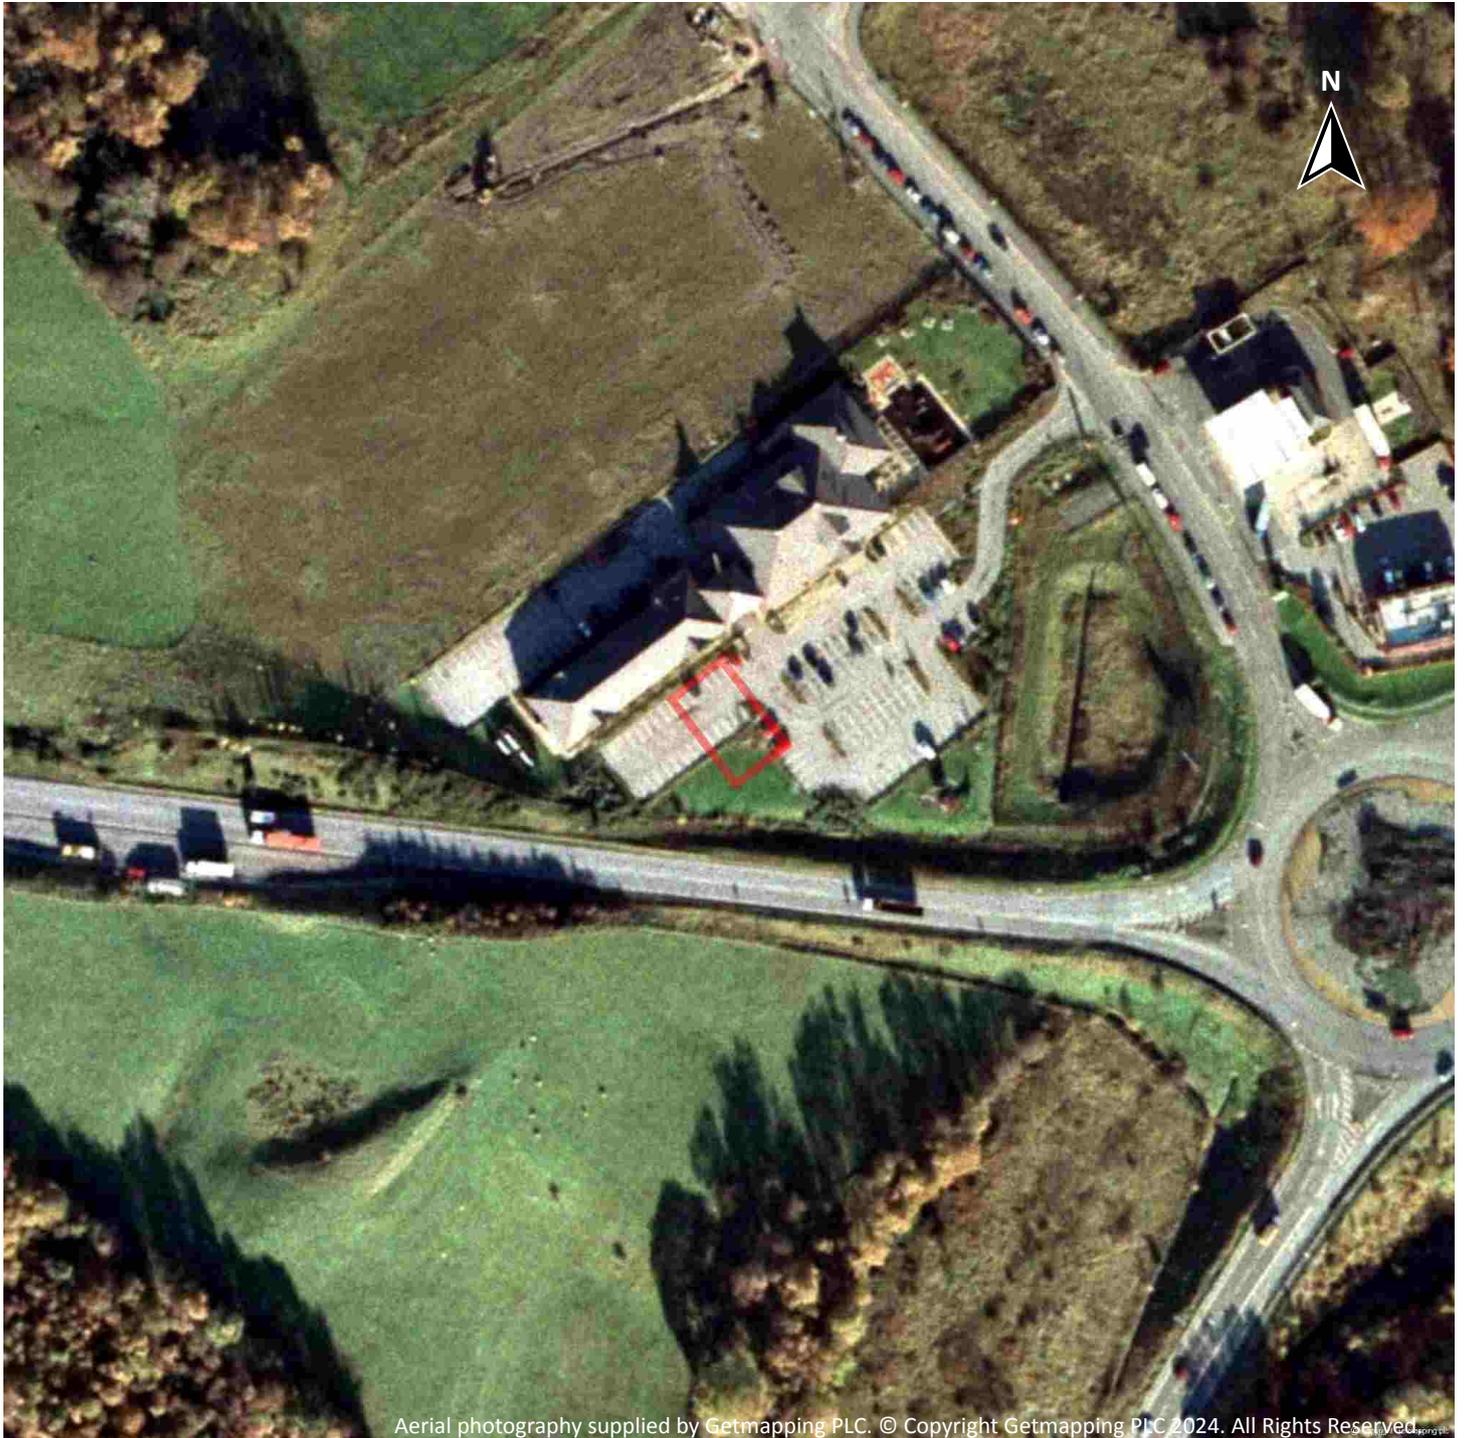
## Recent site history - 1999 aerial photograph

Capture Date: 10/07/1999

Site Area: 0.04ha
