## North Facing Elevation As Proposed

### ISSUED FOR PLANNING

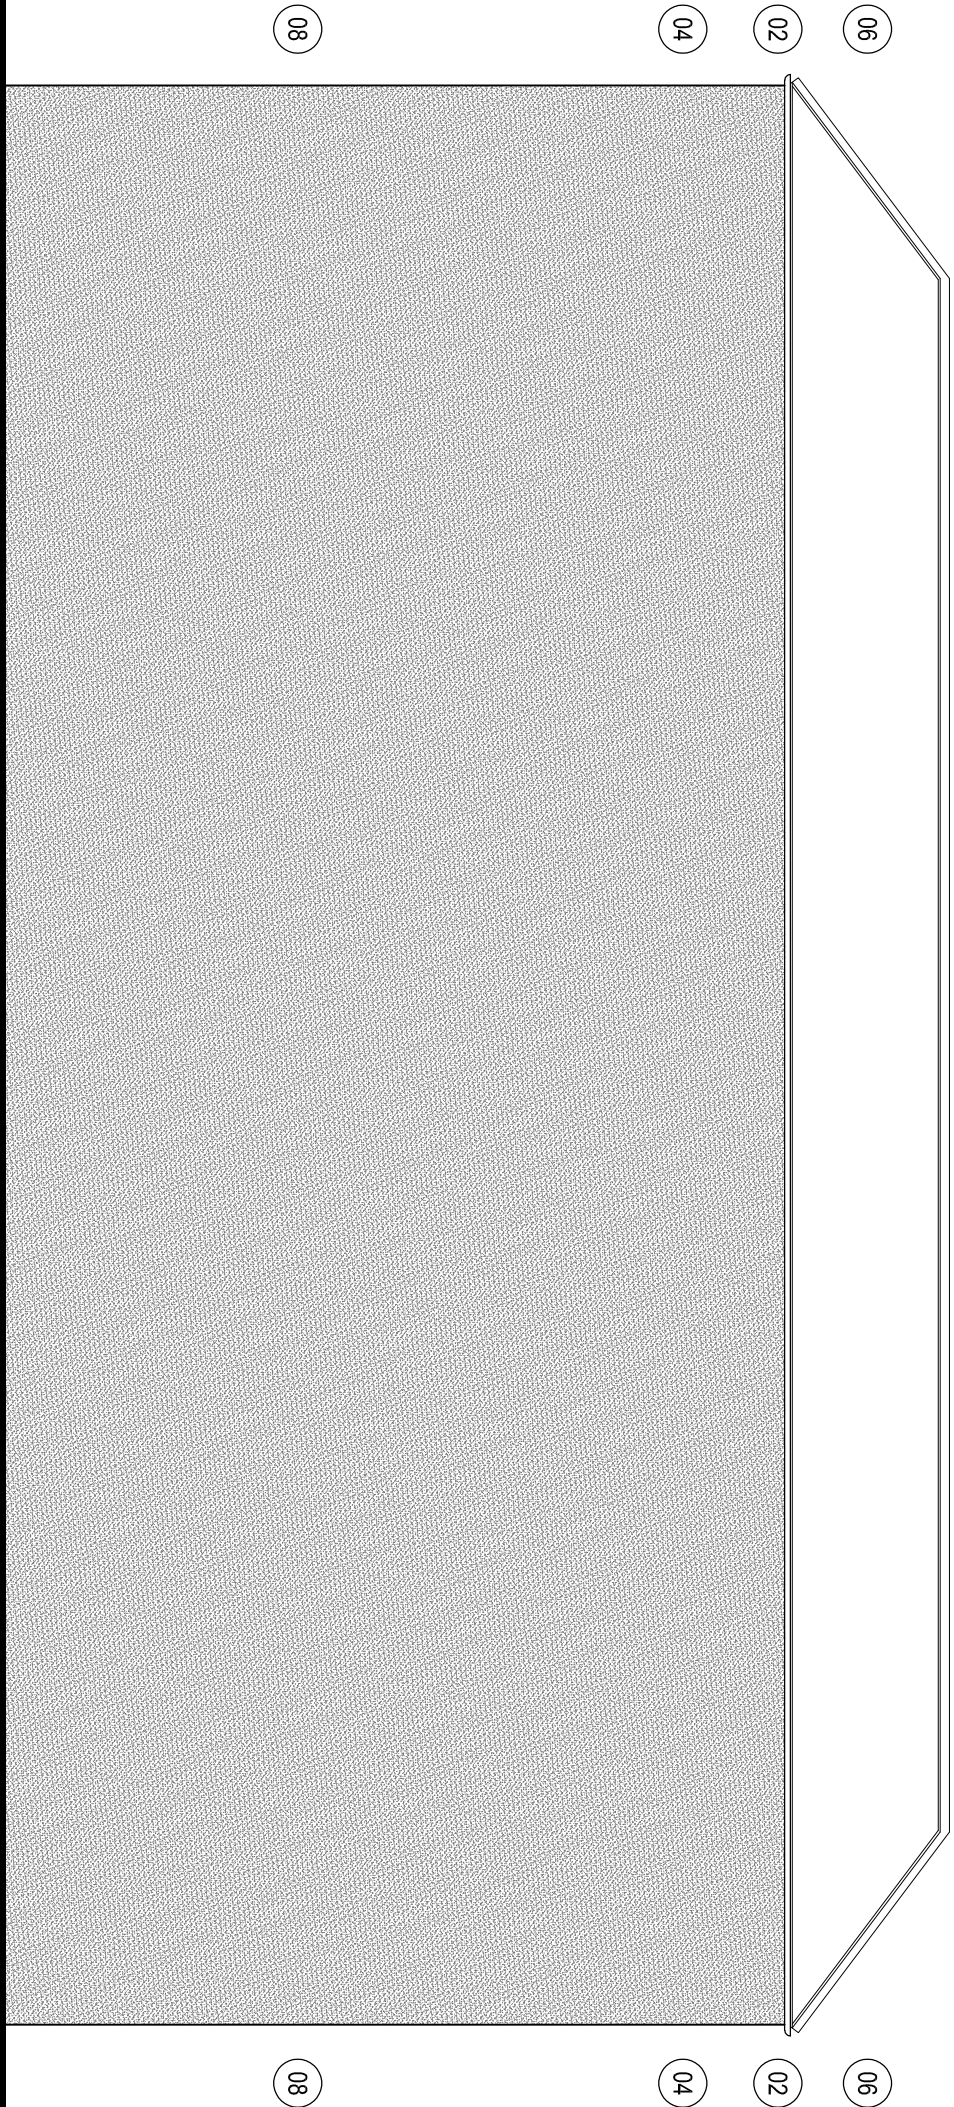
- Carefully remove existing modern shop fascia, signage, walling, entrance doors and glazed windows and dispose of from site, replace with new masonry stallriser as shown on drawing 208, traditional shop frontage windows and relocated recessed door entry as shown on drawings 201 - 207 & 208 - 210

- Carefully strip out existing plastic gutters and rainwater downpipes and install new 'ogee' profile cast metal gutters and 68mm cast metal rain water pipes and connect into the existing drainage

- Existing timber windows to first and second floor to be carefully renovated/overhauled and install new painted timber vertical sliding sash windows to existing opened up window openings as identified on drawings 201 - 203.  
NOTE retain all instances of existing historic glass

- Carefully remove existing failing render system to the front and sides and render to all existing areas with breathable lime roughcast render and paint with breathable paint, colour to be confirmed, for details refer t the specification

- Existing lead flashings above existing water table to be carefully removed and allow for installing new Code 5 Lead flashing to be chased into existiong wall, include for removing existing paint to water table and redecorate with breathable paint to match that of the render above

- Existing roof, flashings and support beneath to be carefully removed and set to one side, battens etc to be disposed of, existing roof structure to be inspected by the CA, include for 15% timber spliced repair and 15% timber replacement, reinstall existing roof tiles allowing for 20% replacement to match the existing on SW timber battens and counterbattens on Tyvek Supro breathable membrane on existing SW timber rafters and with 100mm Kingspan Kooltherm K7 rigid roof board insulation laid between rafters and 62.5mm Kingspan Kooltherm K18 Insulated Dry-Lining fixed to the underside all to achieve a U-Value of 0.13W/m<sup>2</sup>K

- Carefully remove the existing failed canopy between the 2 buidlings and dispose of from site, make good the existing walls
- Existing brickwork walling to rear and main side elevation to be repaired to include removal of growth to bottom 1m full length and to areas around the existing fire escape staircase. wall to be treated with Biocide and repointed with NHL 3.5 Lime mortar.

- Existing brickwork walling to rear and main side elevations to be repaired and repointed fully with NHL 3.5 Lime mortar - allow for removal of previous repairs using cementitious mortar
