**HERITAGE STATEMENT  
By PETER THORNBORROW GNSM,  
PGDipELH (CNAA)**

In support of works of repair and gutters to the  
roof of a Grade II\* listed building:

**Darley Cliffe Hall**

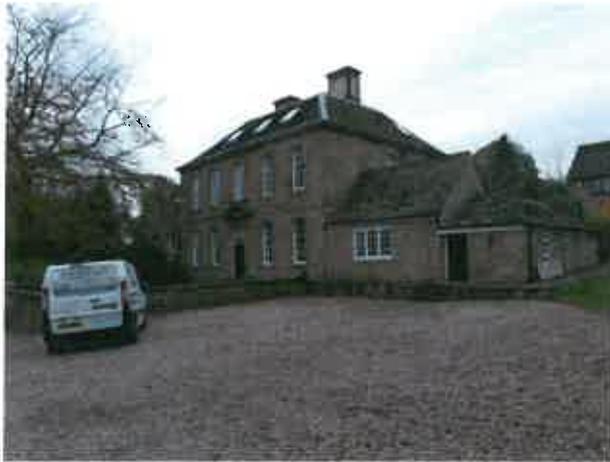
**Figure 1. Oblique view of east front through the entrance gates: shows Tudor House to left and single-storey 'kitchen' and its lower addition to right**

2. It is significant that the opposite side of the house has an intact roof without the intrusion of roof lights for the servant's attic dormers (see figs. 1 & 2) cut into its slope. This suggests that while the east side of the house was its Public face, the west side was its Polite face, and may at one time have been the principal entrance for visiting Gentry, and the owner/occupier, via the entrance off Kingwell Road, the former Bank End Road as illustrated on the c.1906 map (see fig. 5), thus avoiding going through a farmyard which must be deemed as always being a secondary farm entrance in the past. Nor does the west garden-side of the house feature basement / cellar windows and permits a more appropriate parkland and impressive approach to the house through lawns and a garden.

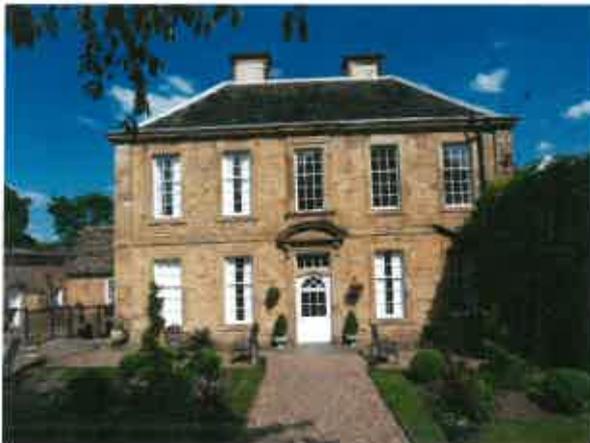
**Figure 2 West Entrance Front to garden**

doors with raised panels but with glazed inner French-doors with an arched fan-light above; this permits the outer doors to be folded back against the thickness of the wall during the day permitting greater light within the house and a more attractive approach, but the outer doors secured at night for greater security. Above the door is an impressive window with an eared-and-lugged architrave its sides tapered and rusticated that balances well with the impressive entrance door below it (see fig.2 that shows the identical one on the rear west side of the building).

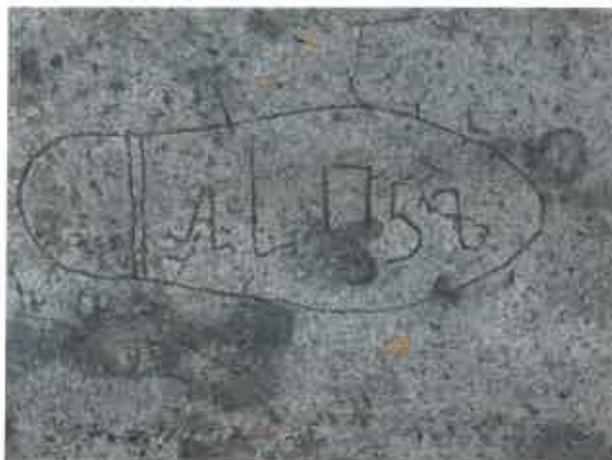
**Figure 3 Example of Georgian graffiti dated 1758 scratched into lead-flat on roof**

builders who were engaged in repairing or altering the building in the mid-18th century; the sheer physicality of their presence is shown by their hands and feet outlined on the roof (see fig. 4). The dates may indicate when the various Georgian alterations were made to Darley Cliffe – the leaded-light windows replaced with timber sash windows – when they were actually carried out.

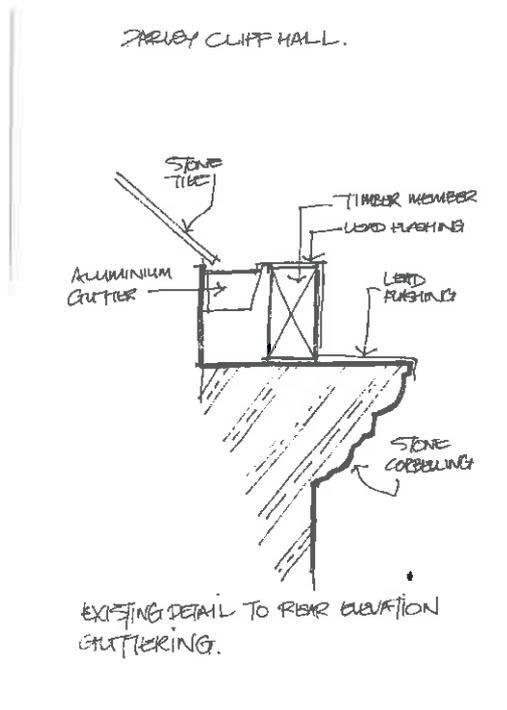
Fig. 6 a: Sketch as Existing section.

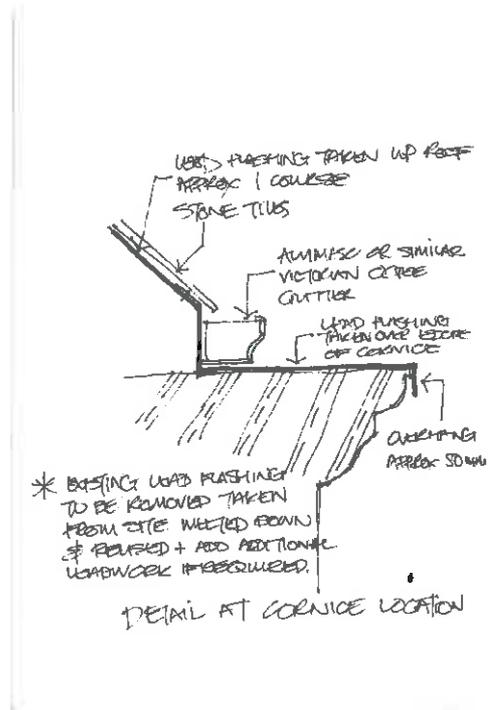
Fig 6 b: Sketch as Proposed section
