WENTWORTH CASTLE GARDENS,  
SOUTH YORKSHIRE.

REPORT ON AN ARCHAEOLOGICAL WATCHING BRIEF

OSA REPORT NO. OSA19WB14

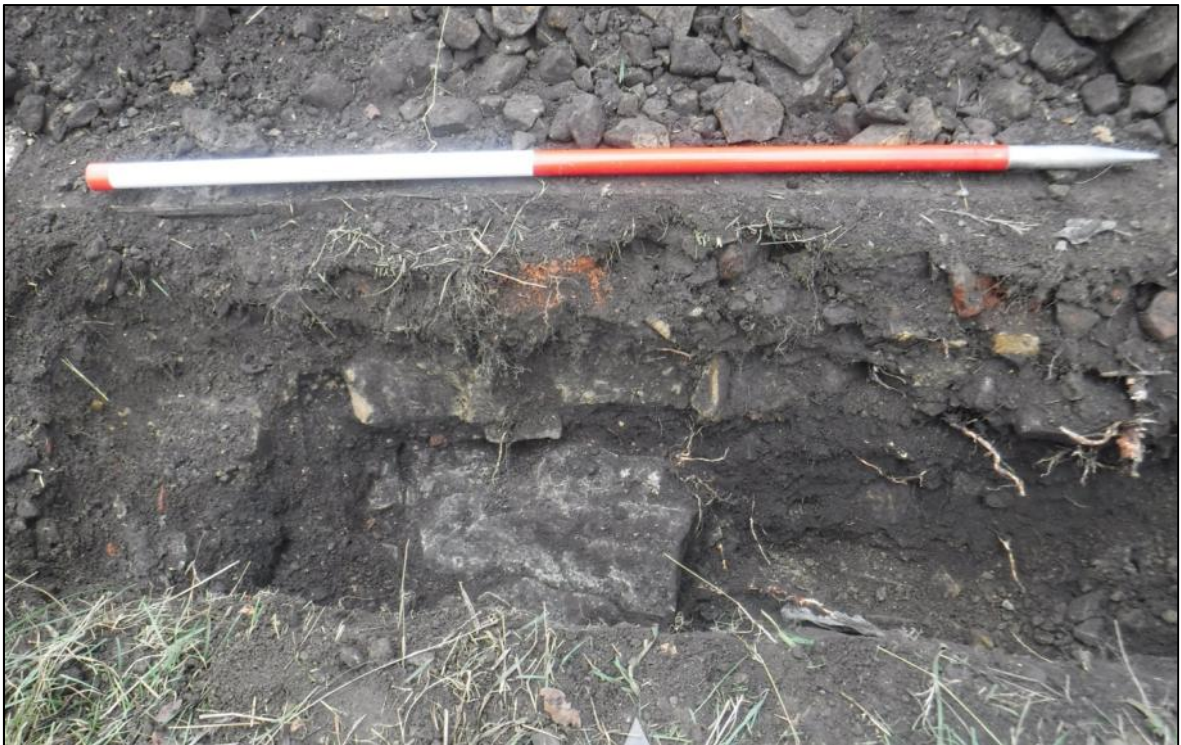
*Plate 1. Trench 1. Southwest facing section of wall (103).*

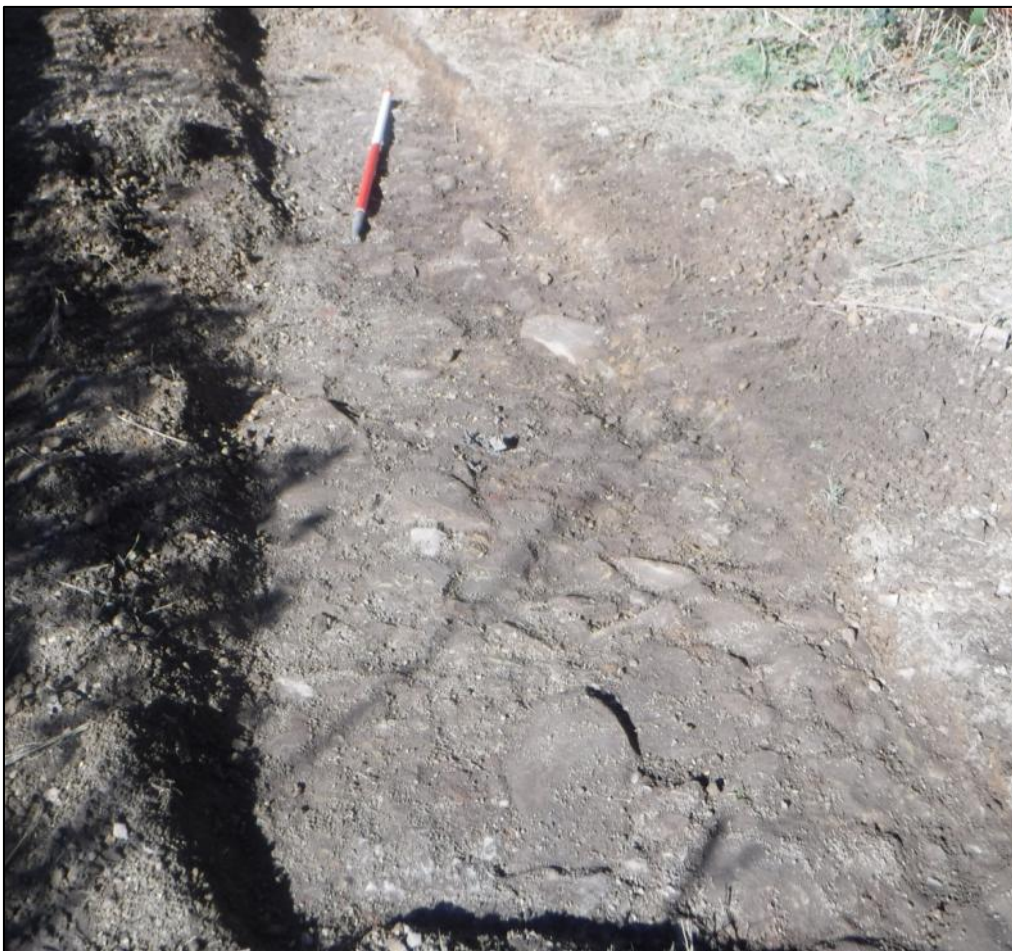
*Plate 2. Trench 1. Surfaces (104) and (105), looking northwest.*

The earliest recorded deposit in the trench was levelling layer (107) of loose mid orange brown sand. In the northern part of the SE arm of the trench a dump of material (102) consisting of firm orange brown clay silt with frequent ceramic building material (CBM) and fragments of sandstone block was found above layer (107) (Figure 3). This deposit was up to 0.20m thick. A small section of random coursed dry stone wall (103) was found 5m to the northwest of dump (102) (Figure 3; Plate 1). This consisted of a series of dry bonded stones. Only a very small section was available to study in the narrow trench but it was felt that the structure was aligned north to south. It was unclear if deposit (101), a later levelling layer consisting of 0.20m to 0.40m of loose dark brown sandy silt, was cut by the wall construction or had built up against it. No obvious cut for the wall was observed during excavation. Further to the north, next to the change in direction of the trench, deposit (101) was overlain by hardcore (104), consisting of light grey gravel. This deposit served as a foundation for modern surface (105) (Figure 3; Plate 2). Sealing the surface was levelling (106) and the modern topsoil (100).

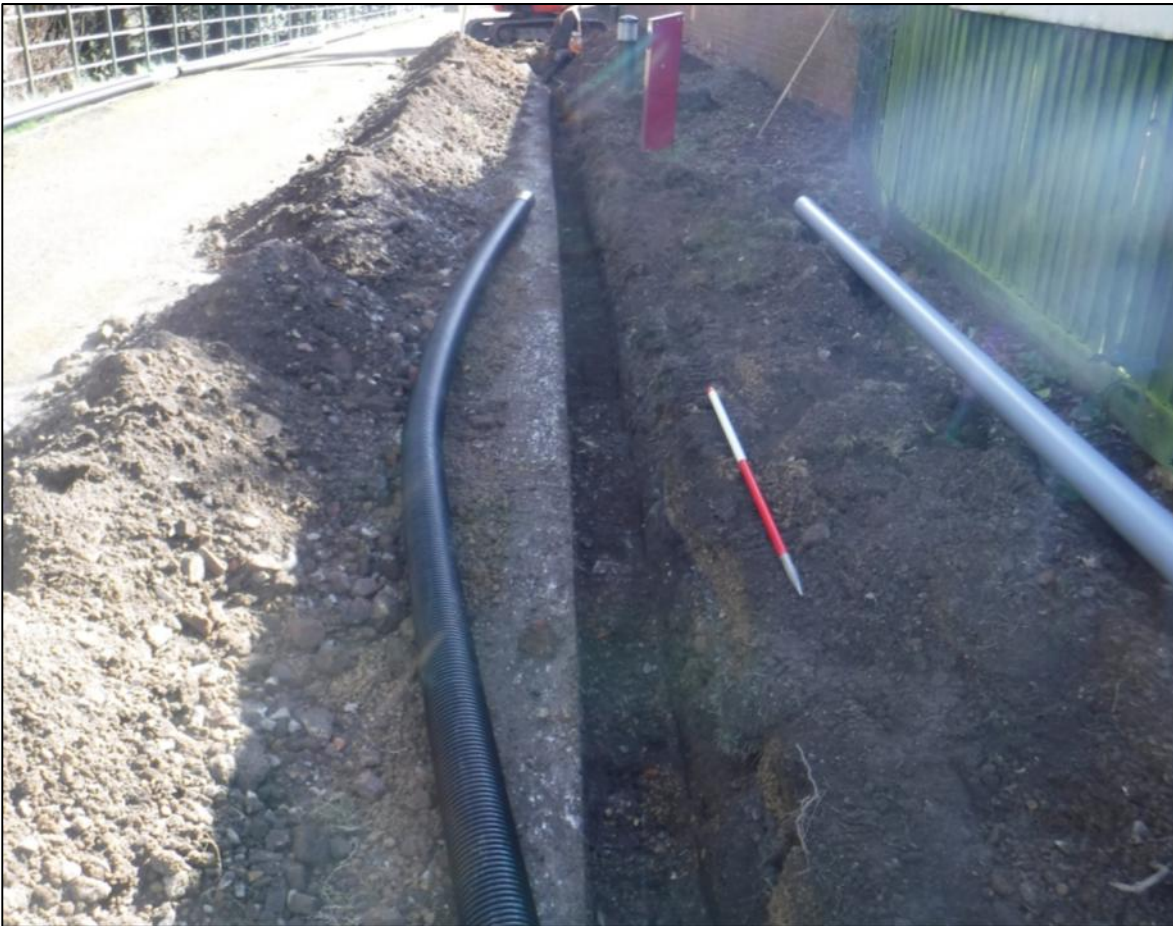
*Plate 3. Trench 2, looking southeast.*

This trench (Plate 3) ran for 150m from the northwest to the southeast along the lane from the car park along the eastern side of the walled gardens complex and measured 0.45m wide. The earliest recorded deposit was (203) a made ground horizon consisting of rubble and CBM. The deposit continued below the level of excavation and was at least 0.30m deep. It was overlain by (202) a more recent levelling of fine white to grey gravel up to 0.30m thick. Sealing this was either (201) 0.10m of grey tarmac, the current lane surface, or topsoil (200).

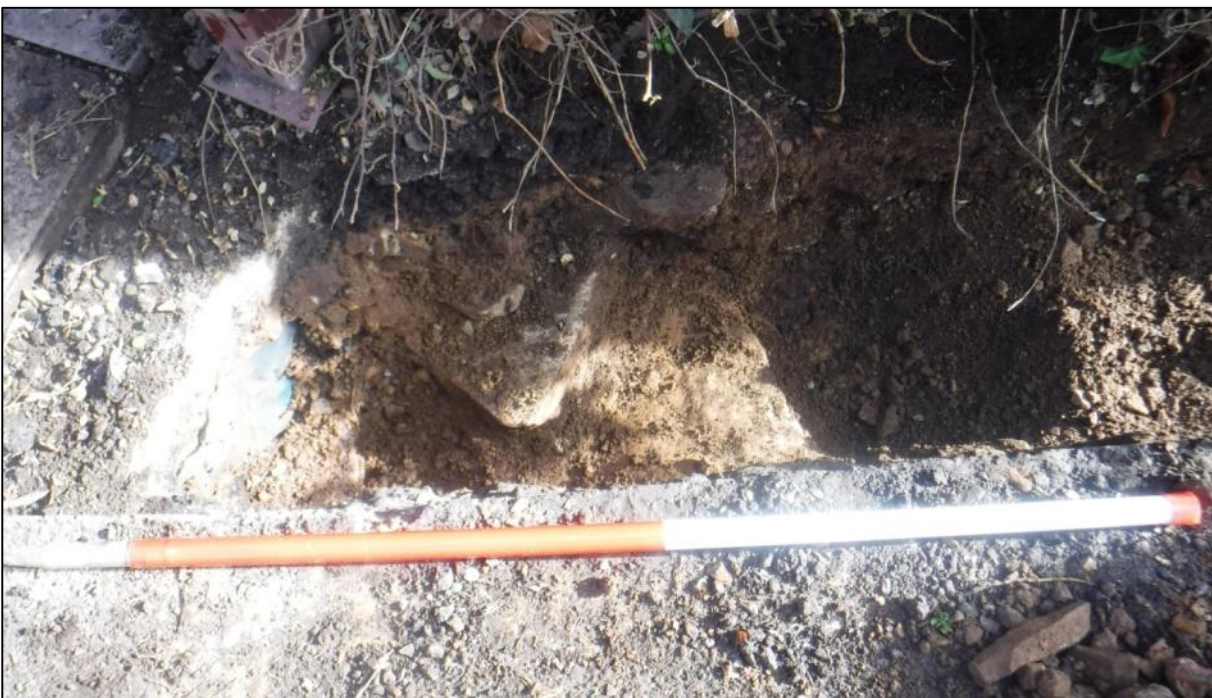
*Plate 4. Wall (302) in Trench 3, looking northeast.*

This was excavated near the southwest corner of the range running parallel to and west of the Long Barn and measured 0.4m wide by 12m in length. The earliest features recorded in the trench were structural elements (Figure 4). The most northwestern of these was wall (302) located at the extreme northwest end of the trench (Figure 4; Plate 4) constructed with large sandstone blocks. This appeared to be aligned perpendicular to the line of the trench (approximately northeast to southwest) although as only one side was within the limit of excavation and it extended below the maximum depth of the trench this orientation is not absolutely certain. This wall was assigned a notional cut number of [303]. Located 6m to the

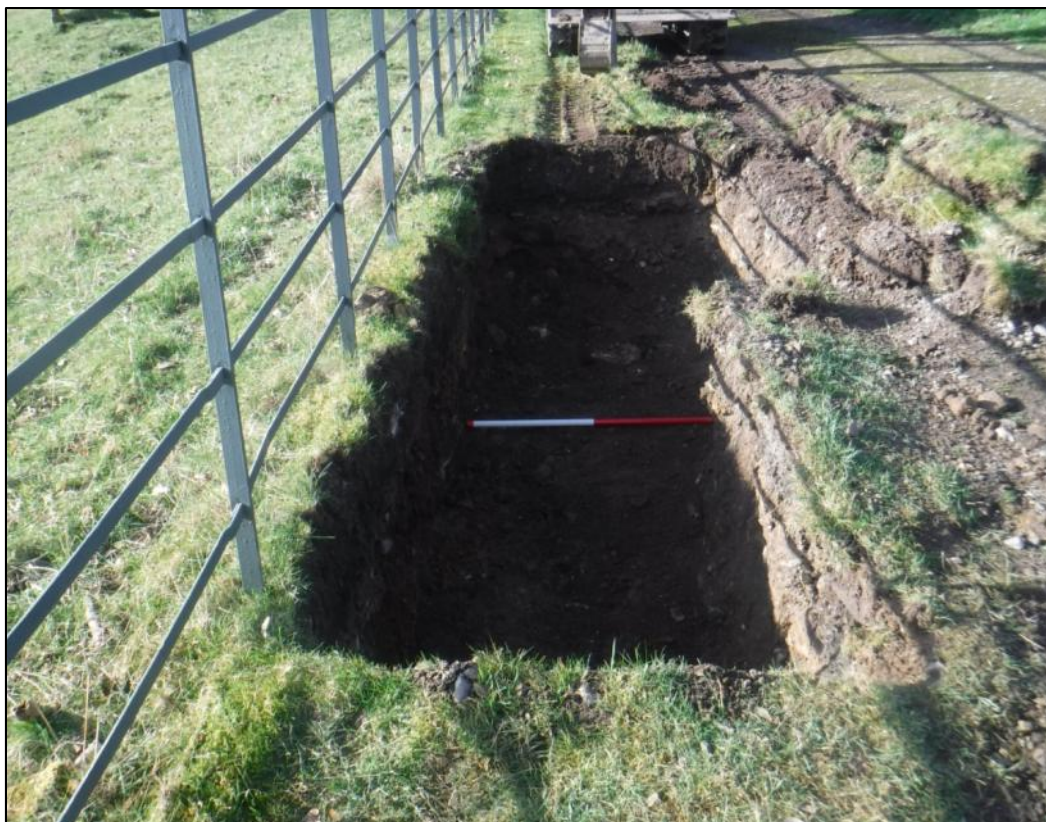
*Plate 5. Trench 4, looking southwest.*

Trench 4 was located to the southeast of the play area and measured 1.3m by 3.7m with a depth of 0.8m (Plate 5). The earliest recorded deposit within the trench was (402) a dark orange red brown silt levelling deposit with frequent fragments of stone and CBM. The deposit was at least 0.30m thick. It was overlain by (401) 0.30m of very dark brown sandy silt that was dumped as made ground. The upper most deposit was the topsoil (400).

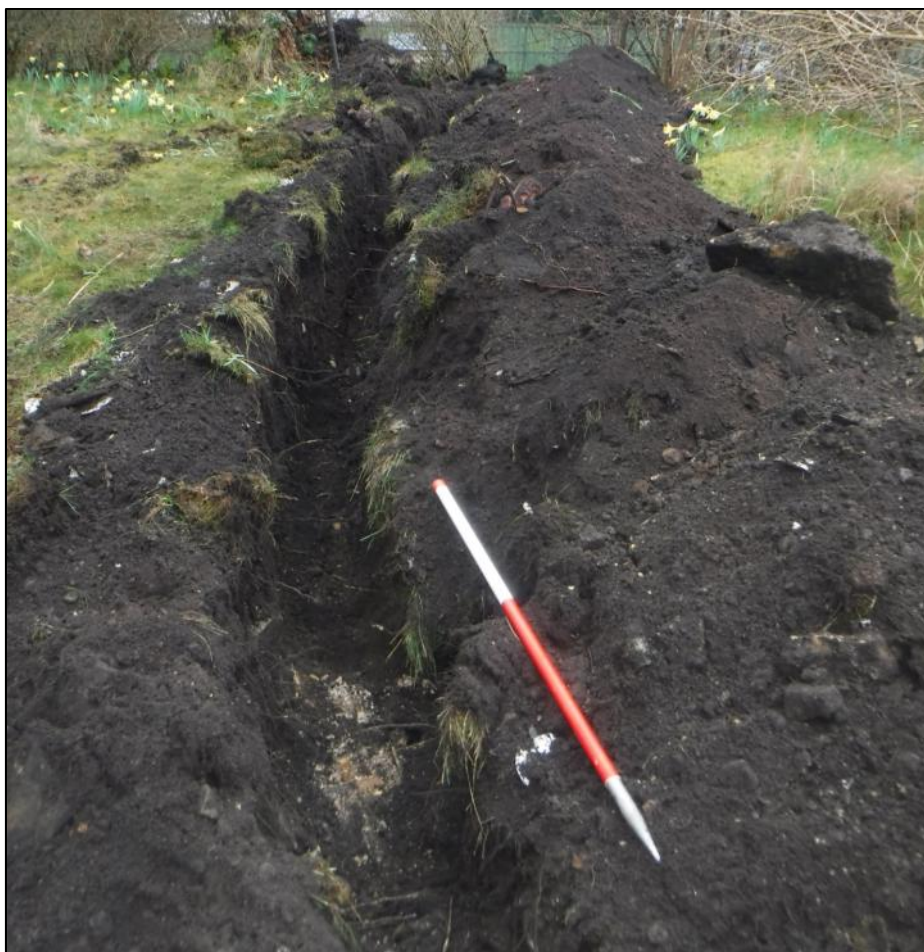
*Plate 6. Trench 5, looking southeast.*

This trench was located between Trench 2 and the car park and measured 0.4m wide and 25m long (Plate 6). The earliest exposed deposit in the trench was (501) an extensive buried landscaping deposit of very dark brown sandy silt up to 0.40m thick, which continued below the basal limit of excavation (Plate 7). This was cut by a modern retaining wall (502), approximately 15m from the southwest end of the trench, on the line of an extant garden boundary wall (northwest to southeast). The upper deposits in the trench were the subsoil (503) and the topsoil (500).

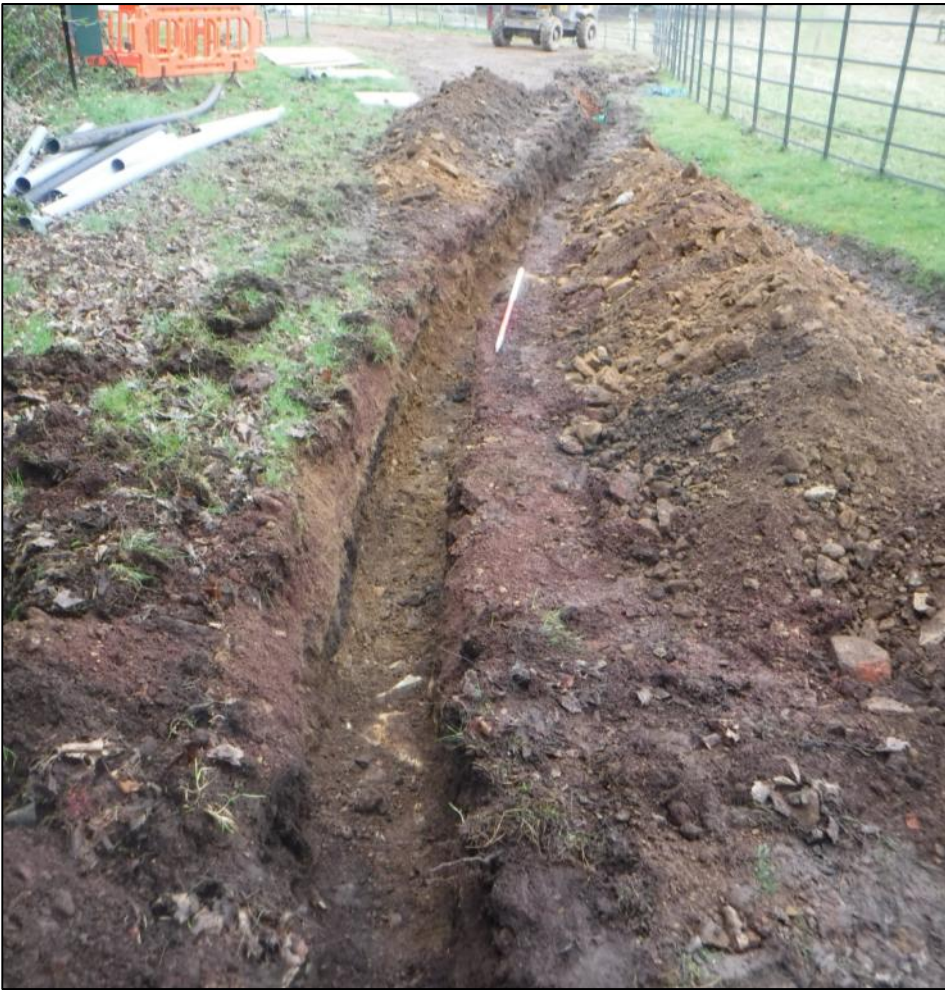
*Plate 7. Trench 6, looking northeast.*

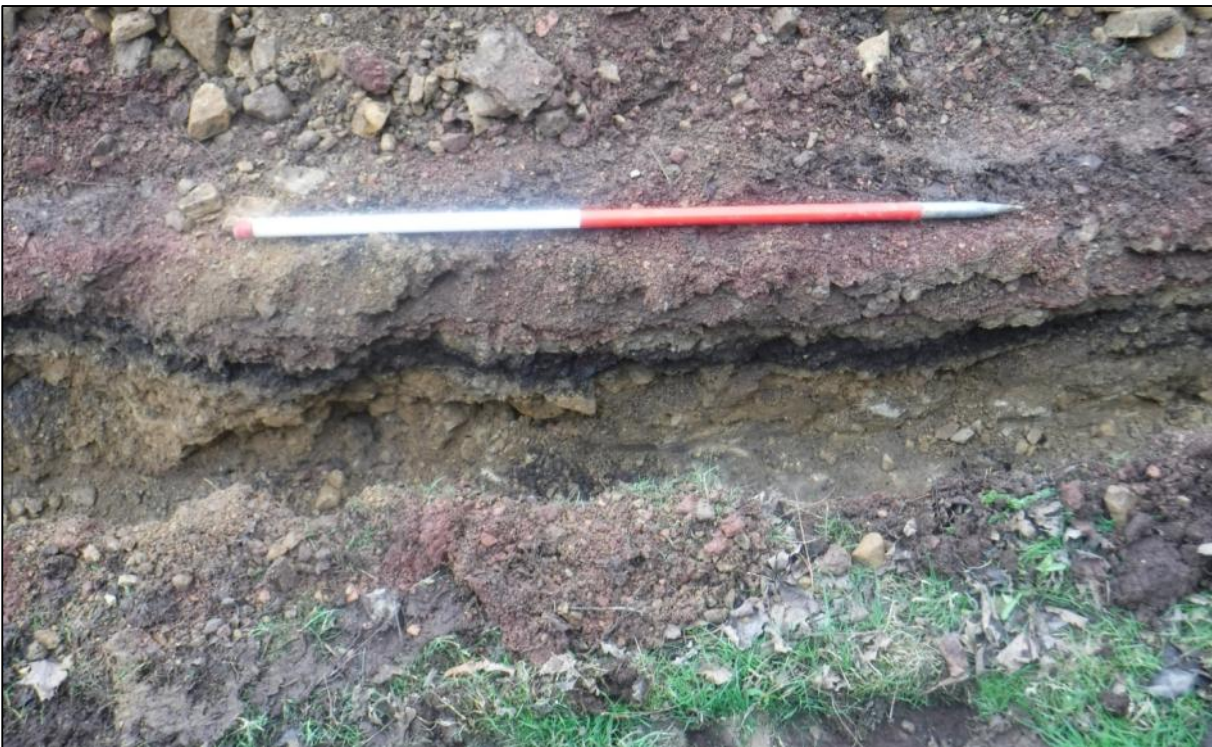
*Plate 8. Northwest facing section of Trench 6.*

This trench ran northeast-southwest from the end of Shed Lane to the south end of the Long Barn. It was a total of 86m long by 0.40m wide and had a maximum depth of 0.60m (Plate 8). It terminated to the southern side of the Long Barn. The earliest recorded deposit was (603) a 0.20m thick levelling of rubble in black clay silt. This was overlain by (602) a crushed CBM and shale hardcore 0.20m thick that supported the present road surface (601). In the portion of the trench where the road was not present the upper deposit was the (600) topsoil.

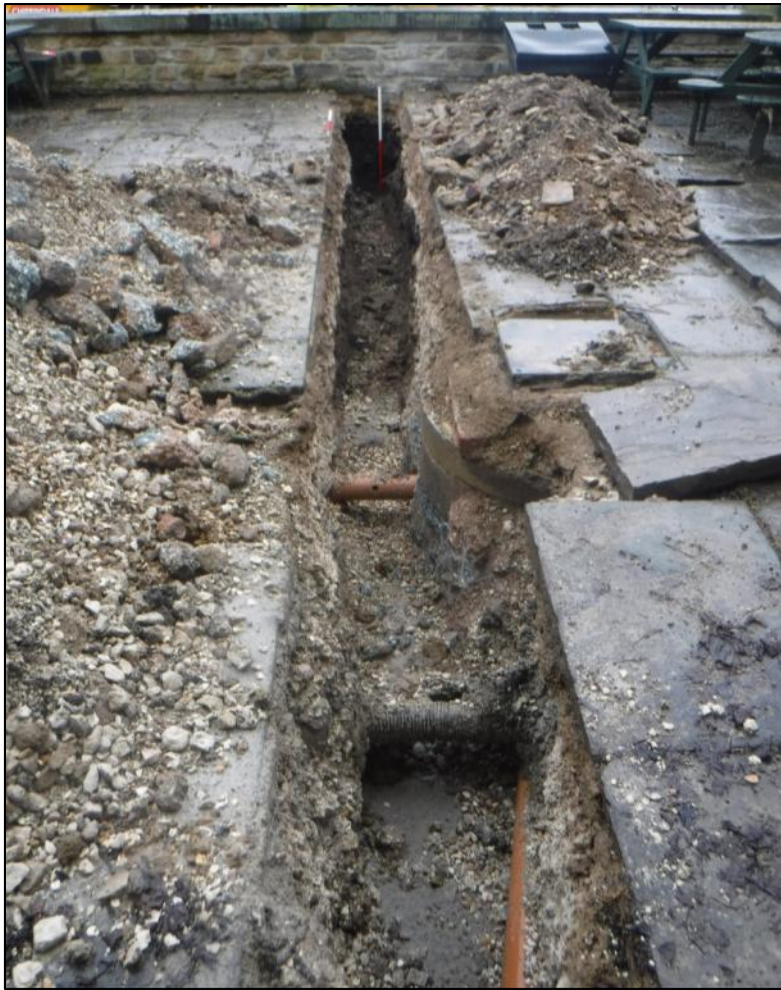
*Plate 9. Trench 7 (southwestern part), looking northeast.*

This trench ran from the southeast side of the Long Barn in a northeasterly direction, across an adjacent patio area for a distance of approximately 9m before passing under the patio wall (Plate 9). A short length (approximately 2m) was excavated to the northeast of the patio wall. Inside the patio area the trench revealed different levels to those seen on the exterior. The trench was 0.60m wide and at its deepest, outside the patio area was 1.40m deep. Within the patio area it was a maximum of 0.90m deep.

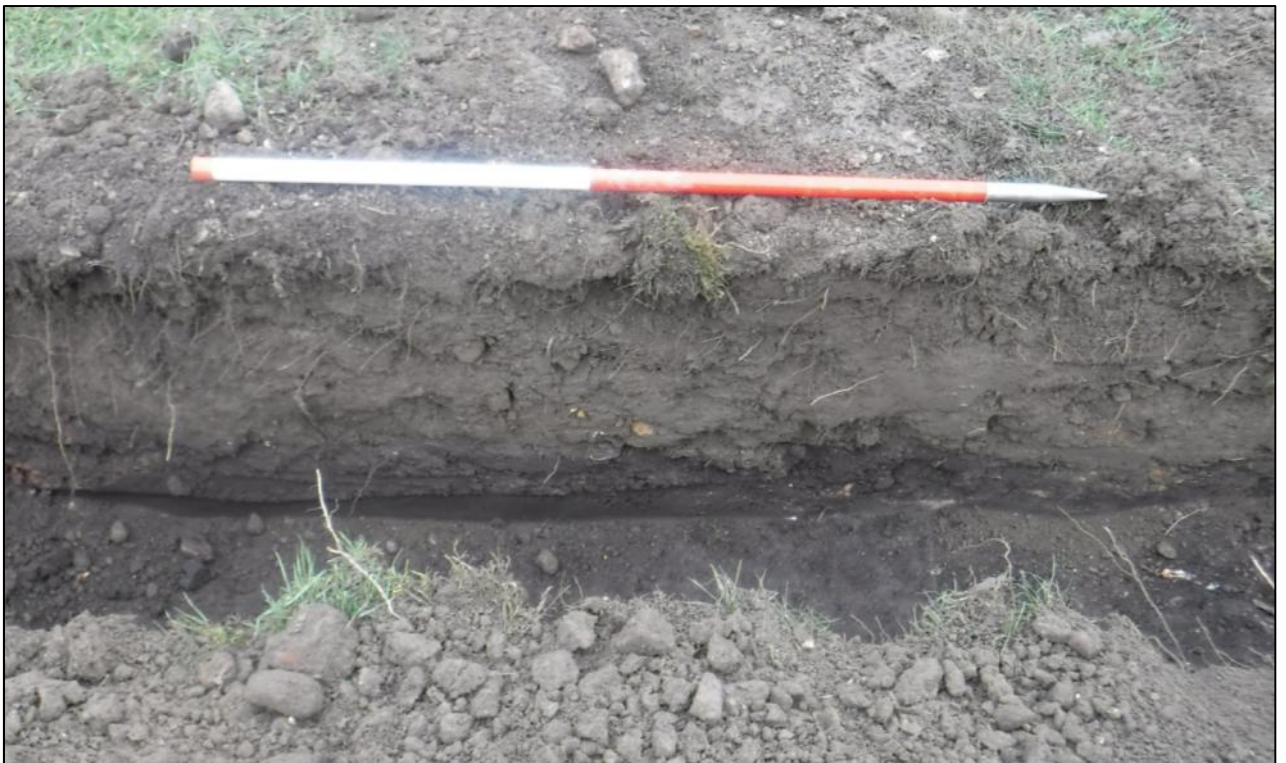
*Plate 10. West facing section of Trench 7 (northeastern part).*

Beyond the patio the earliest recorded deposit was (713) natural sandstone. This was overlain by (712) 0.40m of mid greyish brown sandy silt made ground (Plate 10). Above this was (711) a second made ground deposit, this time of very dark brown clayey silt 0.30m thick. This was overlain by (710) a levelling layer of crushed white mortar with patches of clay and CBM fragments. The upper deposit was dark brown loamy silt topsoil (709).

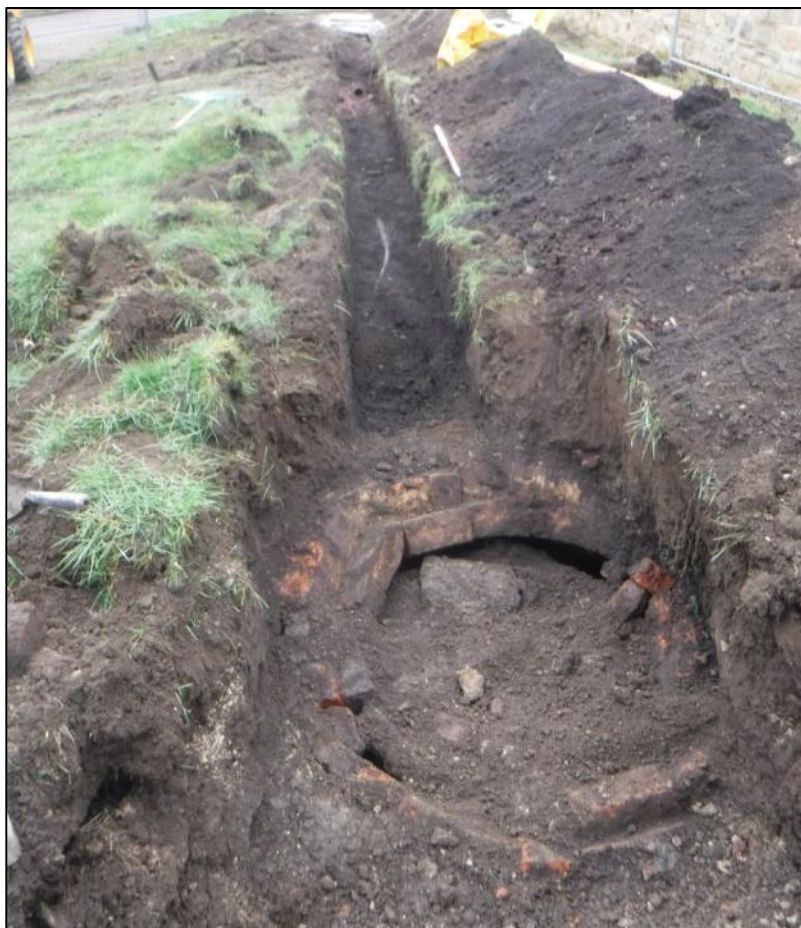
Plate 11. Trench 8 showing Well/Cistern (803), looking southeast.

This trench was a continuation of Trench 7 curving away to the north-northeast and measured 0.45m wide and 30m long. The earliest context recorded within it was (803) a partially dismantled and backfilled structure (Figure 4; Plates 11 and 12). This was constructed of red brick, five courses of which were exposed during excavation. These were arranged to create a sub circular, apparently domed shaped structure. Due to the limited exposure available the interpretation is not certain. It may have been a well or cistern but its domed form may also be suggestive of an ice house. With there being no sign of above ground structure or access the interpretation as a below ground cistern is preferred, rather than the ice house interpretation. The 1893 25 inch Ordnance Survey map indicates the location of a pump close to where this feature was encountered which might support the suggestion that it formed a water holding tank of some kind. The top of a probable brick culvert (806) observed further to the north within Trench 8 and aligned approximately southeast-northwest may be related to this structure, which would appear to support the interpretation as a water collecting structure. The possible cistern was overlain by (801) a loose made ground of dark orange brown sandy silt. This was overlain by two lenses of loose light grey fine gravel, (805) and (804). These were in turn overlaid by (800) the topsoil.

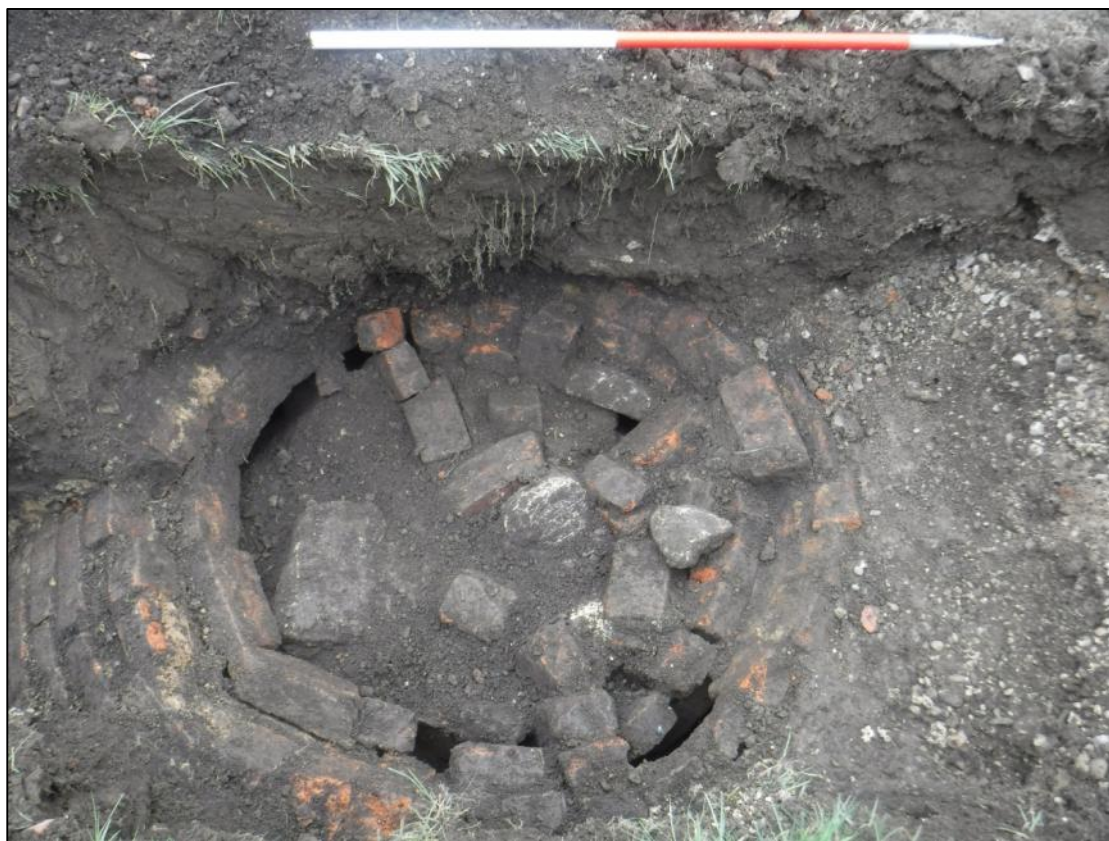
Plate 12. Well/Cistern (803) in Trench 8, looking southwest.

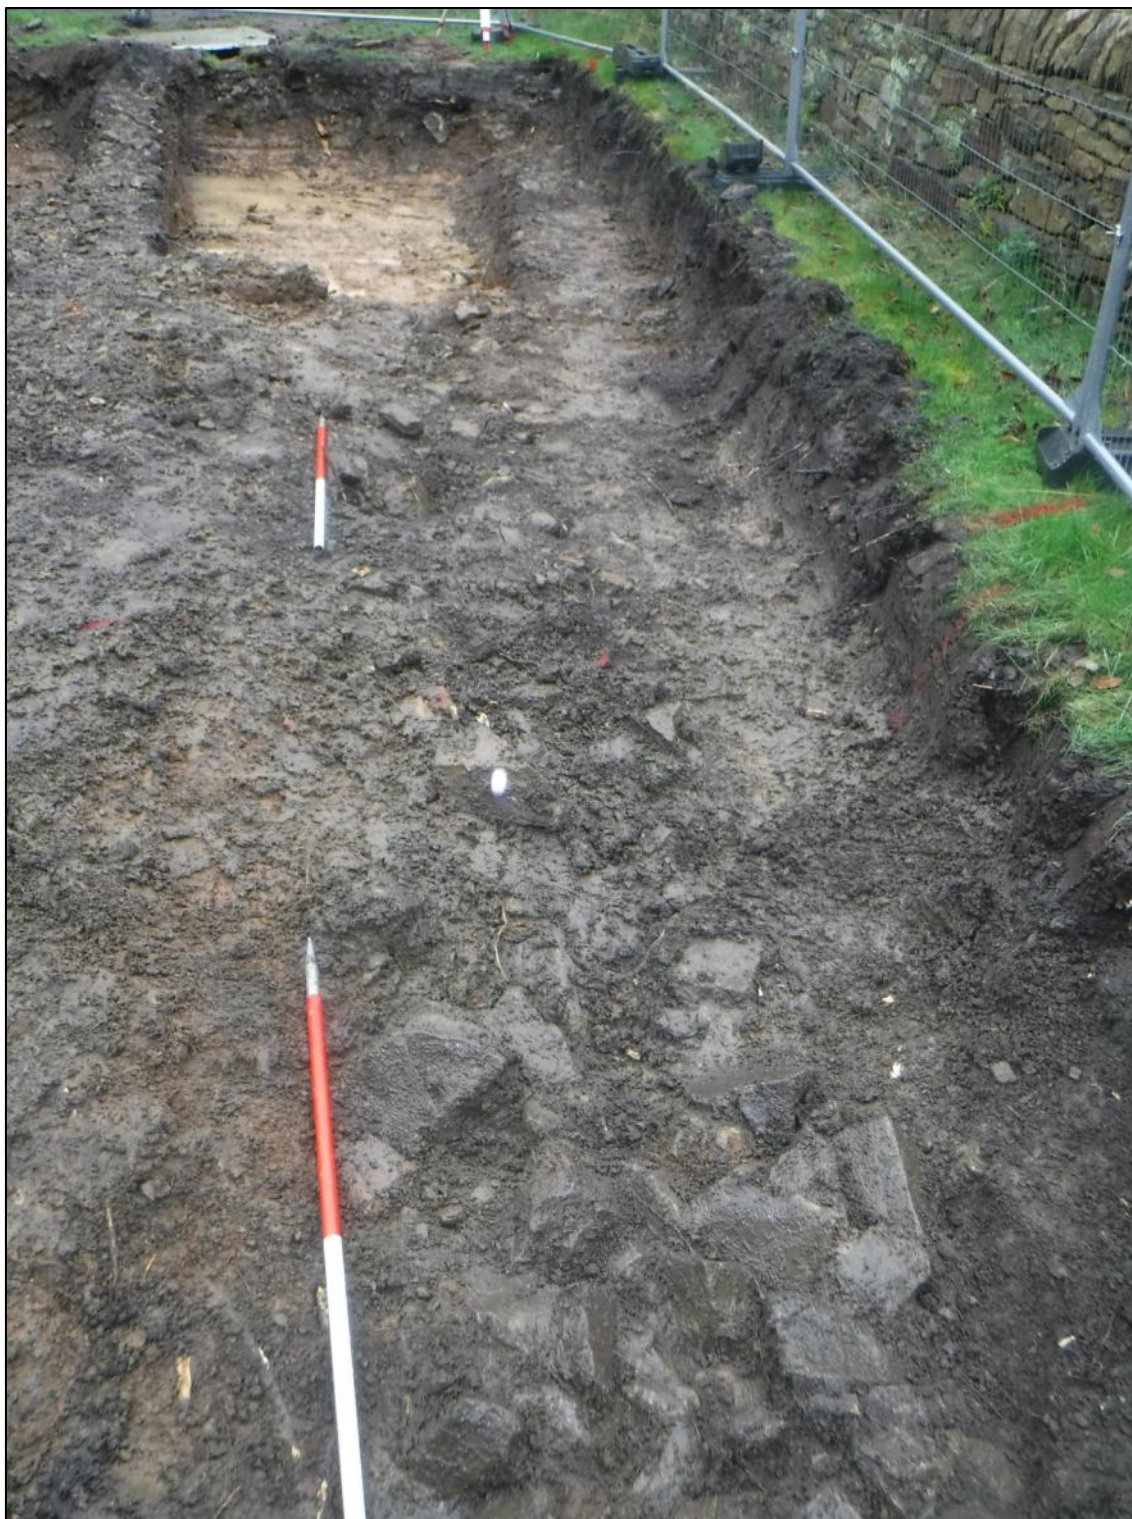
*Plate 13. Wall (902) in Trench 9, looking southeast.*

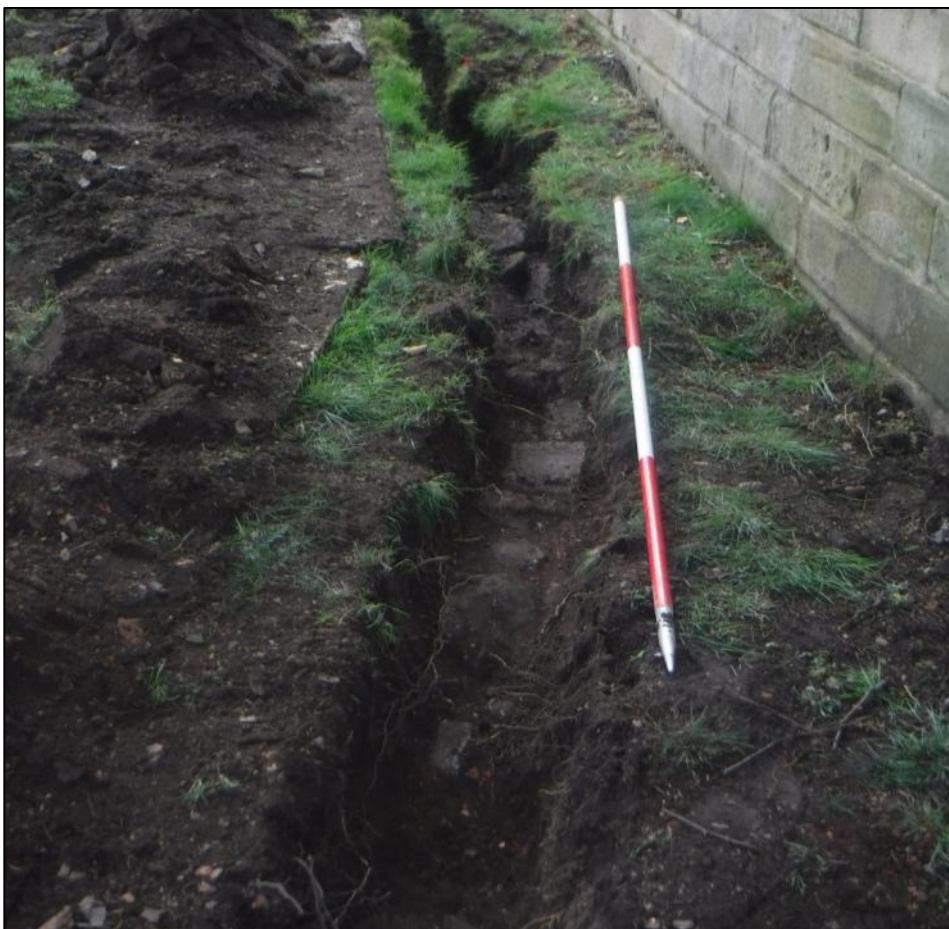
*Plate 15. Surface (1005) in trench 10, looking southwest.*

| Plate 15. Surface (1005) in trench 10, looking southwest..... | 32 |
