| | | <div><div>Current</div><div>11-10-19</div><div>EH</div><div>SS</div></div> | <div><div>PROJECT</div><div>Wentworth Castle and Stainborough Park 2019</div></div> | <div><div>SIZE &amp; SCALE</div><div>A1L 1:50 @ A1</div></div> | <div><div>DRAWING NO.</div><div>2006</div></div> | |
| | | <div><div>ISSUE</div><div>DATE</div><div>DRAWN</div><div>CHECKED</div><div>DESCRIPTION</div></div> | <div><div>240169-PUR-ZZ-00-DR-A-2006</div></div> | <div><div>DRAWING STATUS</div><div>S2 - For Information</div></div> | <div><div>REVISION</div><div>P01</div></div> | |

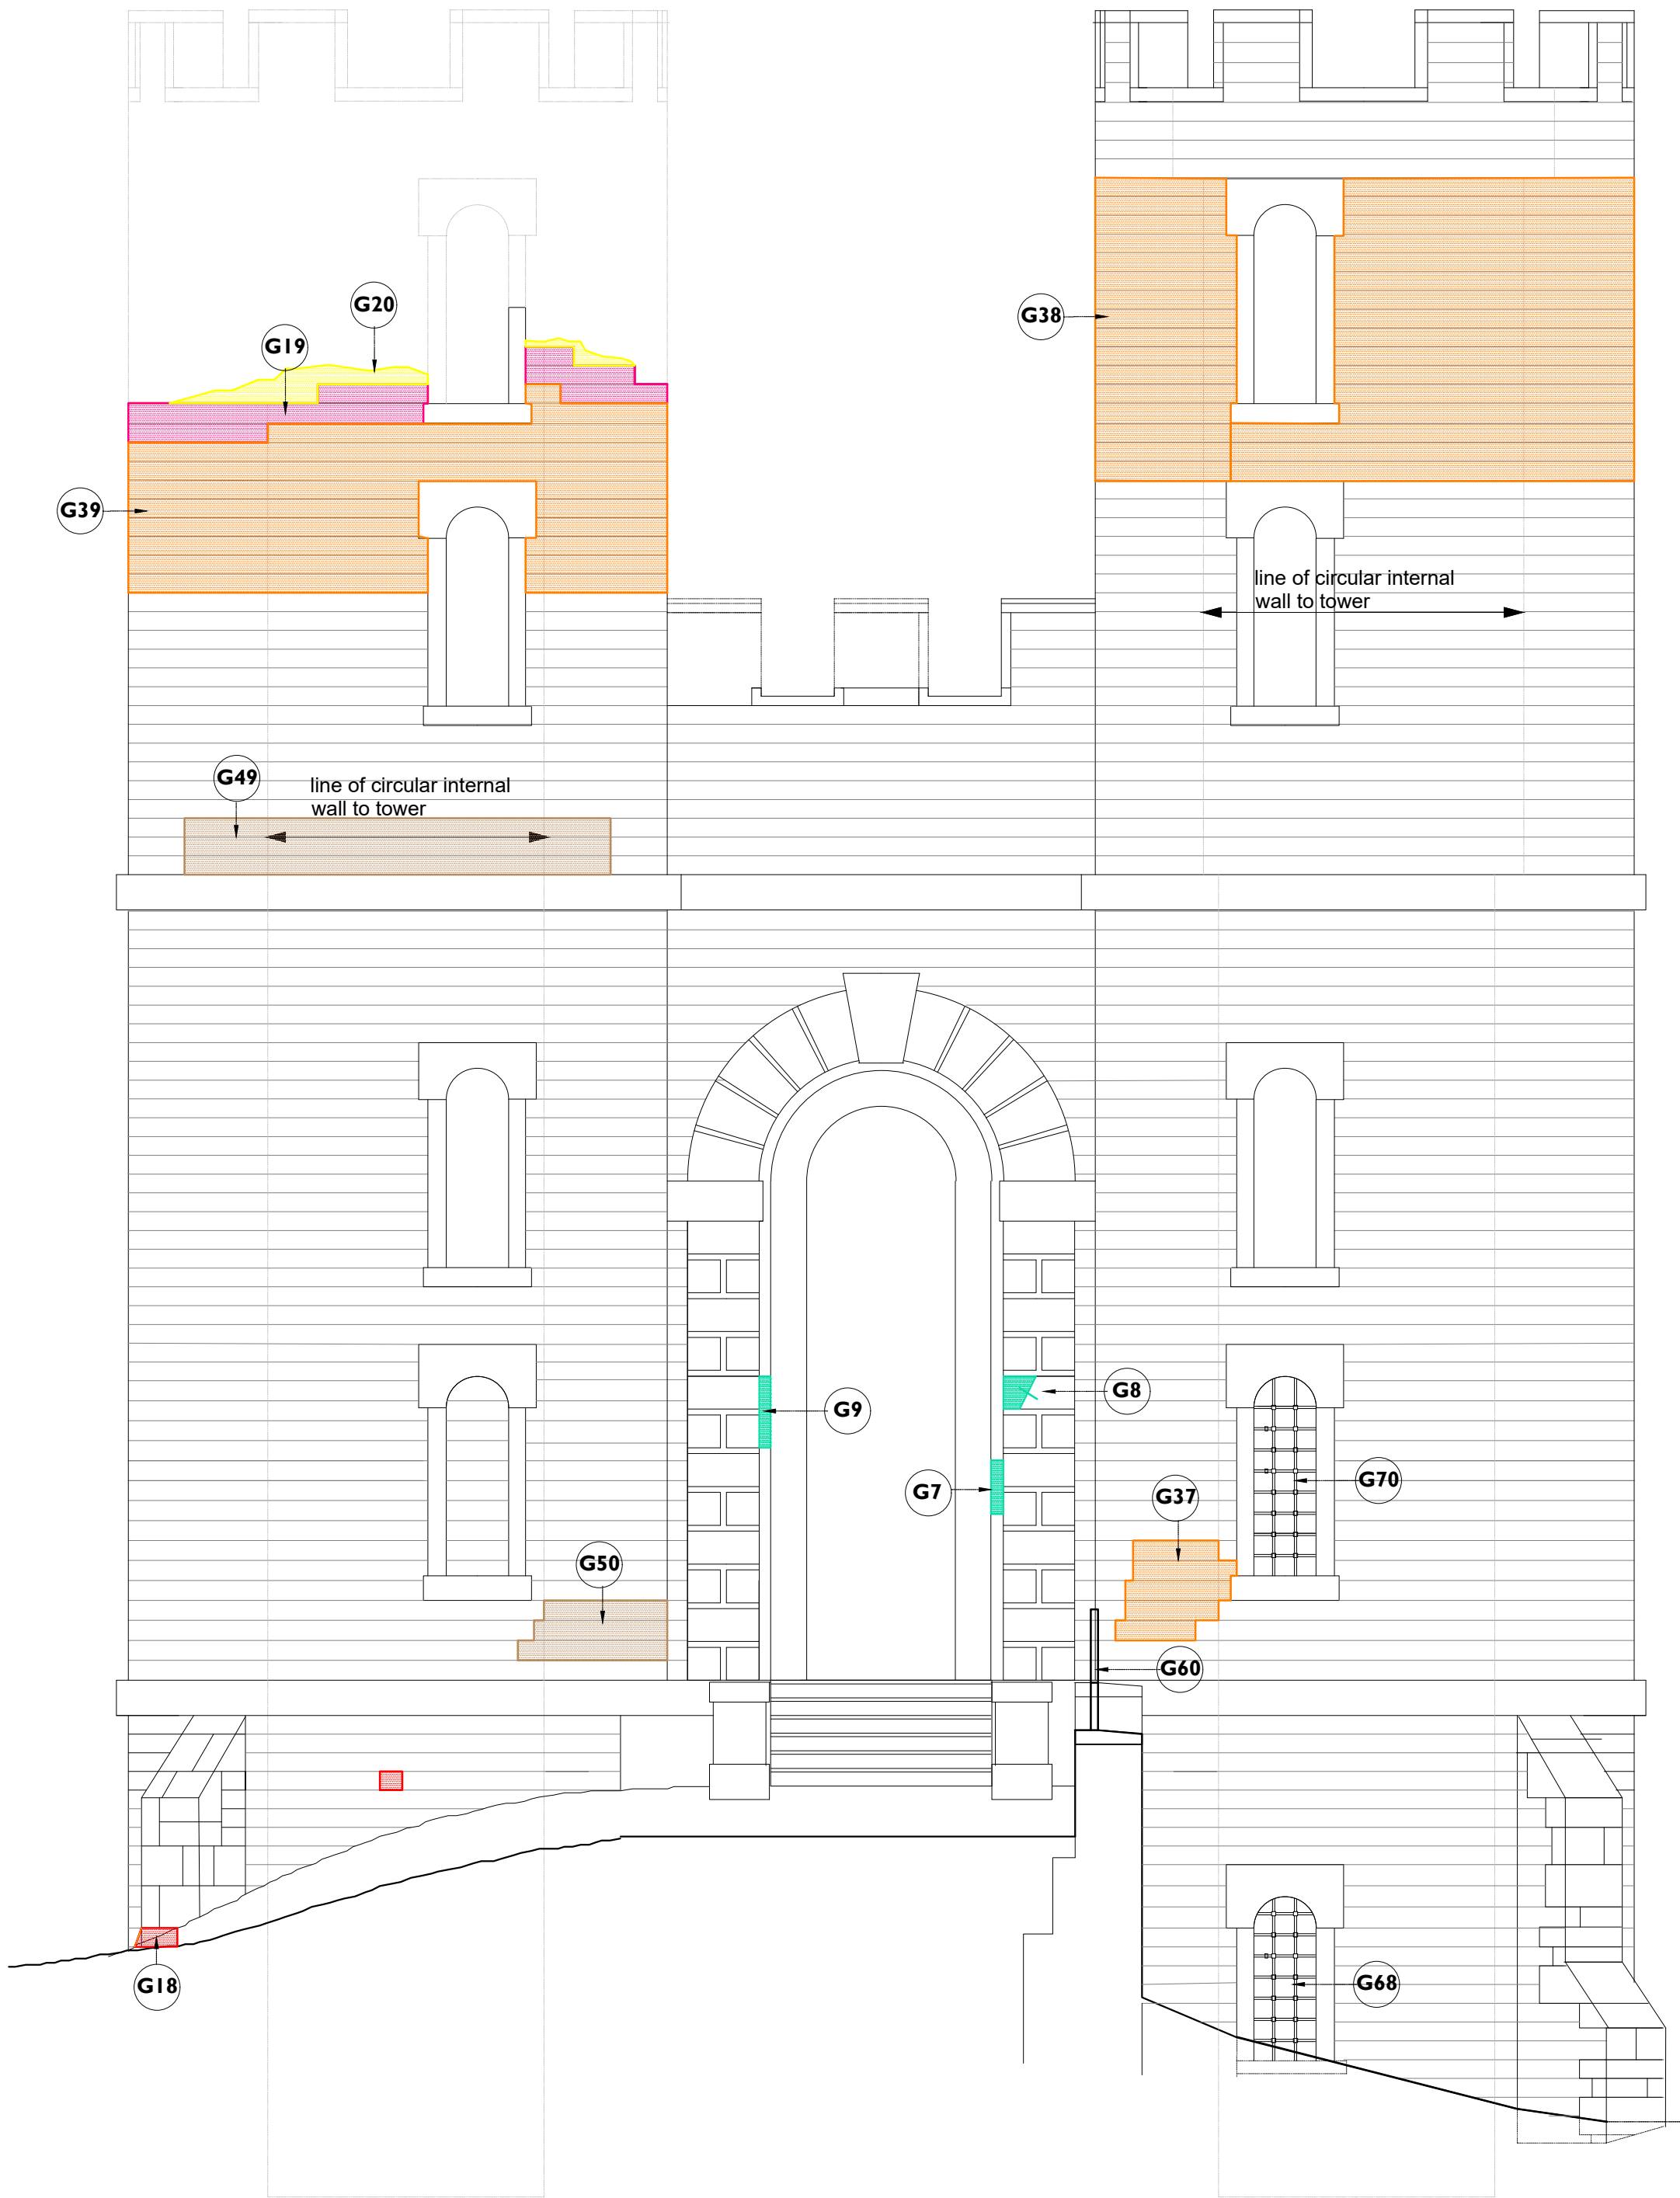
SOUTH ELEVATION

GATEHOUSE TOWER GT2

GATEHOUSE TOWER GT1

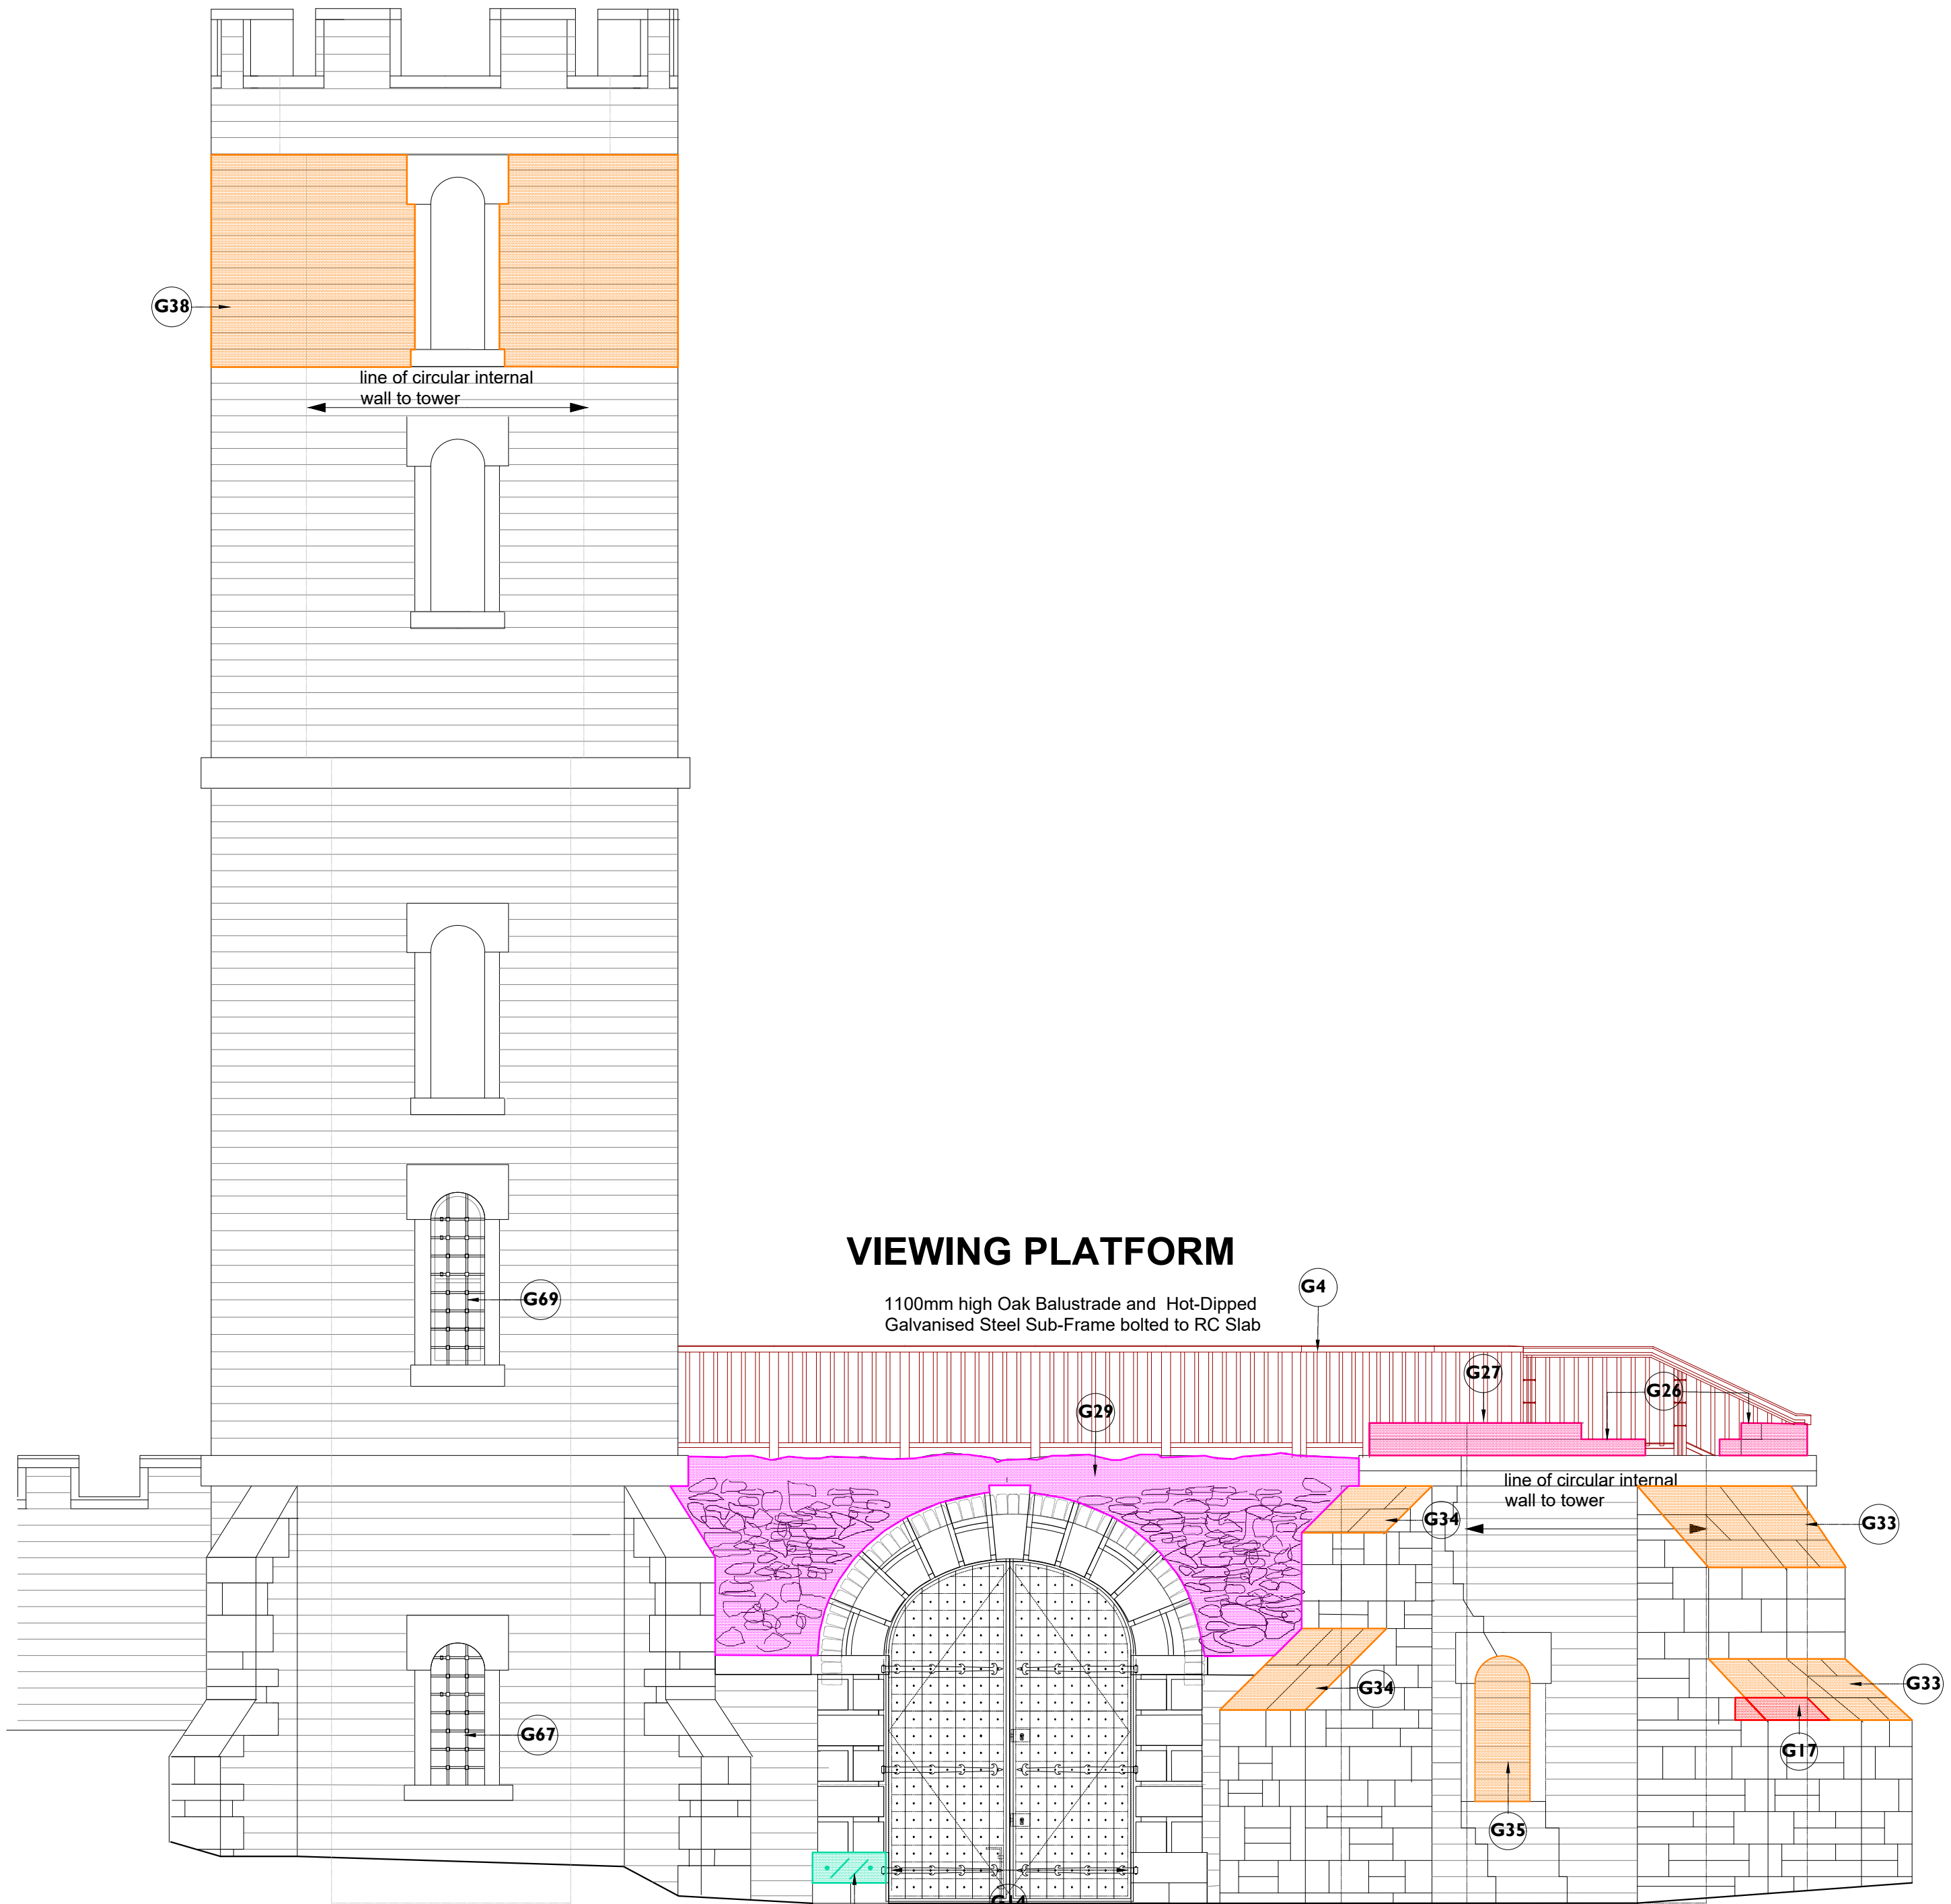
EAST ELEVATION

GATEHOUSE TOWER GT1

VIEWING PLATFORM

1100mm high Oak Balustrade and Hot-Dipped Galvanised Steel Sub-Frame bolted to RC Slab

MAIN VAULT

GATEHOUSE TOWER GT4
