| PROJECT | Wentworth Castle and Stainborough Park 2019 |
| 240169-PUR-ZZ-00-DR-A-2005 | |

| DRAWING TITLE | Gatehouse |

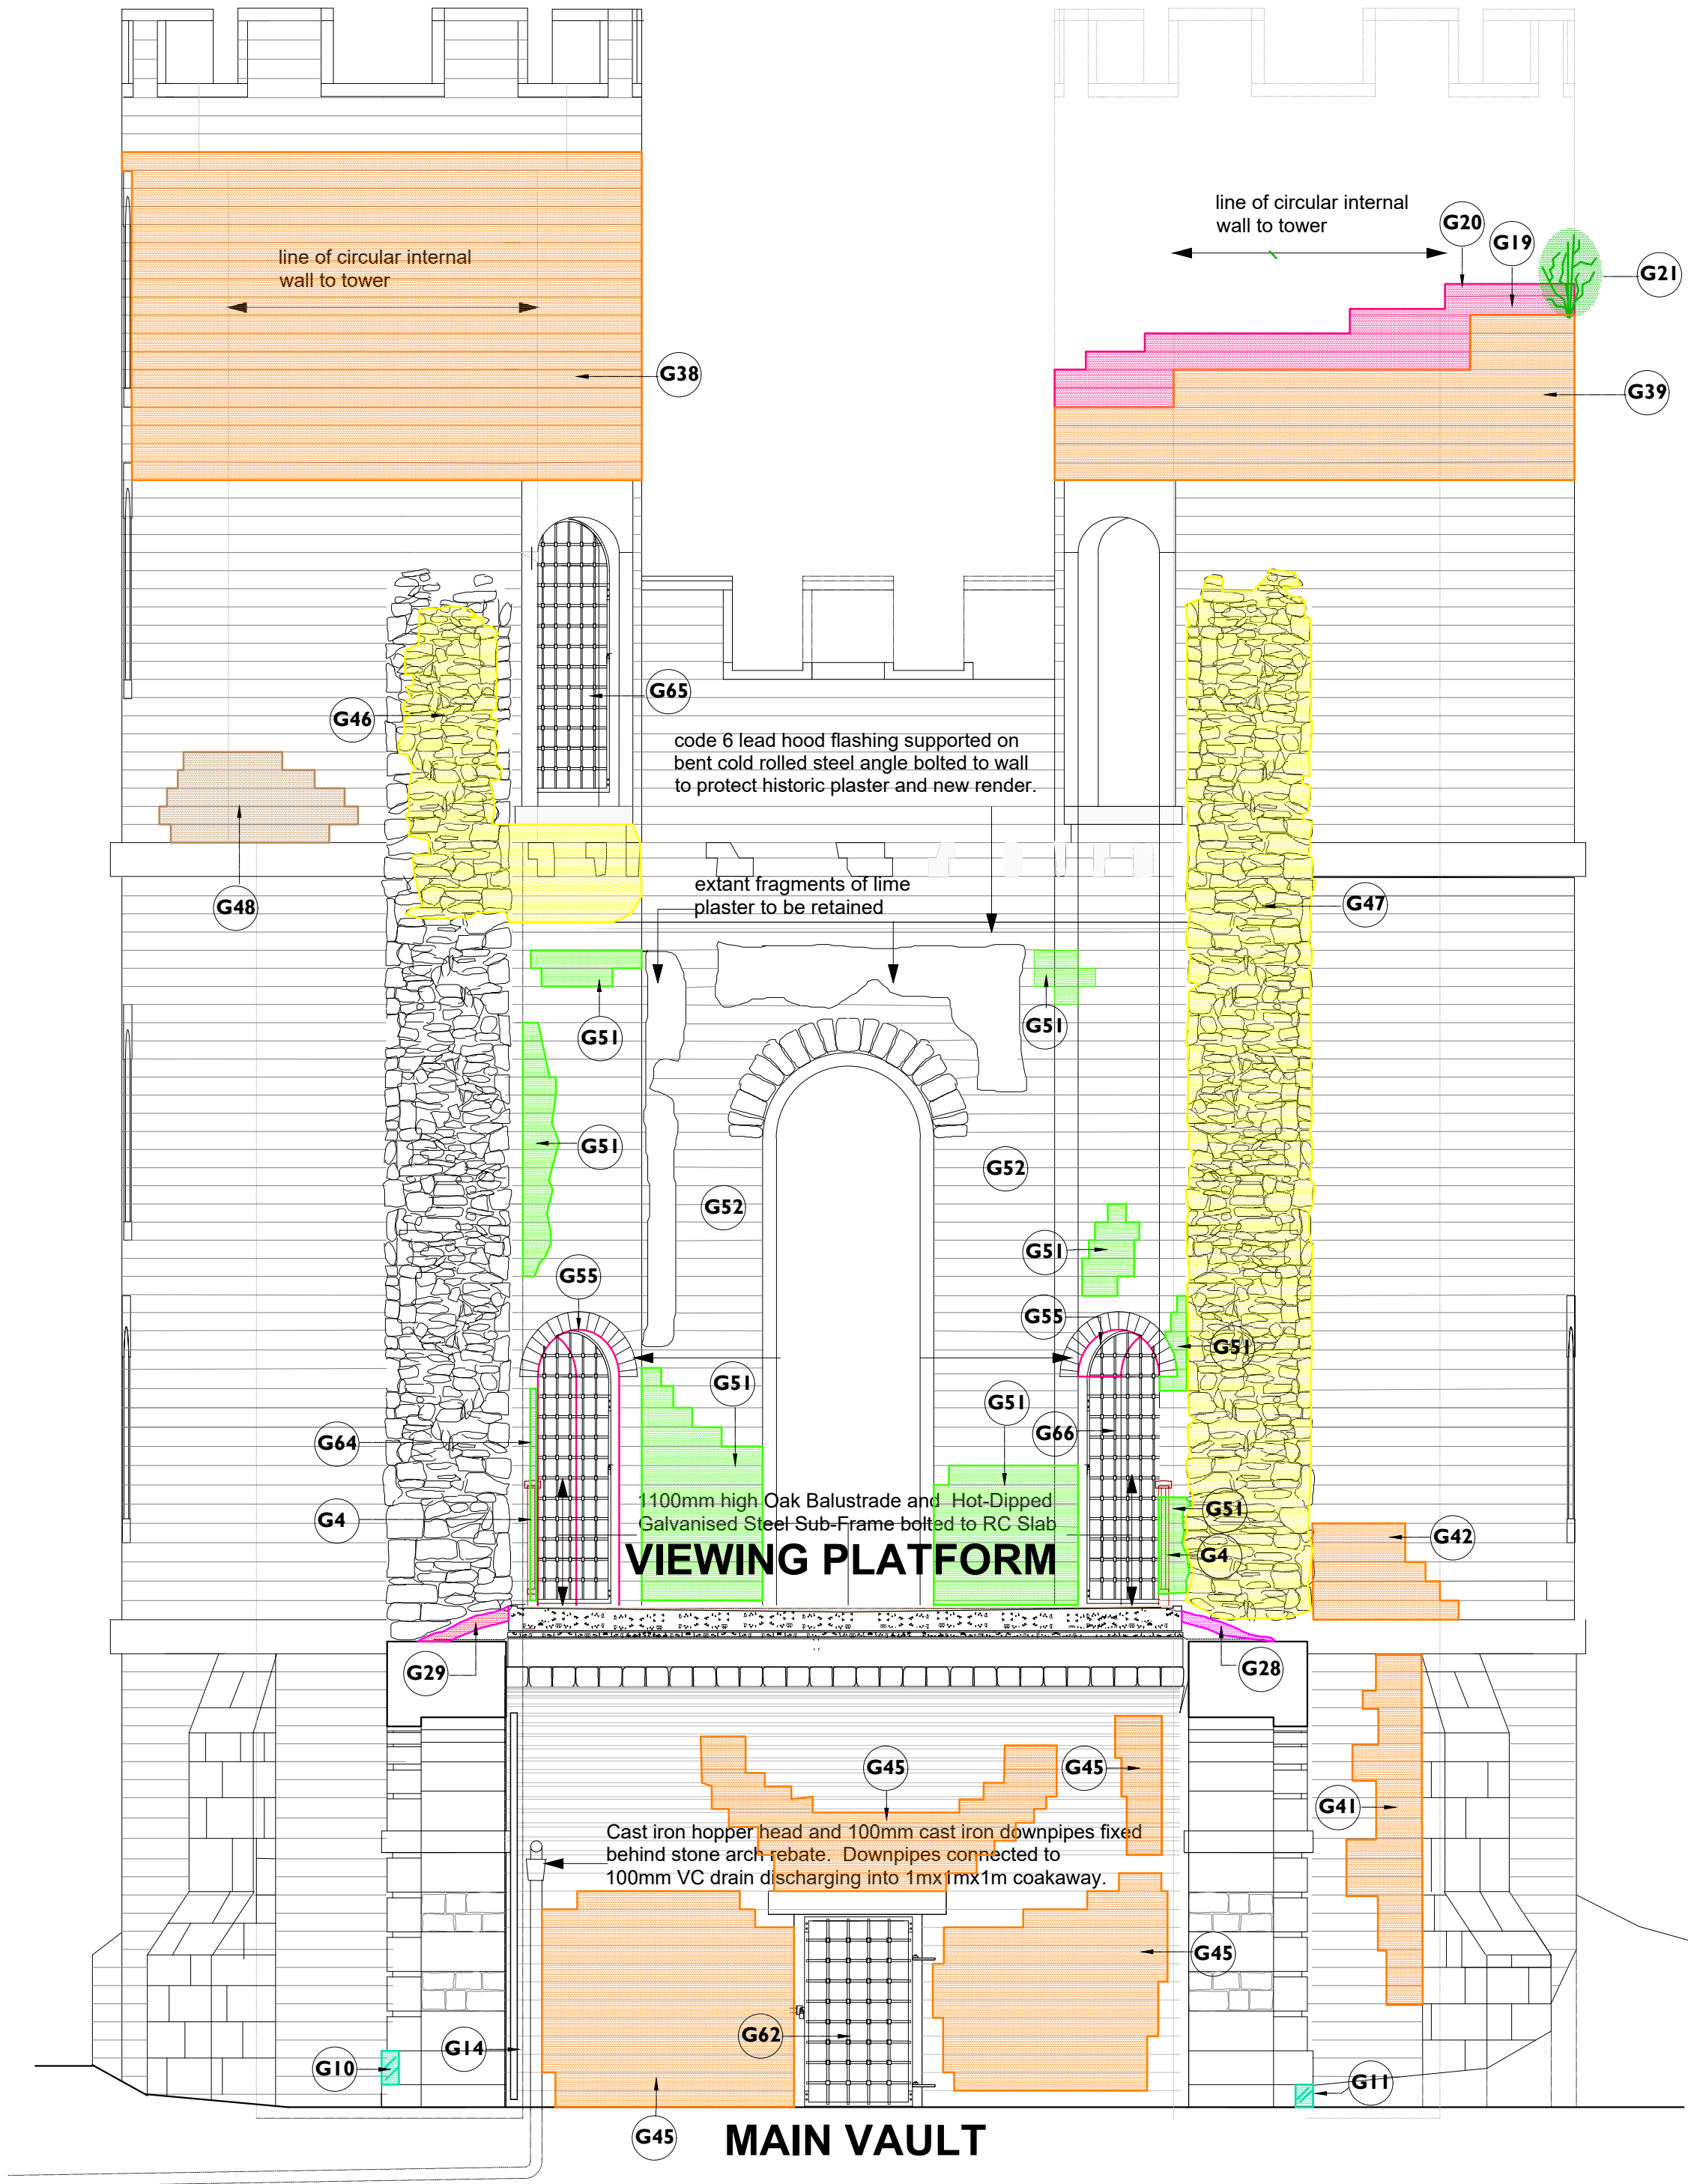
GATEHOUSE TOWER GT1

GATEHOUSE TOWER GT2

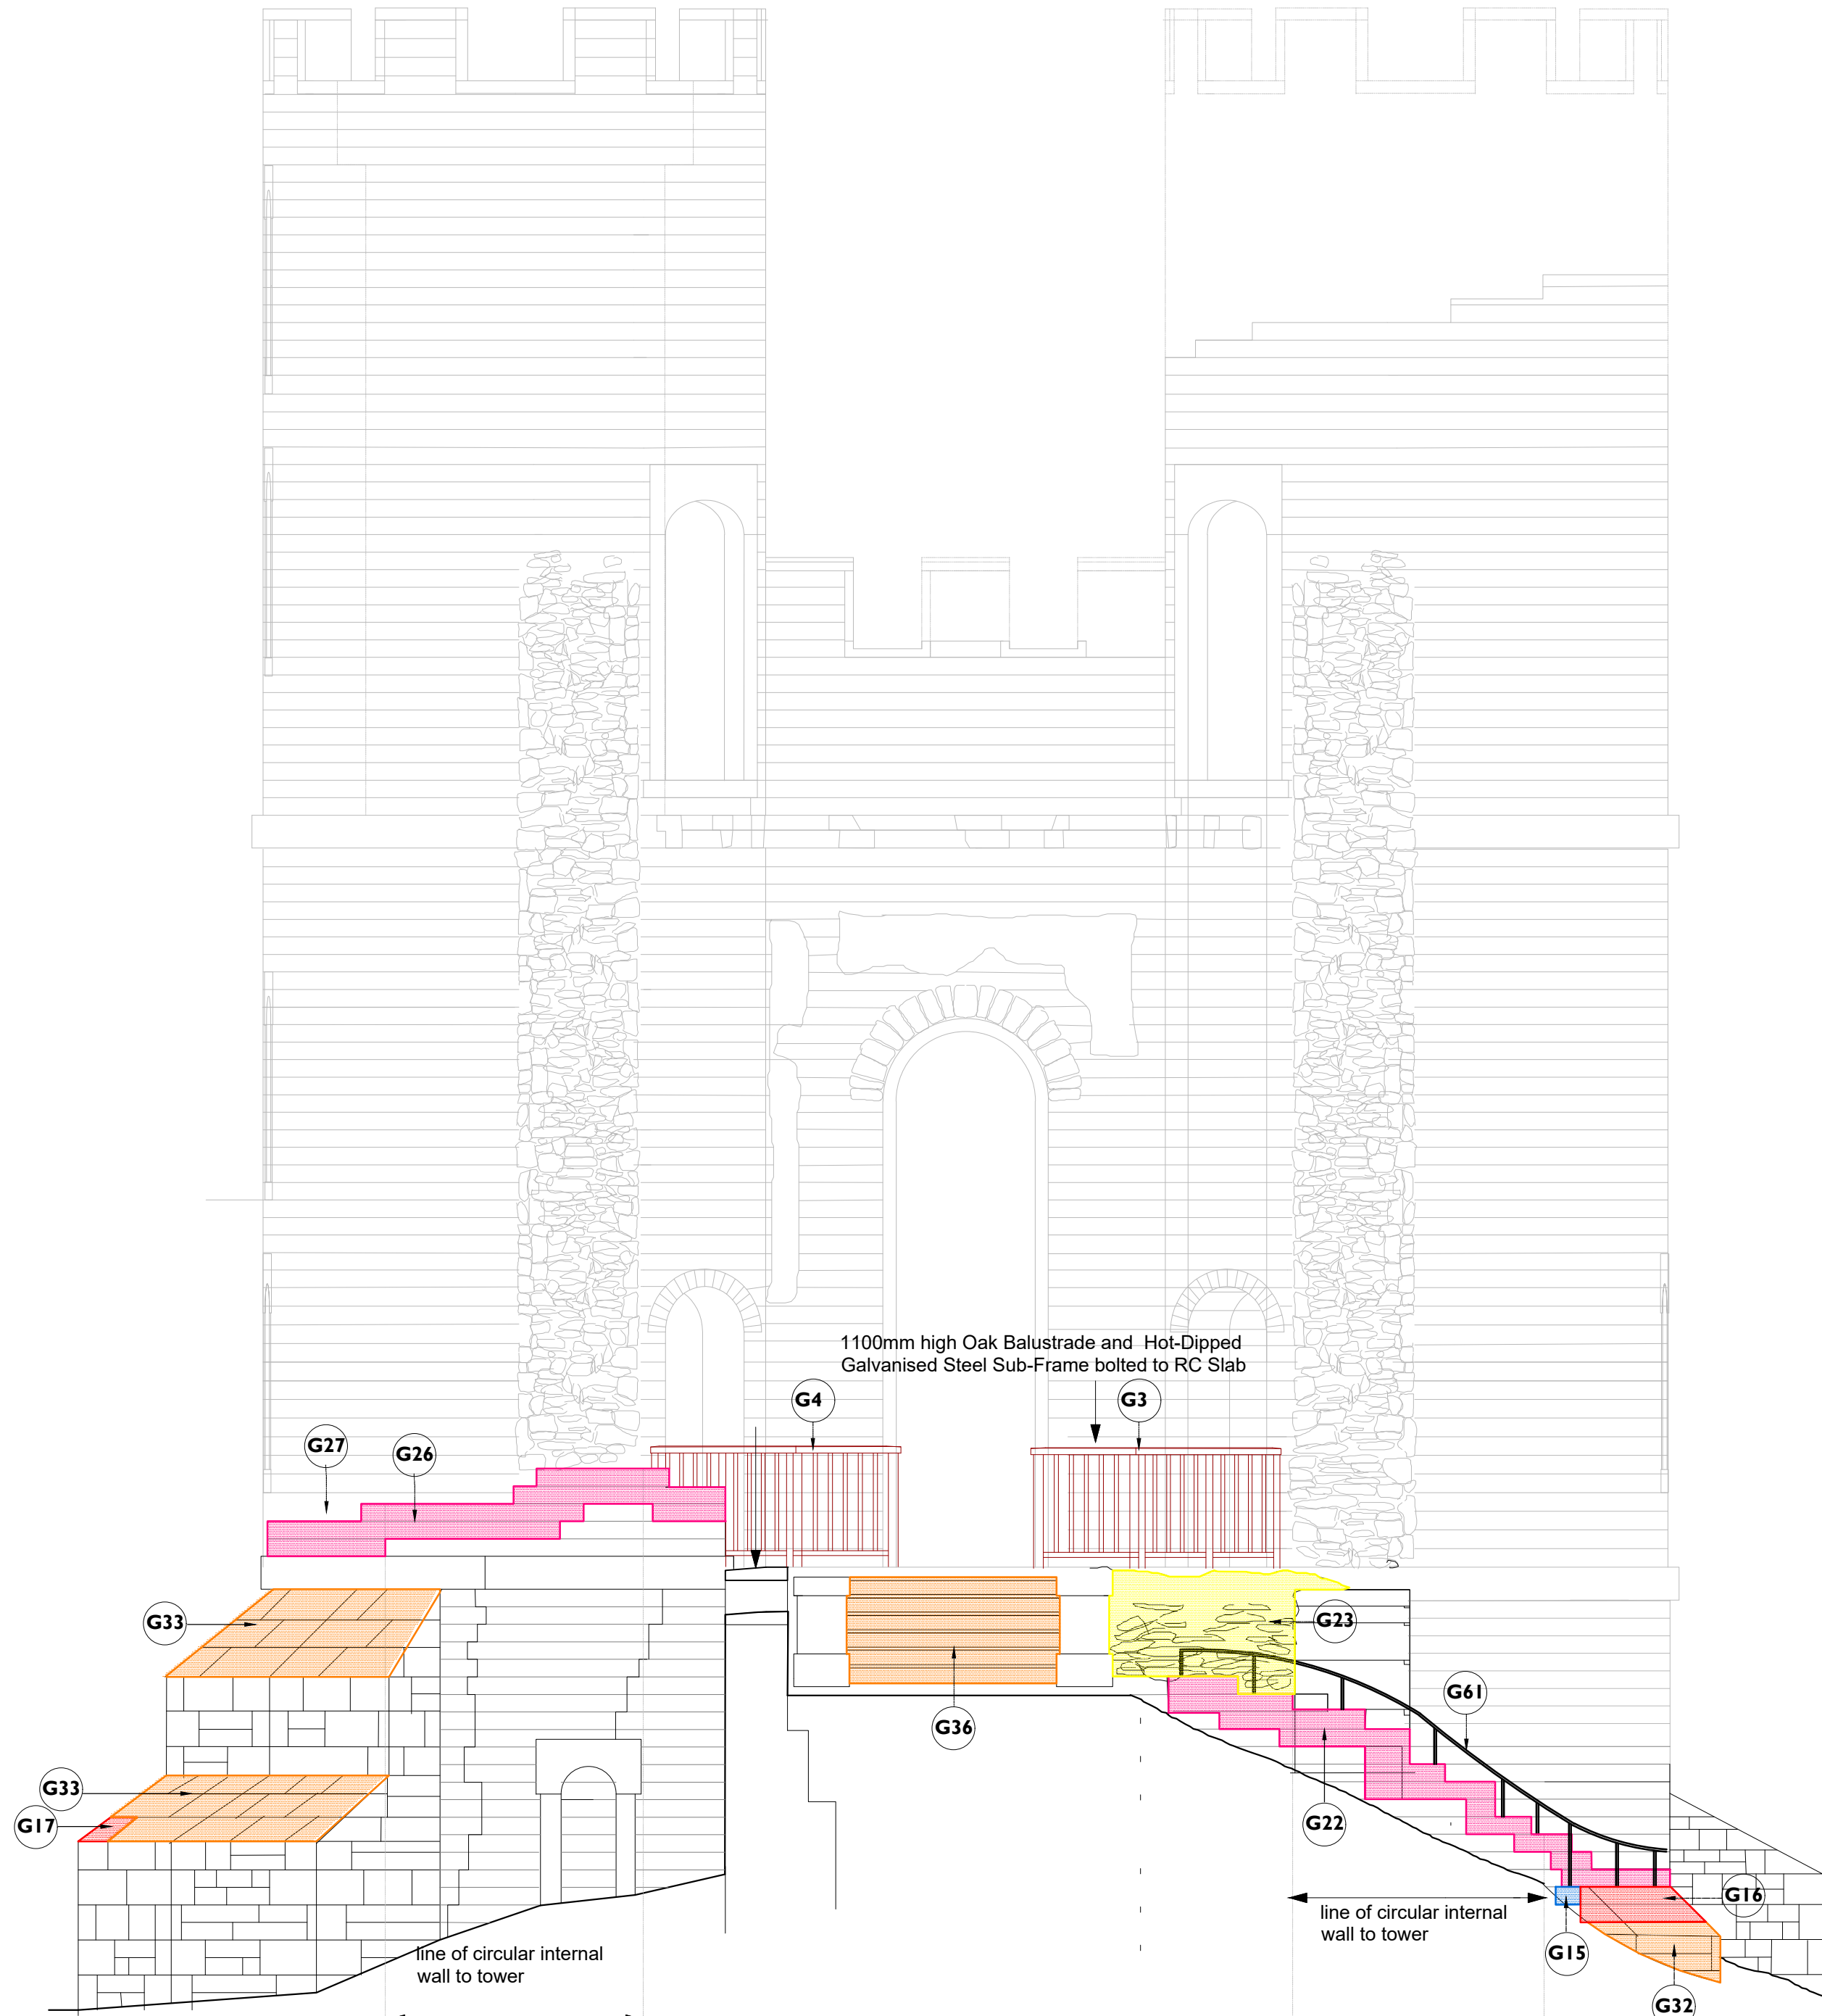
SECTION B-B THROUGH VAULT LOOKING SOUTH

GATEHOUSE TOWER GT4

GATEHOUSE TOWER GT3

NORTH ELEVATION
