# **ROYD FIELD FARM, CUBLEY.**

# ECOLOGICAL IMPACT ASSESSMENT.

Ref No: 230836/EcIA/Rev 1.

Date: 10<sup>th</sup> January 2025.

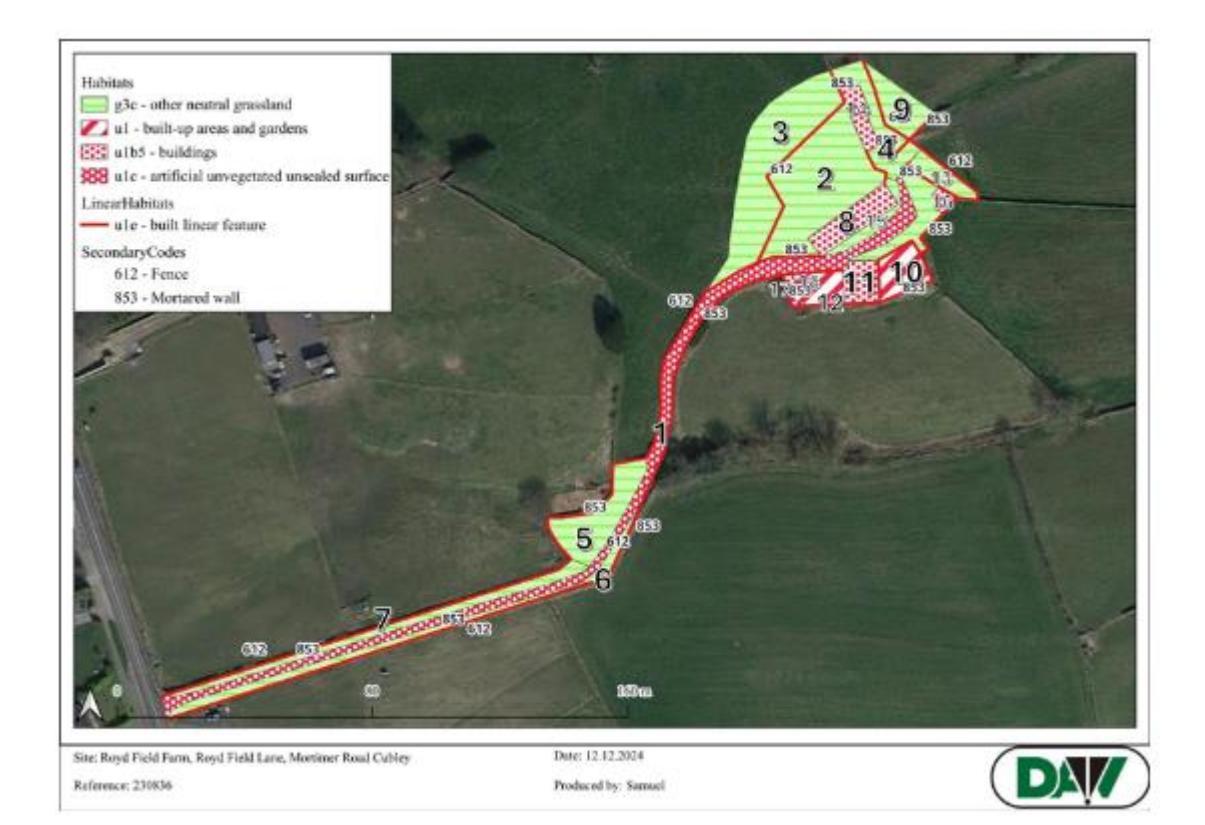
There are various compartments of neutral grassland on the site. The plan below shows those areas and each has a separate reference number used below.

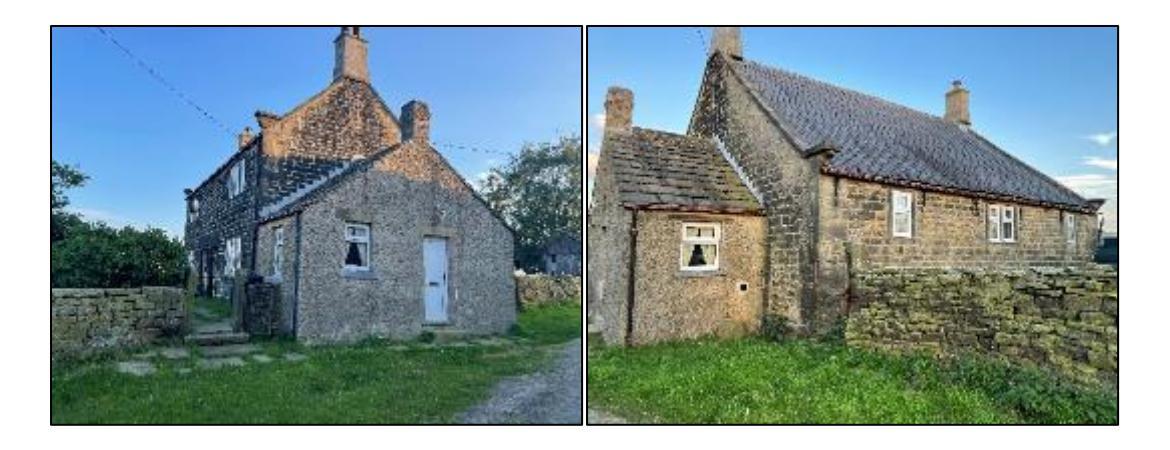
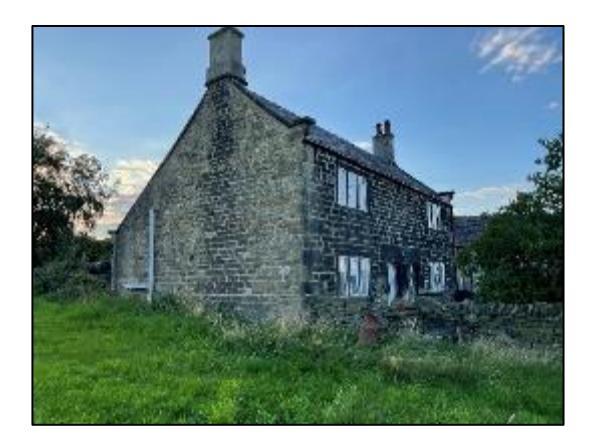
3.4.4.1.1. The house is a two storey, stone building that was originally two cottages but these have been combined to make one larger dwelling with a pebble dashed extension on the northern end. The stonework of the walls is in excellent condition with no cracks or crevices to provide a bat roosting opportunity.

3.4.4.1.2. The roof of the house is pitched and supports a Welsh slate roof that is in very good condition. The roof over the extension is covered with stone slates and there are visible gaps beneath some that provide bats an opportunity to roost.

3.4.4.1.5. Because there were gaps beneath the stone slates of the extension, but no lining beneath, the house was assessed to have a low potential for roosting bats in line with the Bat Conservation Trust Good Practice Guidelines.

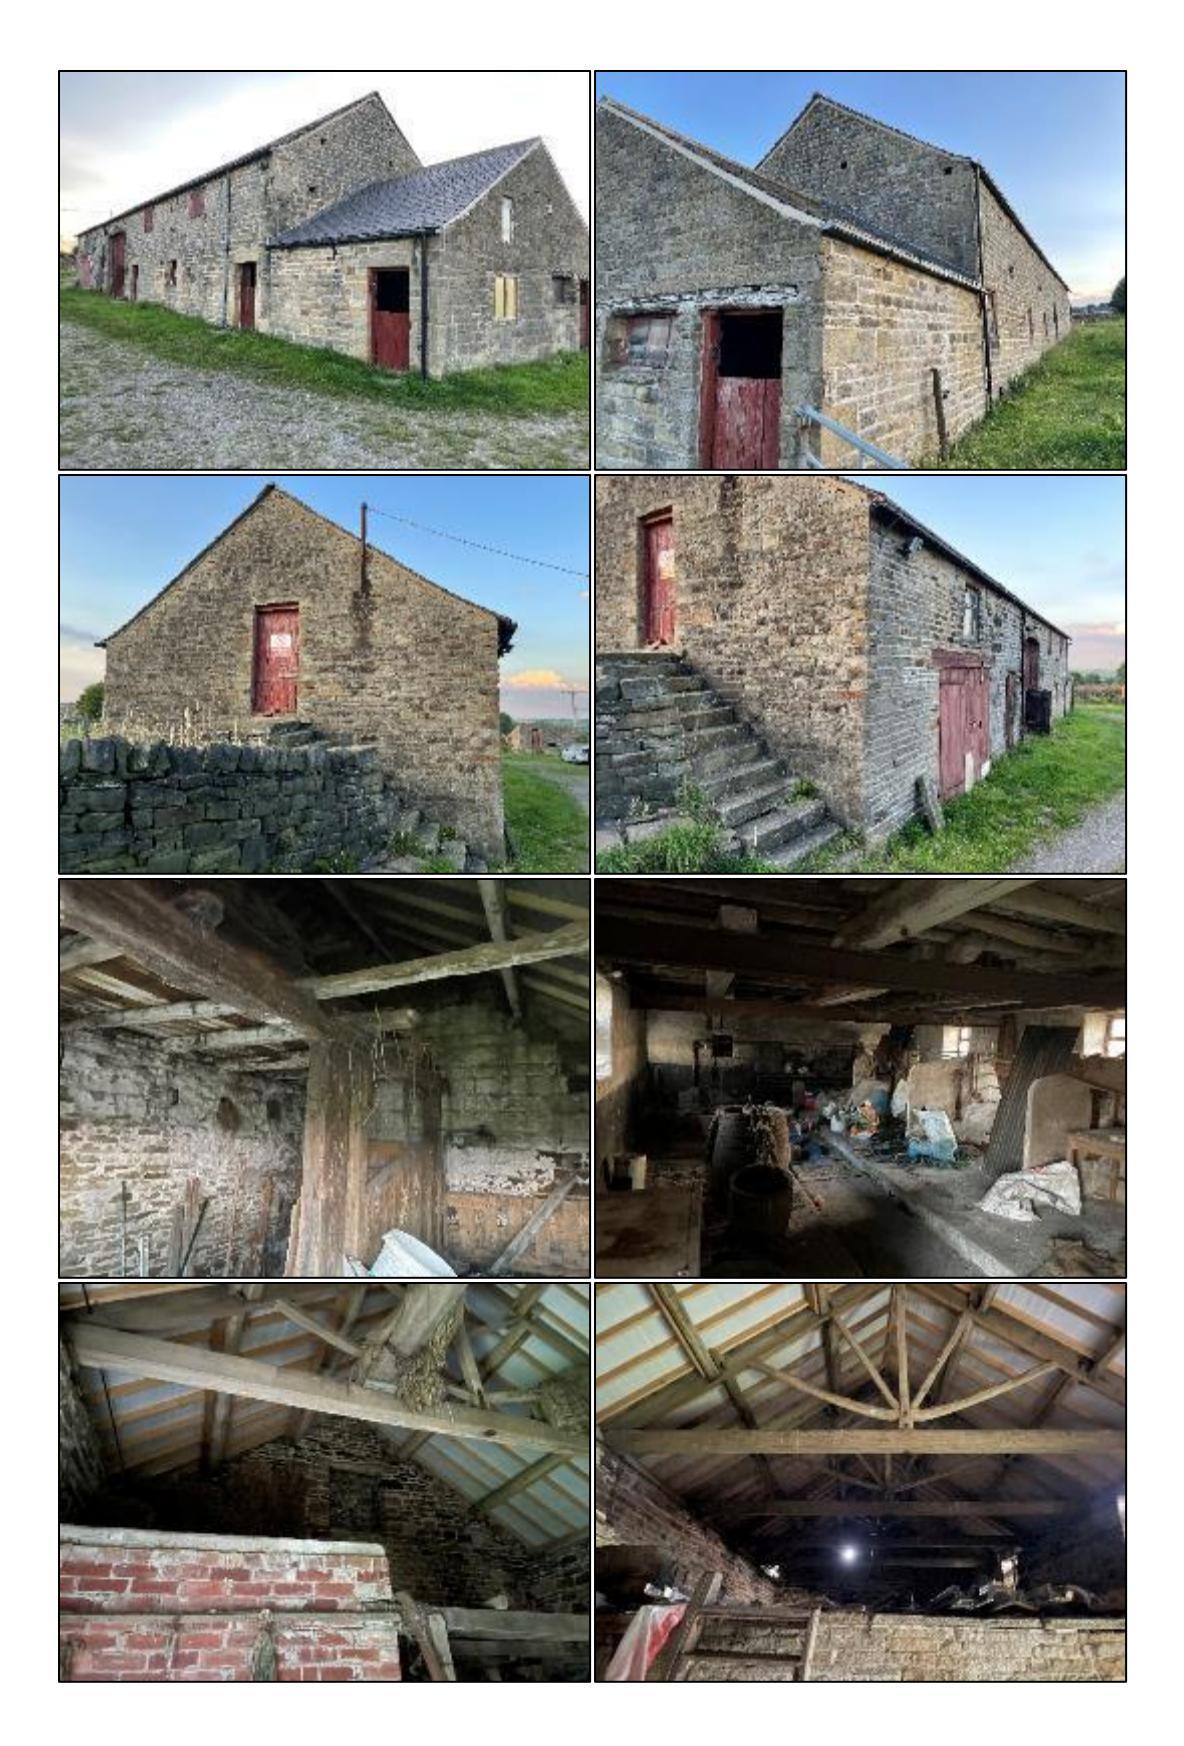
3.4.4.2.1. The barn is a two storey, stone building with a single storey extension on the eastern end. The ends of the barn have stables and storage rooms on the ground floor with a mezzanine landing above giving access from a central full height access door. This enabled storage of hay and straw bales on the upper floor.

3.4.4.2.2. The walls of the barn are generally well pointed and the roof is pitched and supports a Welsh slate roof that is in very good condition and does not look that old because there is a new membrane beneath the slates. There were a small number of holes in the outer walls but no bat field signs.

3.4.4.2.3. The photographs below show the barn.

3.4.4.2.4. The barn was assessed to have a low potential for roosting bats in line with the Bat Conservation Trust Good Practice Guidelines.

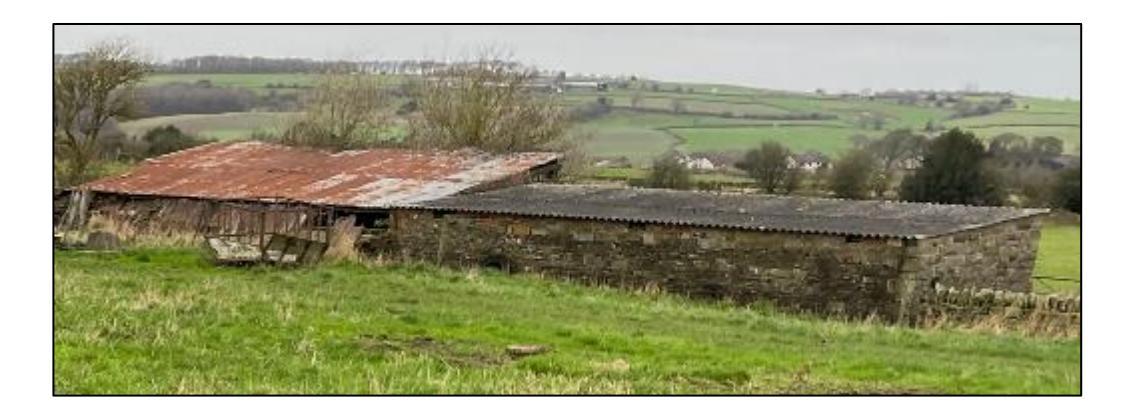
3.4.4.3.1. There are two outbuildings at the eastern end of the site, seen below looking east from the field.

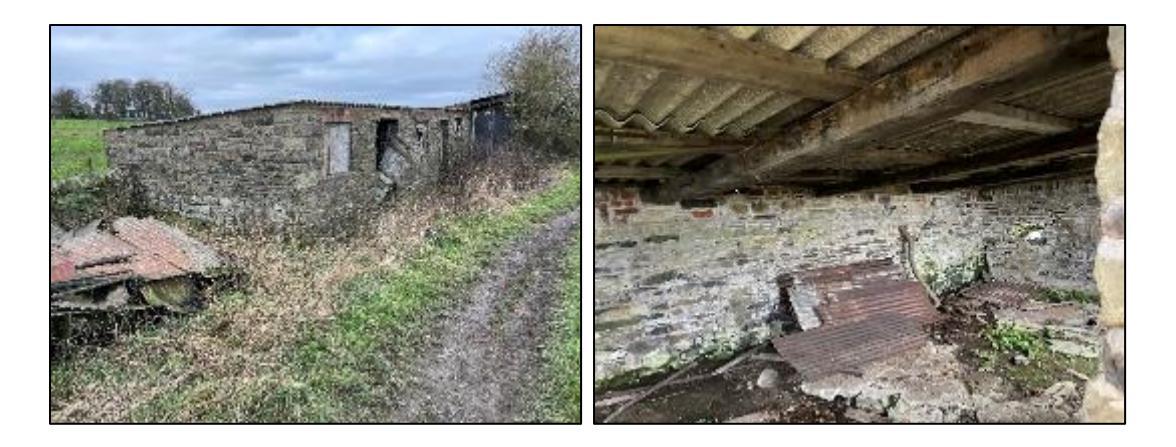
3.4.4.3.2. The southern of these buildings has solid stone walls that have been well pointed and has a flat roof covered with corrugated cement sheets supported on timber beams.

3.4.4.3.3. This building is assessed to have a negligible potential for roosting bats in line with the Bat Conservation Trust Good Practice Guidelines.

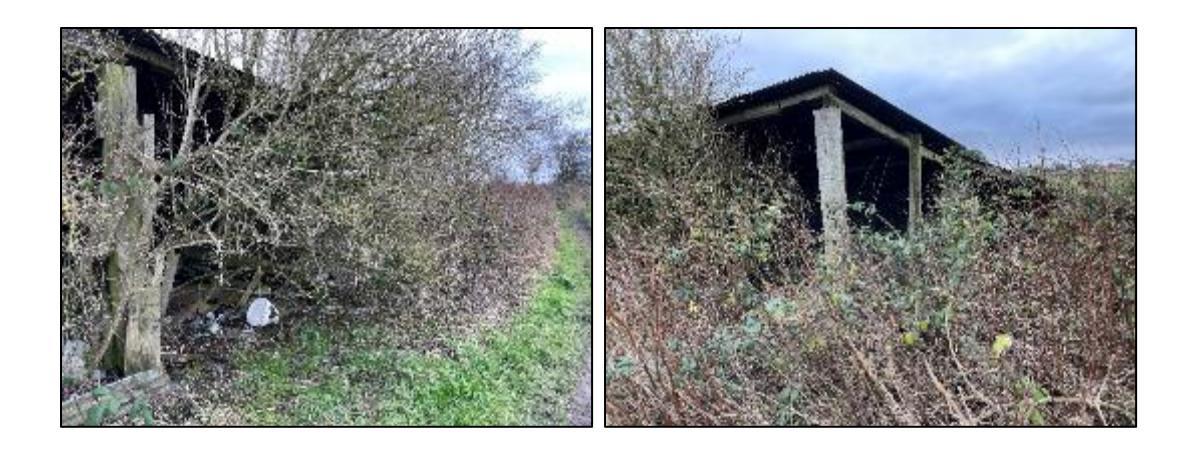
3.4.4.3.4. The northern of these buildings comprises a flat roof covered with corrugated metal sheets supported on timber posts and containing scattered scrub species.

3.4.4.3.5. This building is assessed to have a negligible potential for roosting bats in line with the Bat Conservation Trust Good Practice Guidelines.

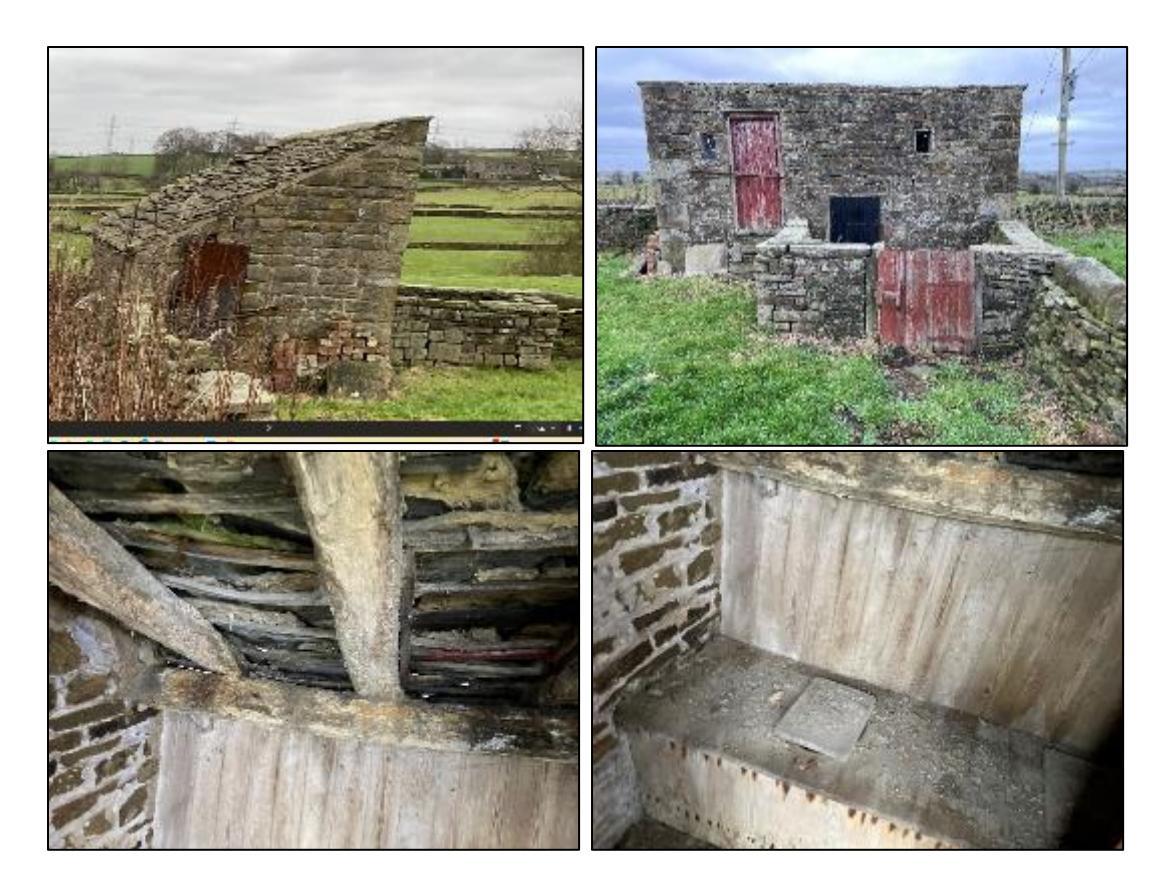
3.4.4.1. This is a stone building with solid stone walls. The pointing on the walls has been maintained and is in good condition. The roof is a flat roof covered with stone slates. These are all in place and have no lining beneath them.

3.4.4.2. This building is assessed to have a negligible potential for roosting bats in line with the Bat Conservation Trust Good Practice Guidelines.

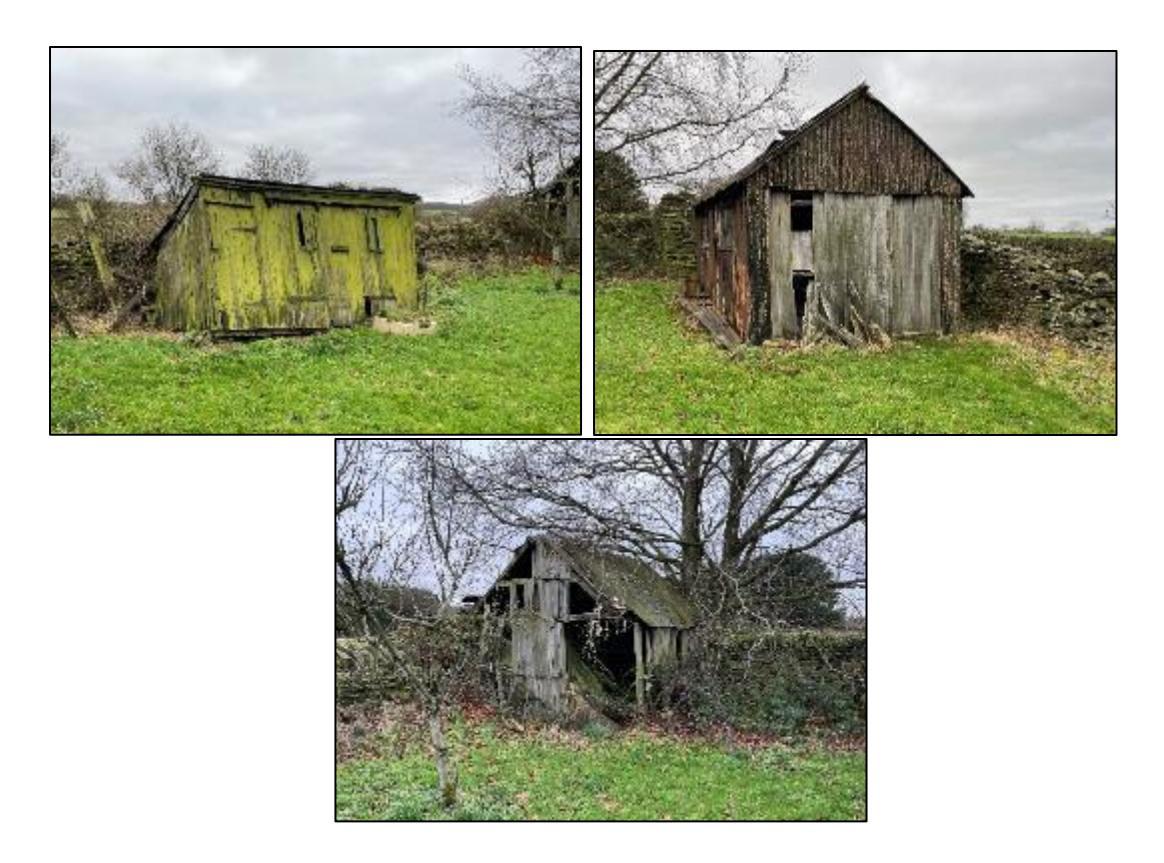
3.4.4.5.1. Within the rear garden of the farmhouse there are three timber sheds. These are all in a poor state of repair and all are assessed to be unsuitable for roosting bats.

3.4.4.5.2. All of these buildings are assessed to have negligible potential for roosting bats in line with the Bat Conservation Trust Good Practice Guidelines.
