Hydrogeological Desk Study Appraisal

Application for the Development of Houghton Main Renewable Energy Park (REP) comprising a Timber Resource Recovery Centre and an Anaerobic Digestion Facility (AD) Including Associated Infrastructure, Barnsley.

Peel Environmental Management (UK) Limited and Houghton Main Waste Limited

Project:	Houghton Main, Barnsley, S72 OHN
For:	Peel Environmental Management (UK) Limited and Houghton Main Waste Limited
Status:	Final
Date:	April 2014
Author:	Chris Betts - Consultant
Reviewer:	Steve Rhodes – Technical Director

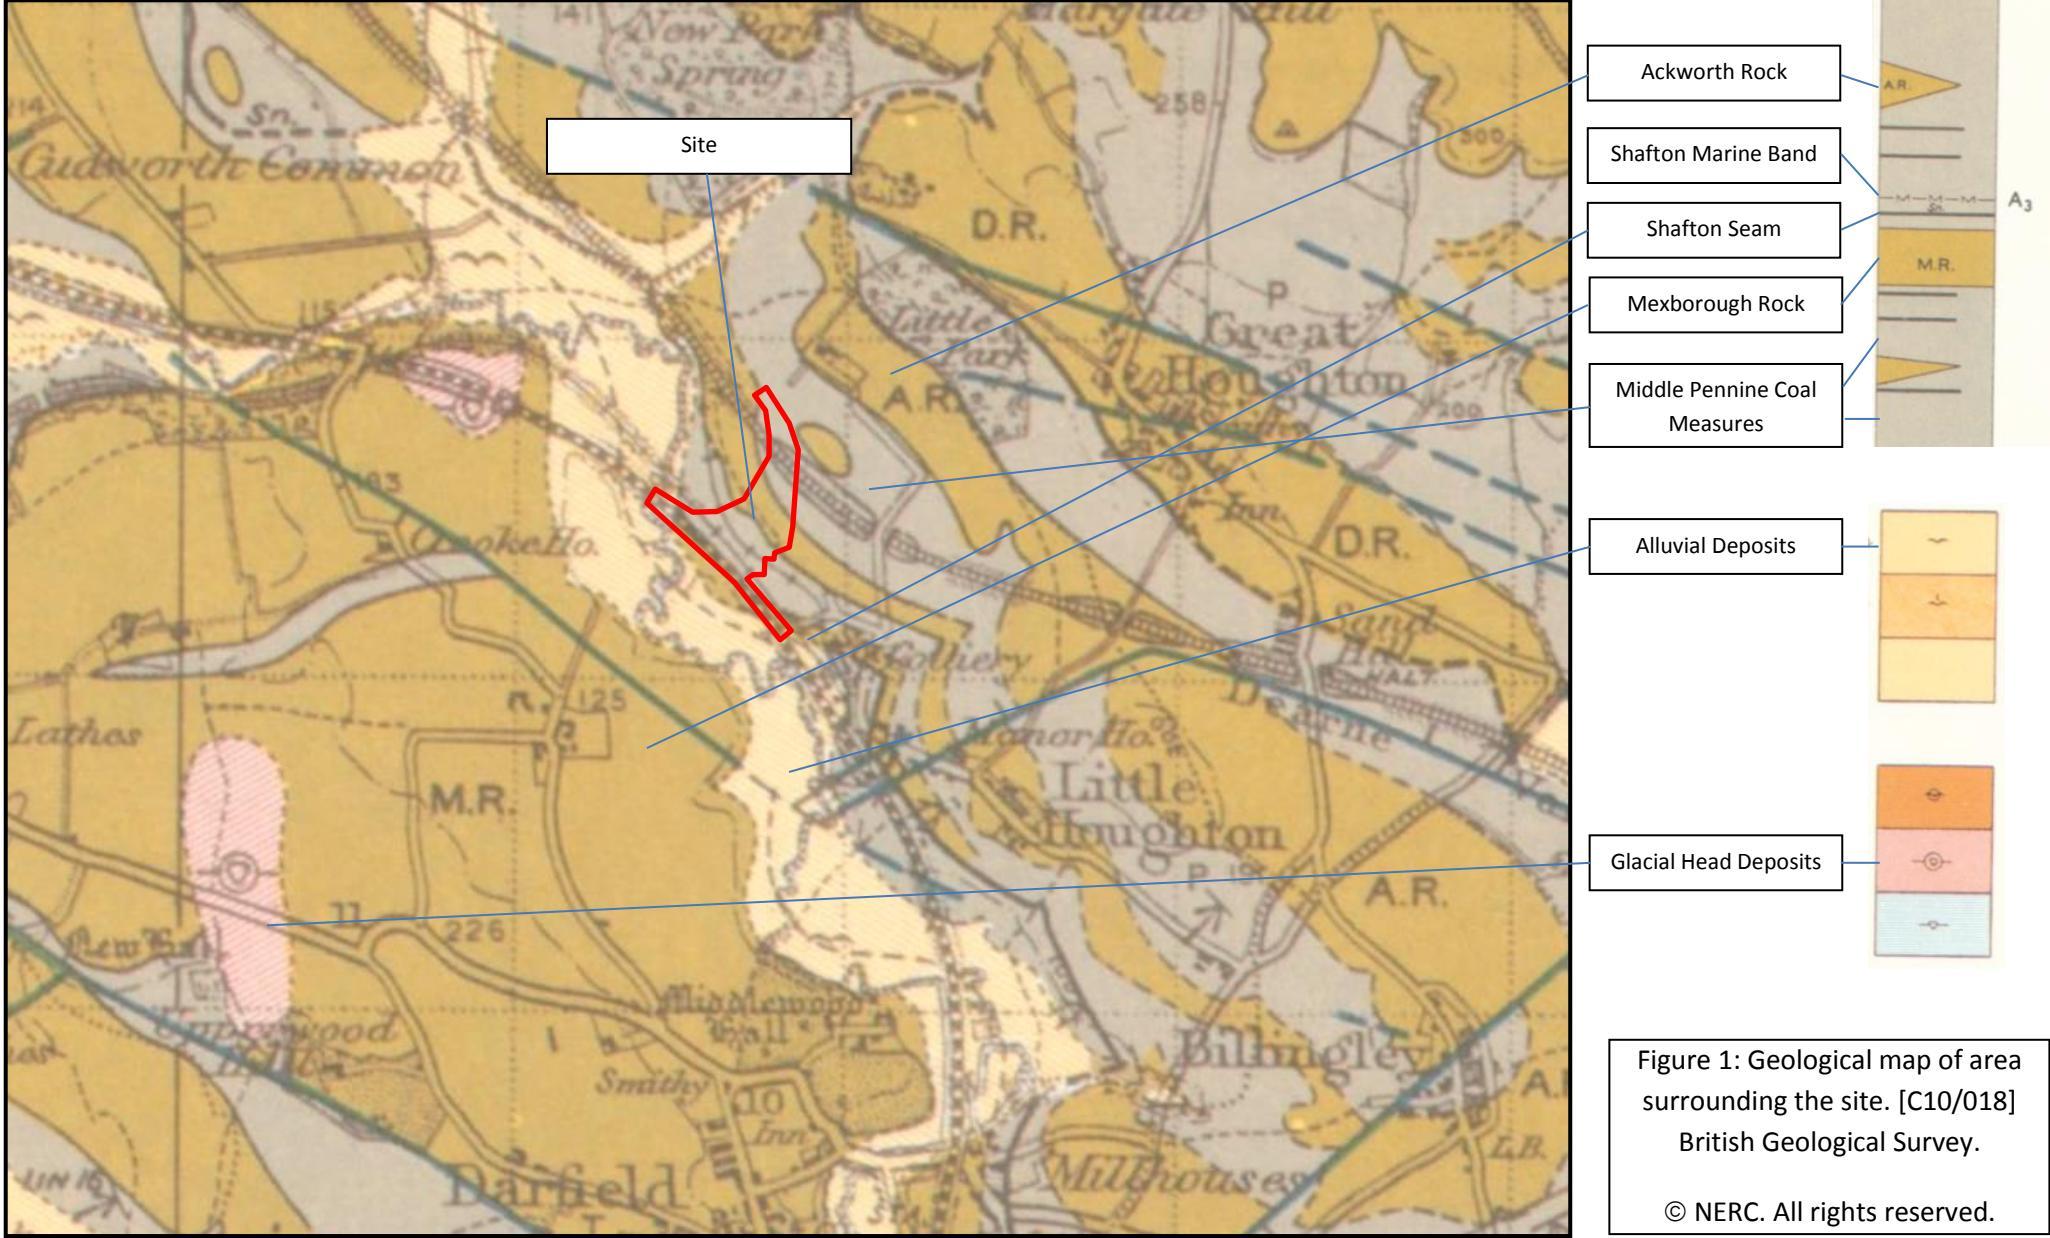
- The dip of the geological strata beneath the site is inferred to be towards the northeast and east. An extract of the Geological Map of the site is included in Figure 1.

- A number of faults have been identified within the surrounding area of the site from the Geological Map, sheet 87. The closet fault to the site is located approximately 250m to the southwest of the site.
