COAL MINING INVESTIGATION REPORT

Report on Rotary Probing								
Location:	Low Cudworth Green Cudworth, Barnsley, S72 8EF.							
For:	Smart Developments Ltd.							
Consultants:	Northern Design Partnership.							
Report No.	C3124/22/E/4730	Report date:	June 2023

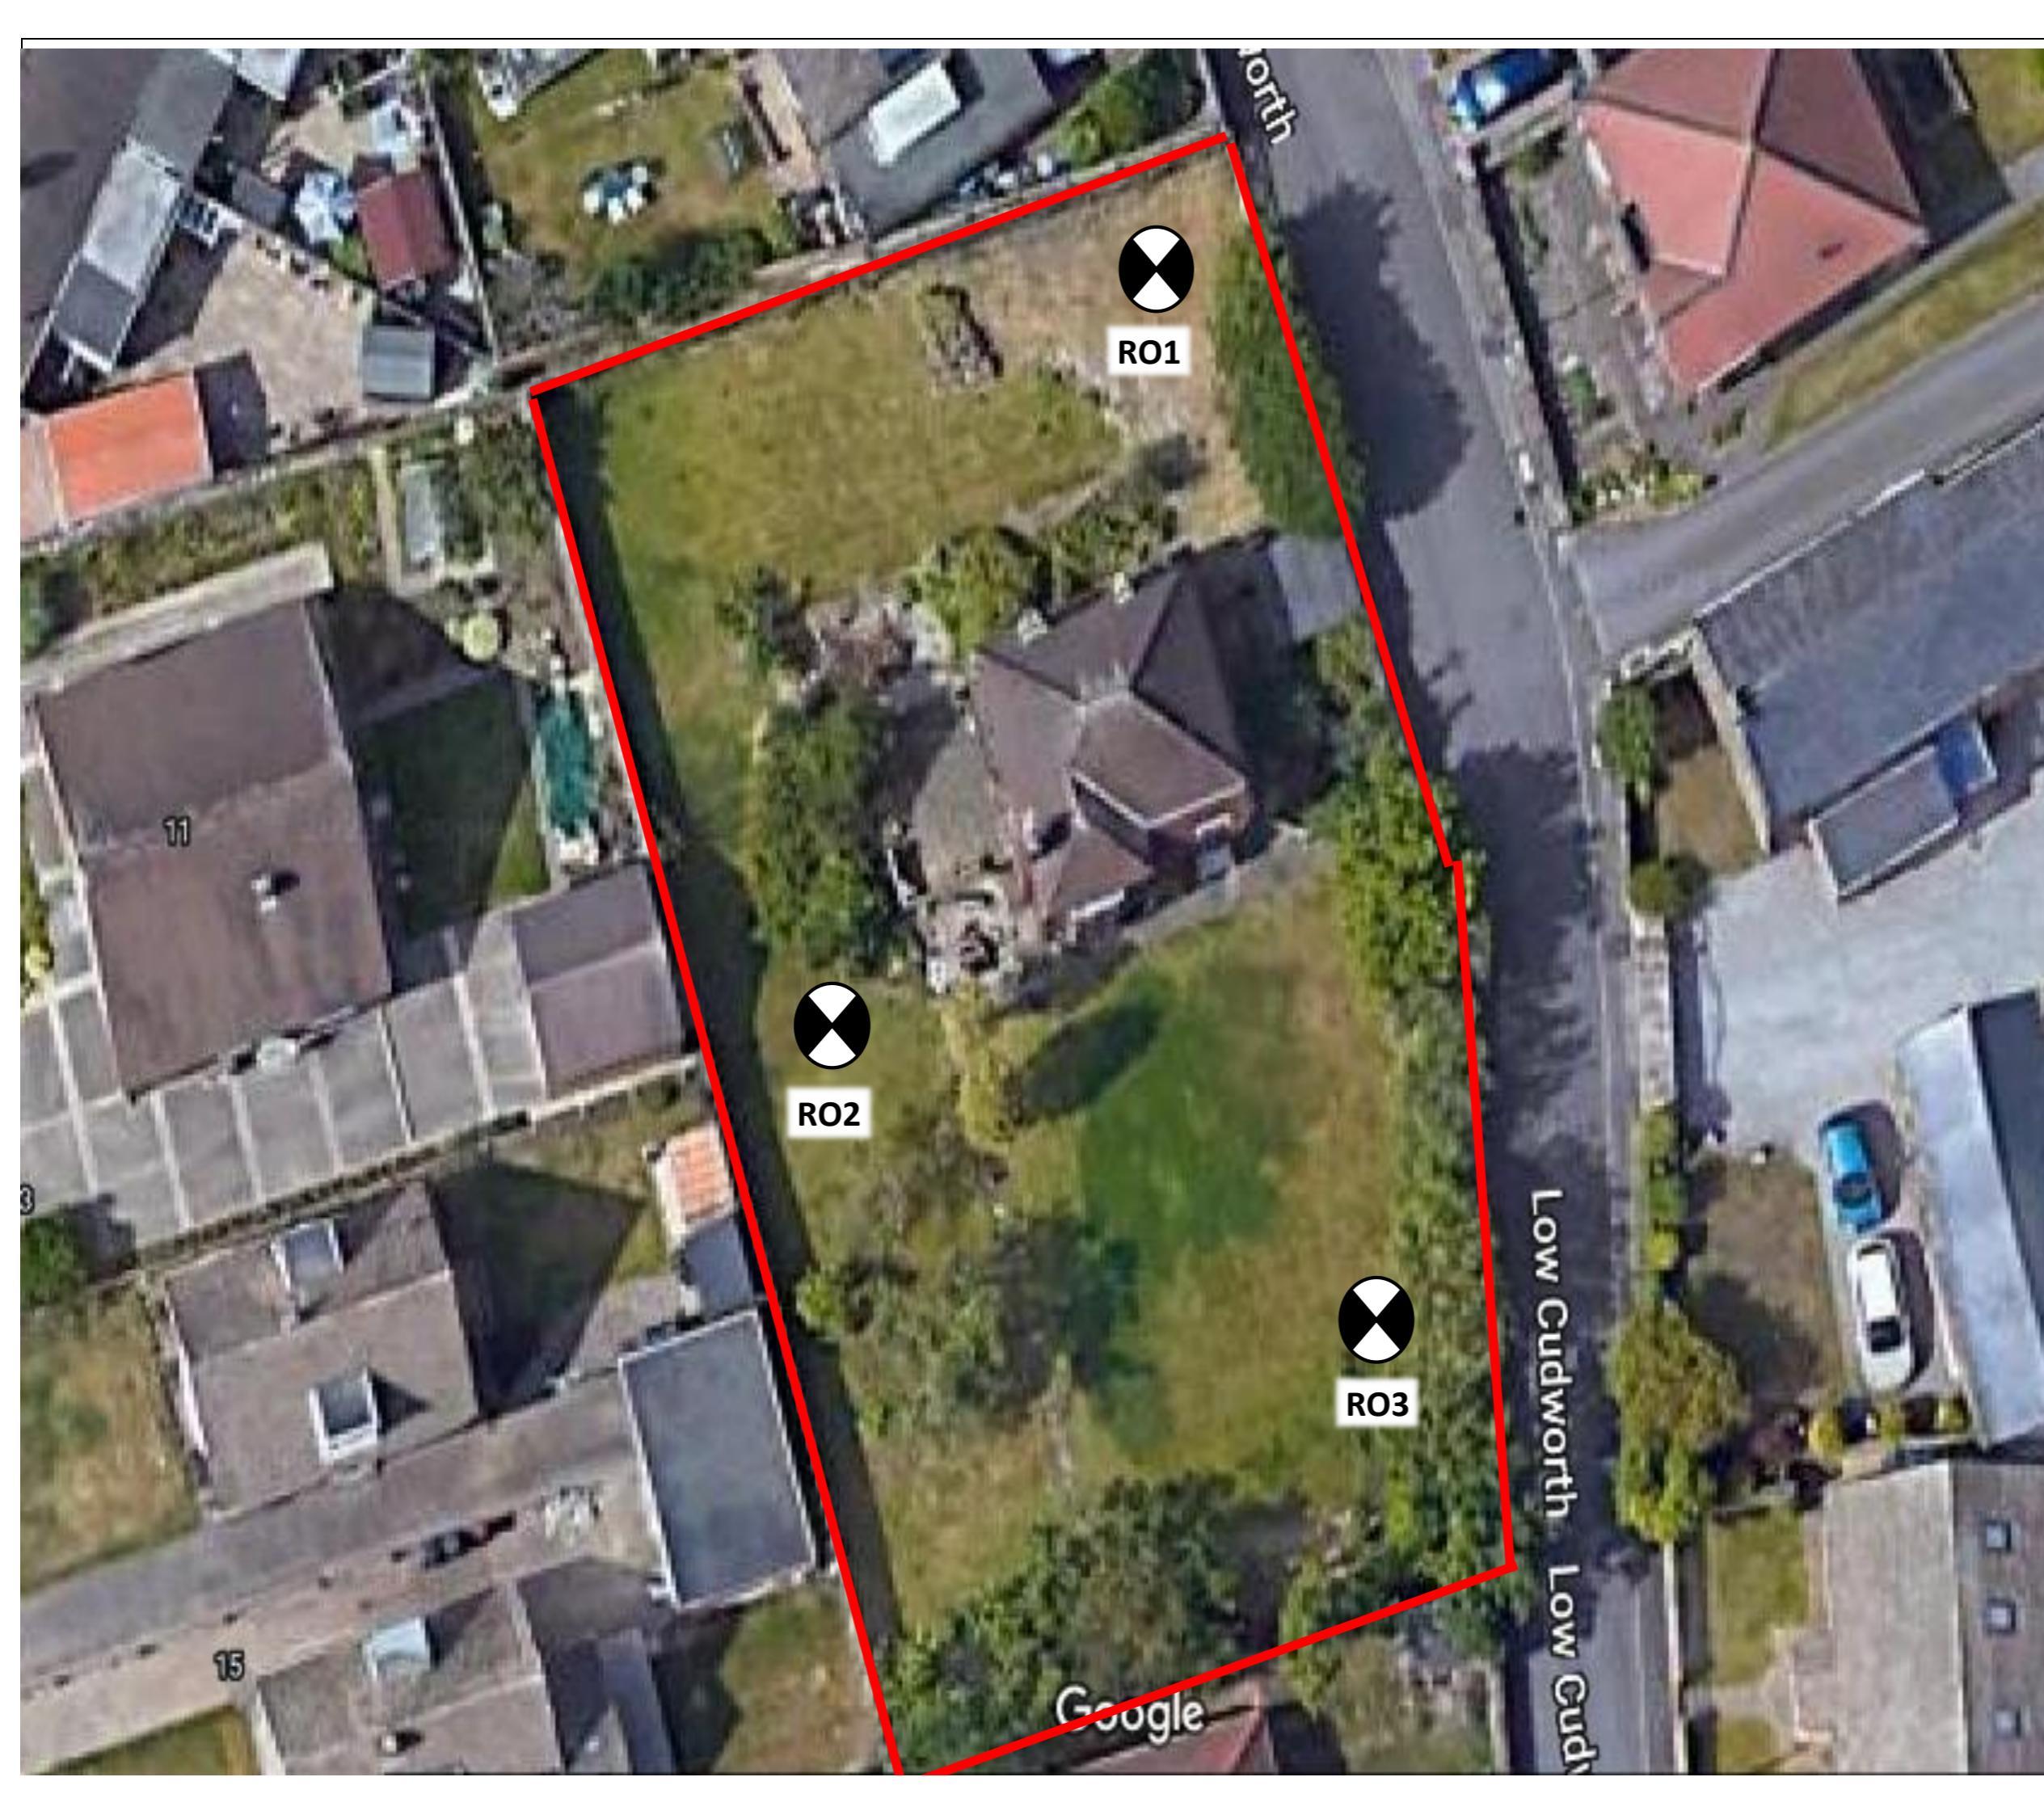
Appendix 2 Site Plan

The boreholes were sunk using a Comacchio 205 rotary drilling rig using rotary open-hole drilling techniques and employing 130mm diameter drag and tricone roller bits. Where necessary, 140mm diameter casing was temporarily installed through the overburden to support the bore. The investigation was undertaken using water flush drilling techniques in accordance with the Coal Authority and Health and Safety Executive positioning statement. Drill chippings brought to surface in the flush returns were inspected by the driller on a screen, which forms part of the re-circulation tanks. In addition, representative disturbed samples of the arisings were taken at regular depth intervals and sealed in plastic containers. The borehole positions are shown on the site plan, which is presented in Appendix 2 and the strata conditions are presented on the borehole records in Appendix 3.
