# MANSE FARM, CUDWORTH.

# **BAT SURVEY REPORT.**

**Ref No: 240601.**

Date: 30<sup>th</sup> August 2024.

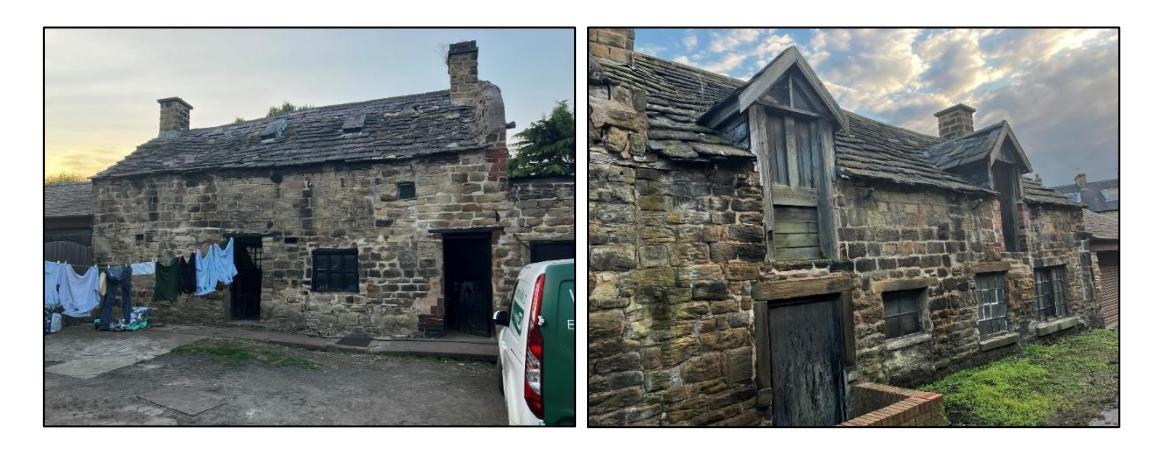
3.2.3. Building 1 was a small two storey stone agricultural building with a lined pitched stone tile roof with no loft space. The building was attached to two other single storey buildings externally on the eastern and western elevation. Internally the building has numerous rooms and windows and doors which are usually well sealed. The building was currently used for storage.

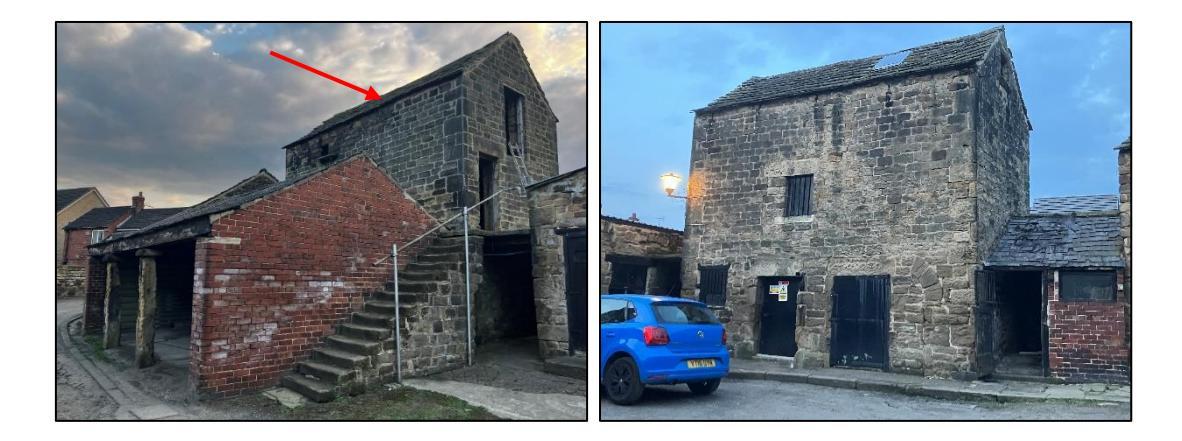
3.2.4. Building 2 was a three storey stone building with a pitched stone tiled roof with no lining. Internally the building has numerous rooms and windows and doors which are usually well sealed. The building was currently used for storage.

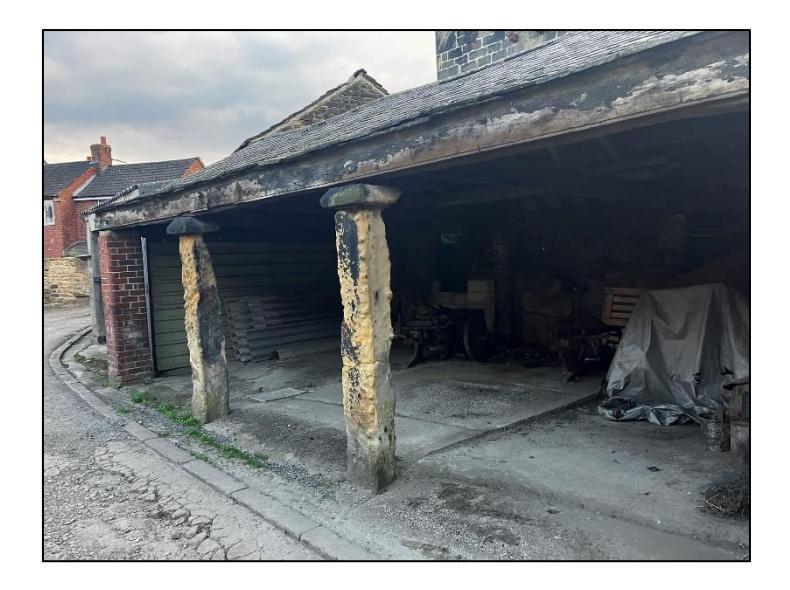
3.2.5. Building 3 was a single storey brick building with a pitched blue slate roof with no lining. The building was attached to the eastern elevation Building 2 and was open on the eastern elevation. Internally the building was used for storage.

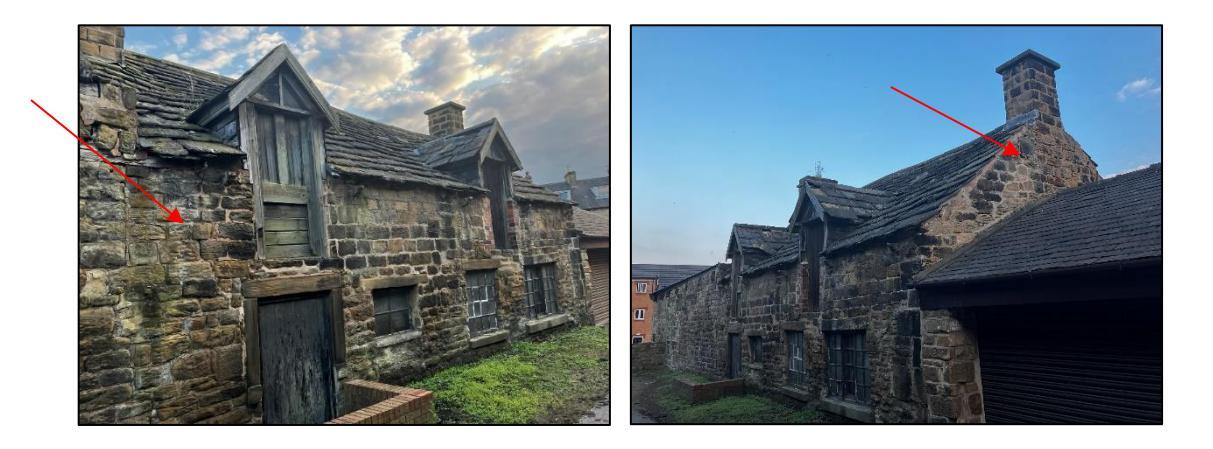
3.3.1.1. The brick walls of the building are largely in good condition, with the exception of some occasional gaps between the stonework, shown below, leading into the cavity wall. These may be used by roosting bats, however some are very low down and the poor condition of the roof leaves the cavity exposed to rainfall, making it significantly less likely that this feature would be used regularly by roosting bats.

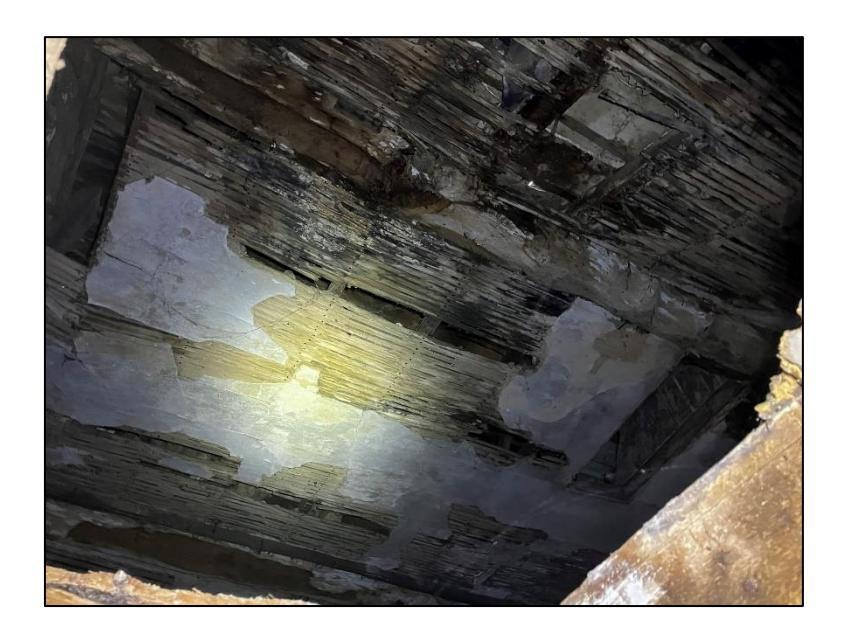
3.3.1.2. The roof of the building is in poor condition, broken in places leaving the internals extremely exposed and few opportunities for bats to roost. The building does not have any soffits or fascia boards.

3.3.1.3. Internally no loft space is present and as noted above, the internals are extremely exposed through broken windows and gaps in the roof. The internals of the building are not ideal for roosting bats.

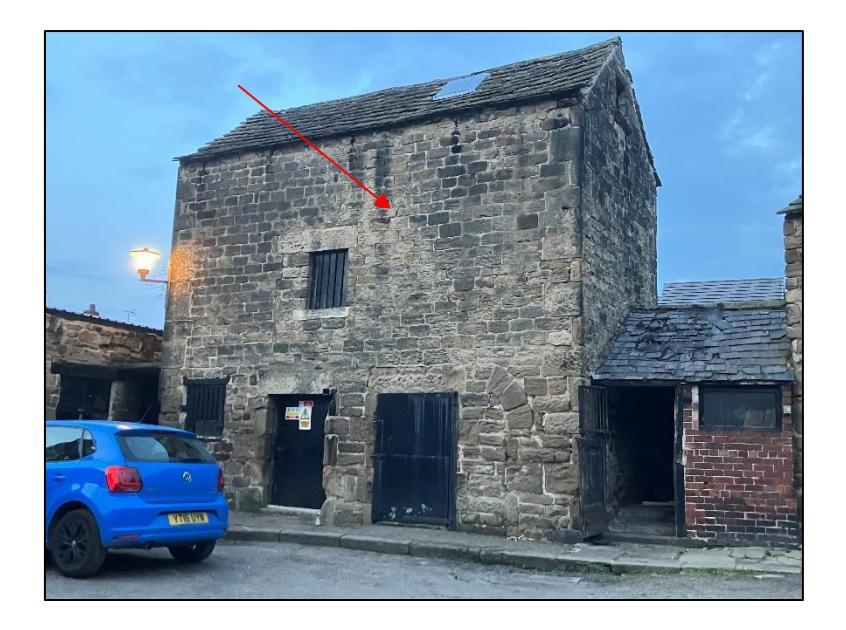
3.3.2.1. The brick walls of the building are largely in good condition, with the exception of some occasional gaps between the stonework mainly on the west elevation, shown below, leading into the cavity wall.

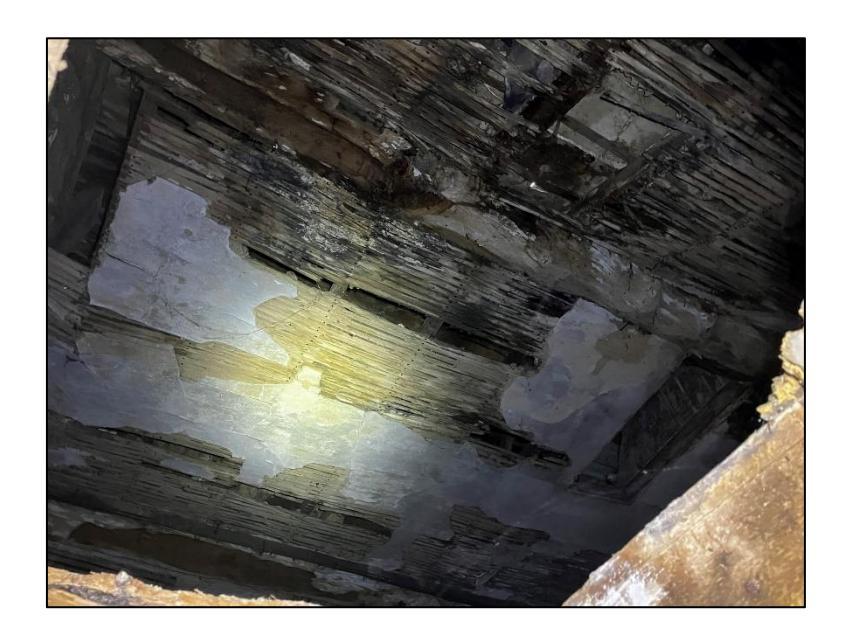
3.3.2. The roof of the building is in poor condition, broken in places leaving the internals extremely exposed and few opportunities for bats to roost. The building does not have any soffits or fascia boards.

3.3.3. Internally no loft space is present and as noted above, the internals are extremely exposed through broken windows and gaps in the roof. The internals of the building are not ideal for roosting bats.

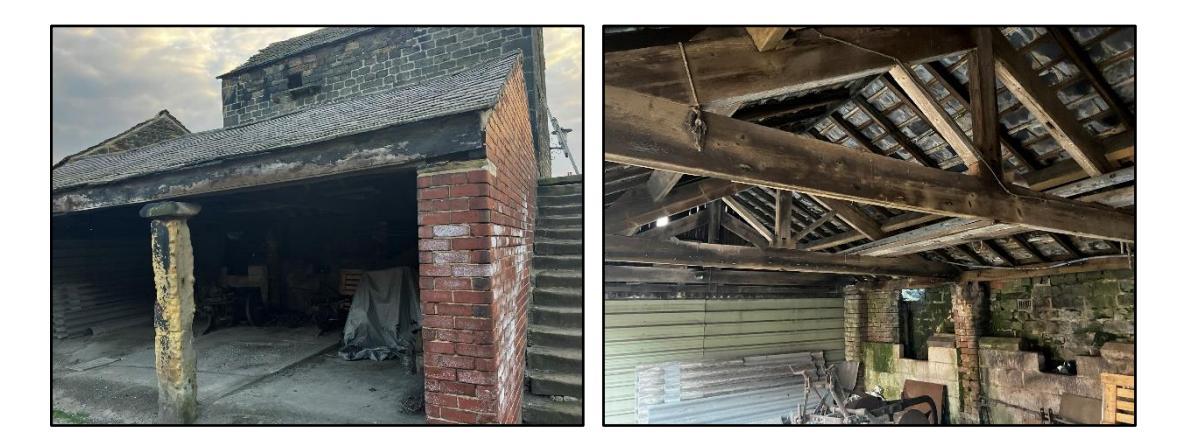
3.3.4.2. The roof is in fair condition, but does have some occasional gaps under the tiles, including the ridge and ends of the tiles at the top of the gable end. There is no roof lining under the tiles, limiting any bat roosting potential. The building is open along one side and is open to the underside of the roof tiles and therefore is generally open and draughty.

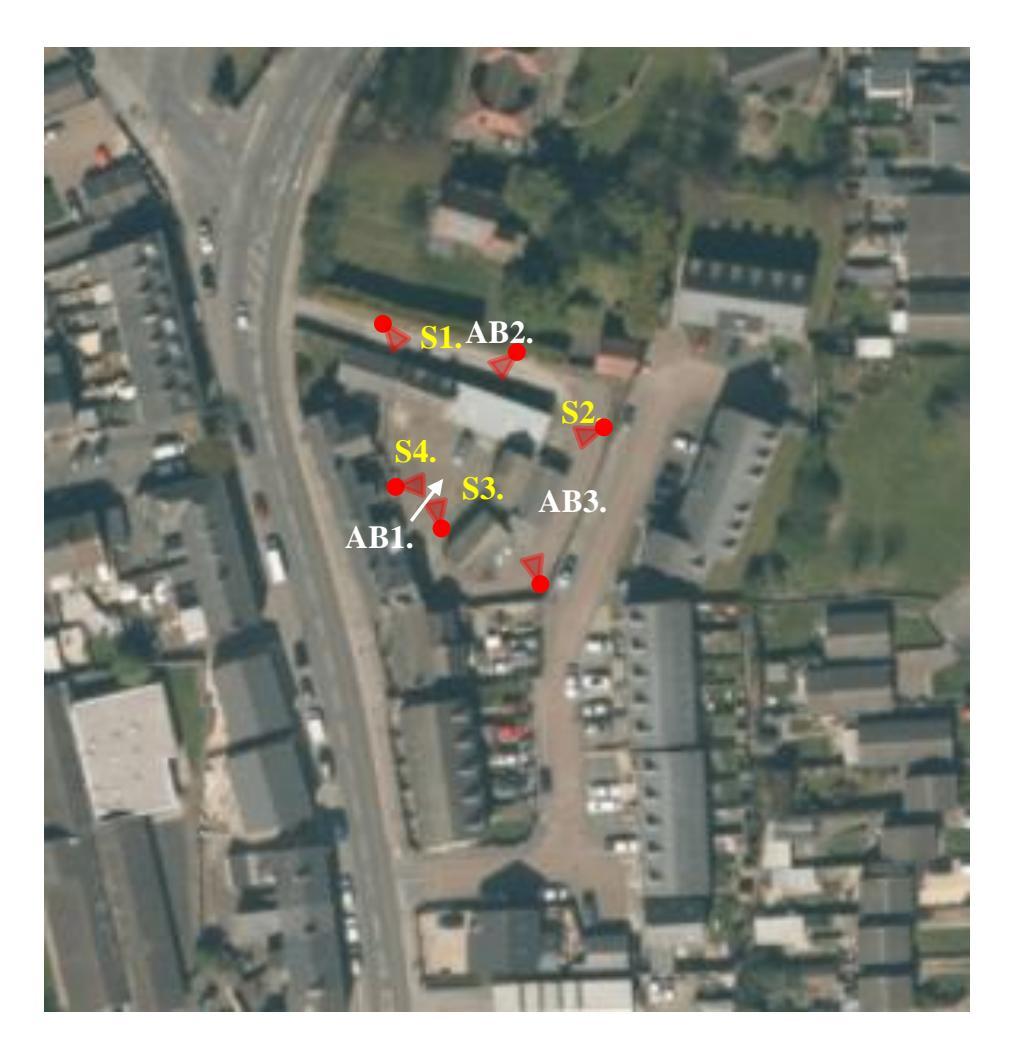
3.4.6. The aerial photograph below shows where the Surveyors (S) were positioned. The location and viewing angles of the NVAs are shown in red.

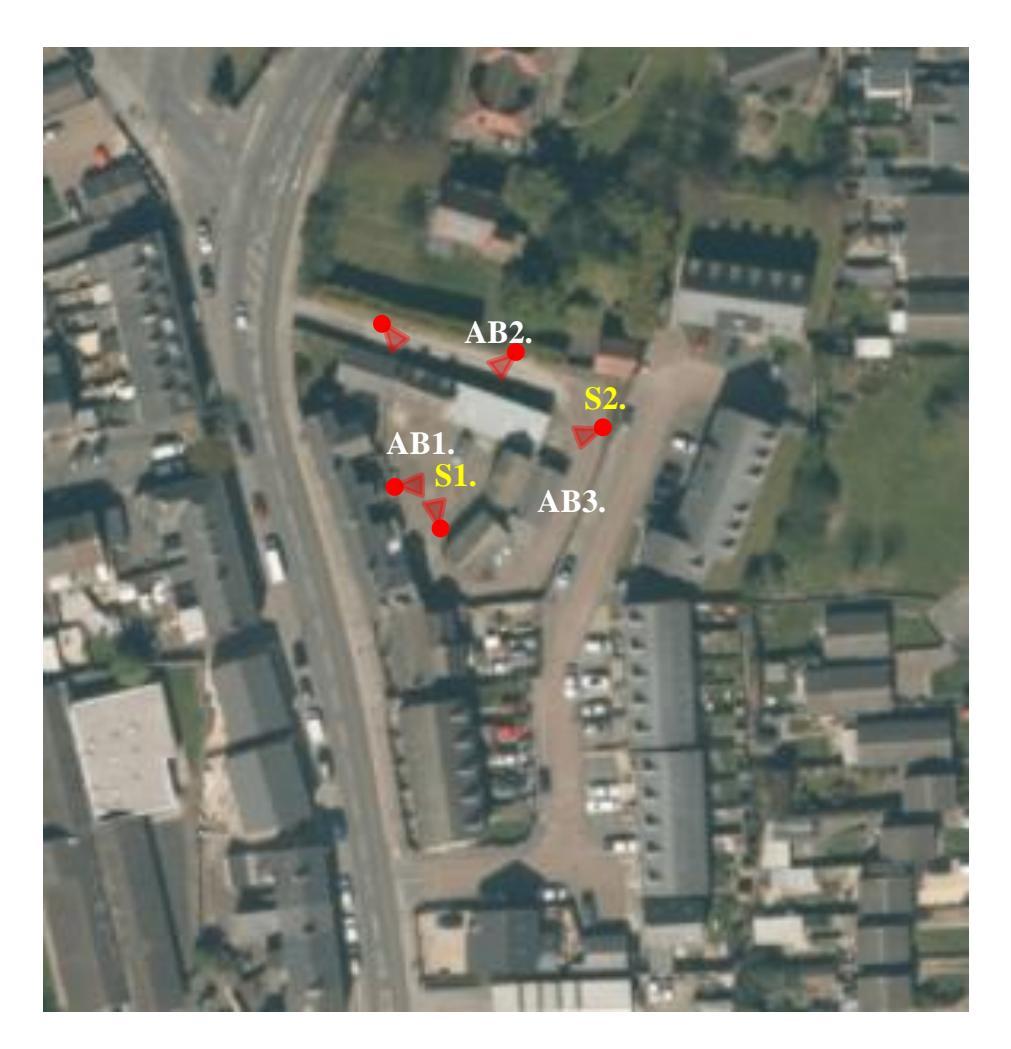
3.5.6. The aerial photograph below shows where the Surveyors (S) were positioned. The location and viewing angles of the NVAs are shown in red.
