Your Ref: Our Ref: MAN.948.001.EC.R.001 Date: 3<sup>rd</sup> June 2024 Email: <u>chris.schofield@enzygo.com</u>

# RE: Ecology Walkover and Assessment Note – Land at Stocks Lane, Barnsley

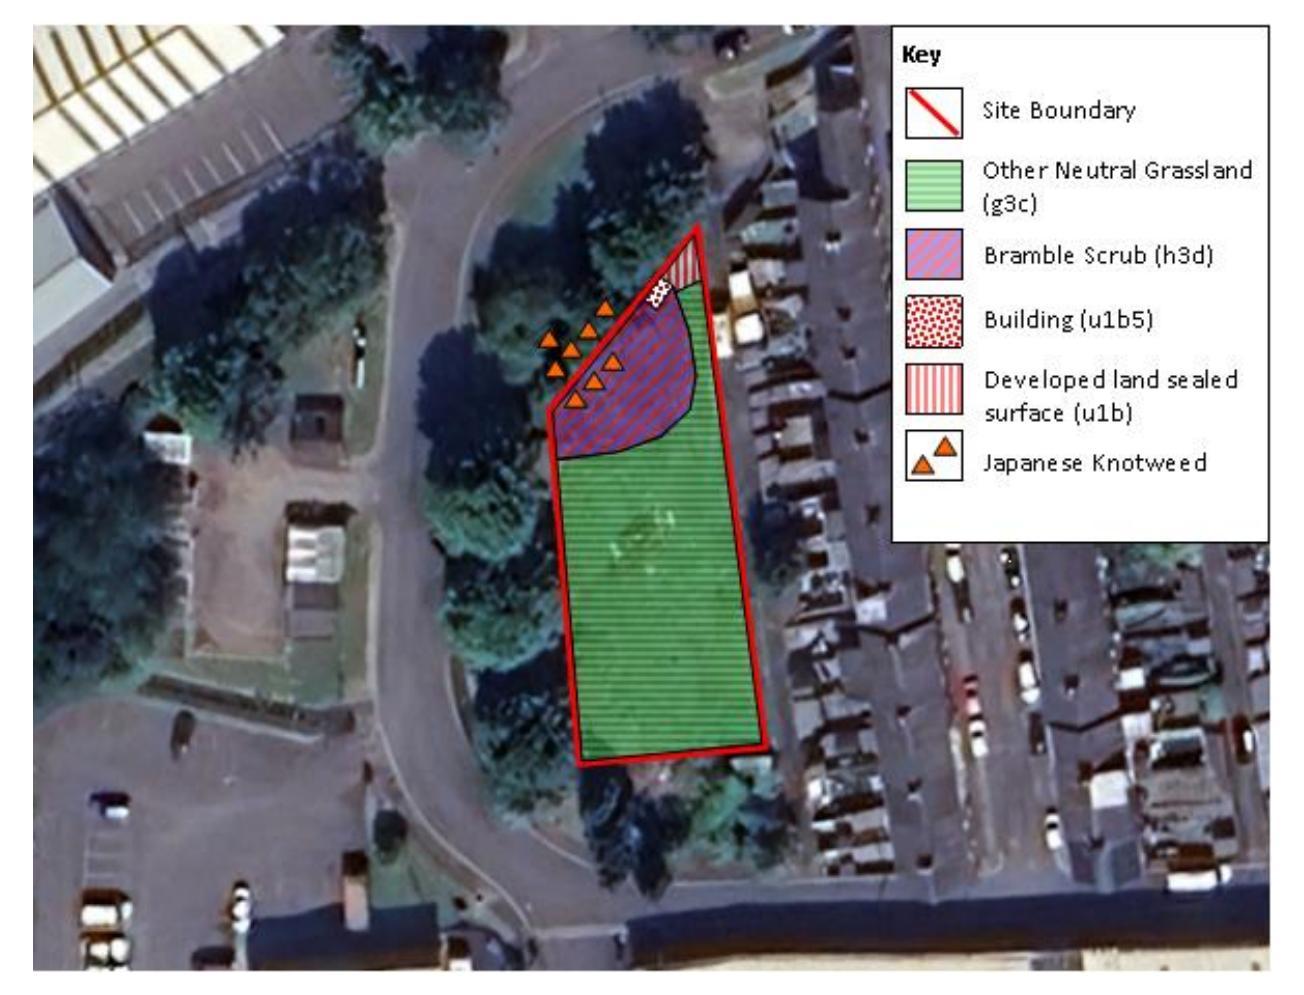
Insert 1: UK Habitat Classificaiton Map

The predominant habitat at the site is unmanaged species-poor neutral grassland with abundant tall ruderal herb vegetation, localised bare ground areas (circa 20% of area) and evidence of fly tipping and deadwood piles. The species assemblage is characterised by abundant Yorkshire-fog (*Holcus lanatus*), False Oat-grass (*Arrhenatherum elatius*), Creeping Buttercup (*Ranunculus repens*) and Bramble (*Rubus fruticosus* agg.), with frequent Cock's-foot (*Dactylis glomerata*), Broad-leaved Dock (*Rumex obtusifolius*), Common Nettle (*Urtica dioica*) and Creeping Thistle (*Cirsium arvense*). This is a common and a typical species assemblage with no indicators of any species-rich or uncommon grassland types.

At the north of the site is a localised area of unmanaged scrub which is dominated by Bramble, with occasional Japanese Knotweed (*Reynoutria japonica*), Broad-leaved Dock, Common Hogweed (*Heracleum sphondylium*), Great Willowherb (*Epilobium hirsutum*), Mugwort (*Artemesia vulgaris*), Common Ragwort (*Senecio jacobaea*) and Sycamore saplings (*Acer pseudoplatanus*).

Along the north boundary is a small garage with concrete and pebble-dash render walls and a flat corrugated, suspected asbestos, roof. This garage is a notably good condition with no signs of damage or gaps.

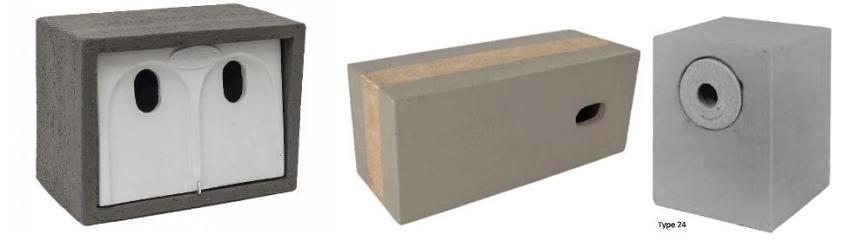
### Insert 2: Recommended Bird Boxes

Vivara Pro Woodstone House Sparrow Nest Box, Woodstone Build-in Swift Nest Box, and Schwegler Type 24 Brick Nest Box (from left to right).

In addition, in accordance with *BS 42021:2022 Integral Nest Boxes* at least one new bird nest box per plot should be incorporated into the developed site. Suitable box types considering the site location and bird species likely present in the local area include the Vivara Pro Woodstone House Sparrow Nest Box, Woodstone Build-in Swift Nest Box, and the Schwegler Type 24 Brick Nest Box (or similar as approved if unavailable), as shown in Insert 2 below.

Bird boxes should be positioned at the wall tops in a sheltered location beneath the eaves and in a location away from notable sources of disturbance such as security lighting and windows. Bird boxes should also avoid south-facing elevations as these can receive excessive sunlight and cause chicks to overheat in the box.

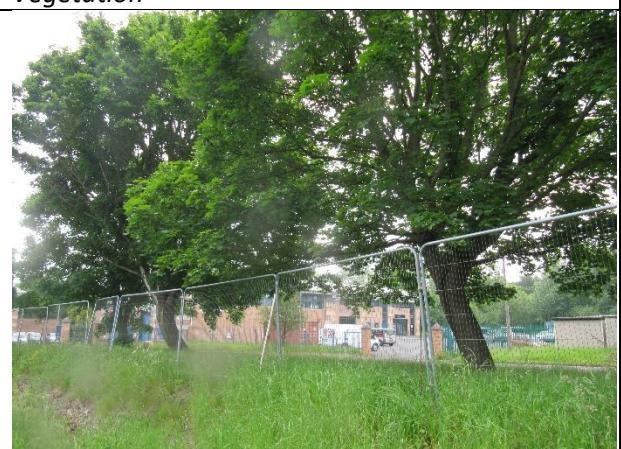
Neutral Grassland and Off-site trees to the west

Immediately beyond the north, west and southern boundaries are trees which provide a limited extent of green infrastructure and wildlife corridor function, and there is a risk these may be damaged during the construction phase. Boundary habitats should be protected throughout the construction phase in accordance with BS5837:2012 *Trees in relation to design, demolition, and construction.* Recommendations include installing and maintaining appropriate protection fencing. To minimise the potential for habitat degradation through excessive artificial lighting overspill, an appropriately designed lighting scheme should be implemented during construction and operation of the site, making use of suitable products such as directional, low-level, capped, screened and/or low-lux lighting.

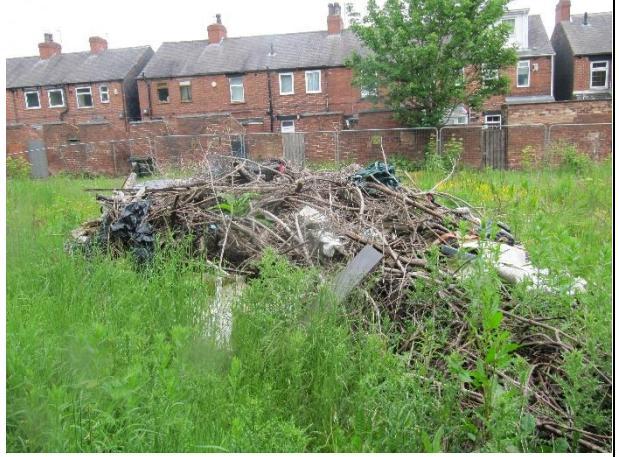
The rough grassland, scrub and deadwood piles do provide a significantly limited extent of refuge and shelter for wildlife which may be present in the developed landscape such as common amphibians, small mammals and potentially individual numbers of common reptiles such as Slow-worm.

Fly-tipping/deadwood pile at the centre of the site

The construction phase should implement a series of best practice precautionary measures to minimise the risk of killing/injury of wildlife such Slow-worm and Hedgehog. This should include avoiding leaving open any pits or trenches in which wildlife may become trapped. Any trenches or pits in which wildlife may become trapped should either be covered, infilled, or a suitable means of escape provided (e.g., plank of wood) overnight. Any wildlife discovered at the site should be either allowed to disperse into offsite areas of relocated by hand.

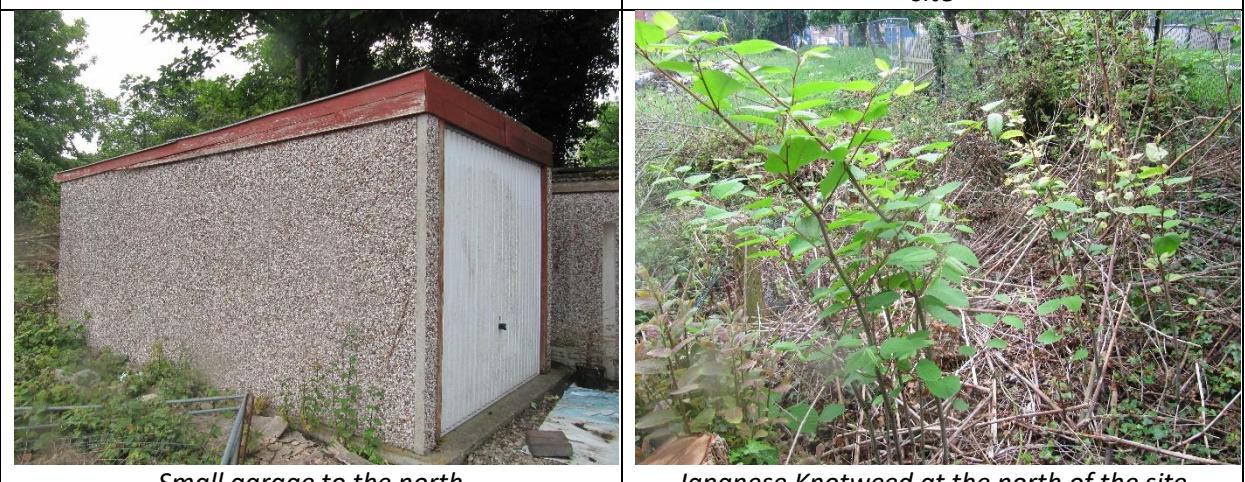
Japanese Knotweed, an invasive species listed on Schedule 9 of the Wildlife and Countryside Act 1981 (as amended) is present within the scrub at the north of the site and extending off-site to the north. No other Schedule 9 species detected within the site.

Small garage to the north

Japanese Knotweed at the north of the site

It is recommended that a specialist invasive species contractor is commissioned to produce an invasive species treatment and eradication plan to ensure that the works do not lead to the spread of Japanese Knotweed in the wild.
