Barns at Jowett House Farm, Cawthorne

Bat Survey Report

19th February 2025

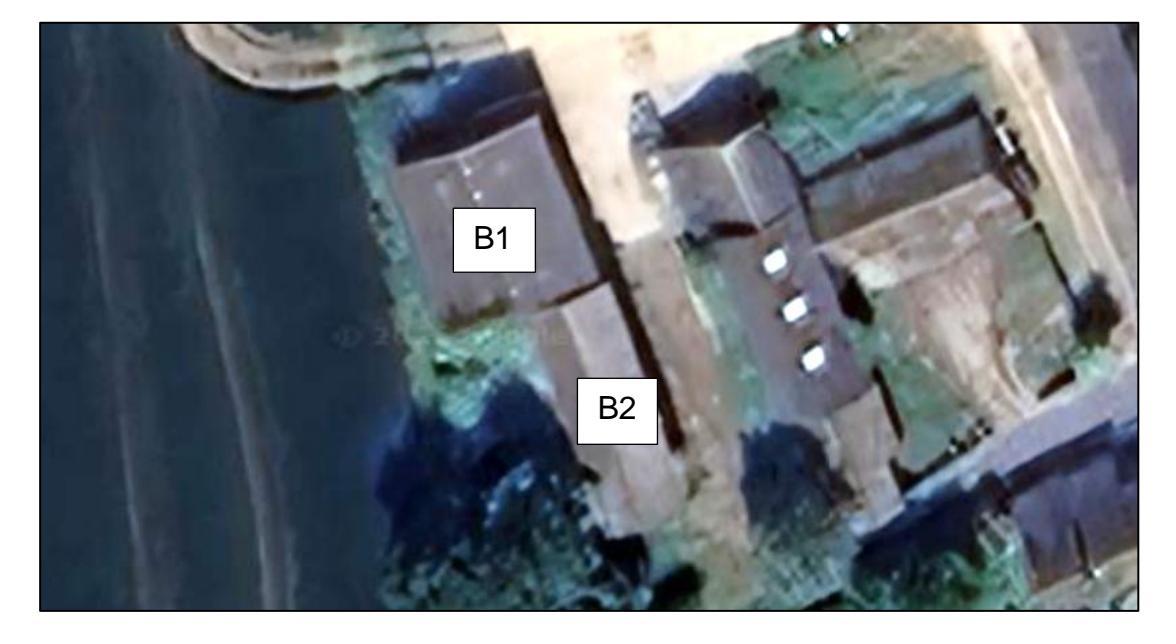
Figure 2. Building layout

5.2.2 For ease of description the buildings have been numbered and are shown in Figure 2 below.

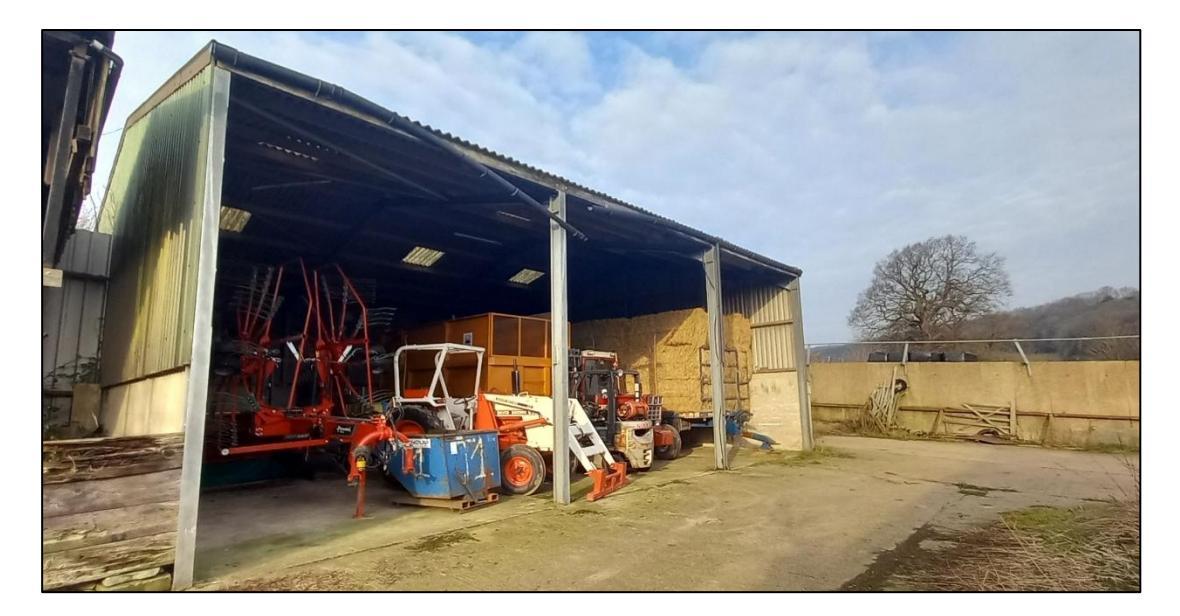
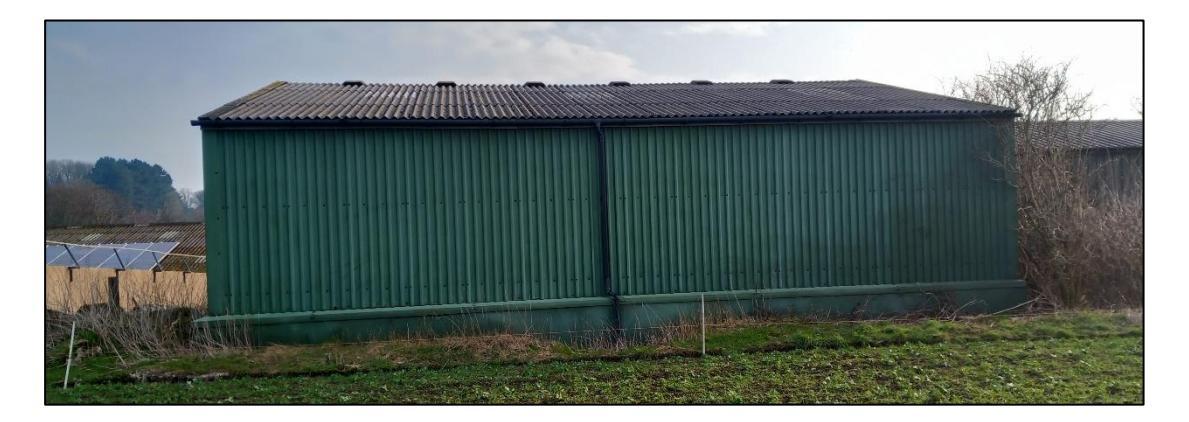
Plate 1. B1

5.2.3 Building B1 was a modern steel framed agricultural building beneath a pitched corrugated fibre-cement roof, supported by wood purlins on steel trusses. A two metre high solid concrete block wall was on two sides (rear and northwest elevation) with a similar height precast concrete panel wall on the southeast elevation. The outside rear walls were clad with profiled metal sheets. Fibre-cement verge capping was present on both gables. The barn was open fronted (Plates 1, 2 & 5).

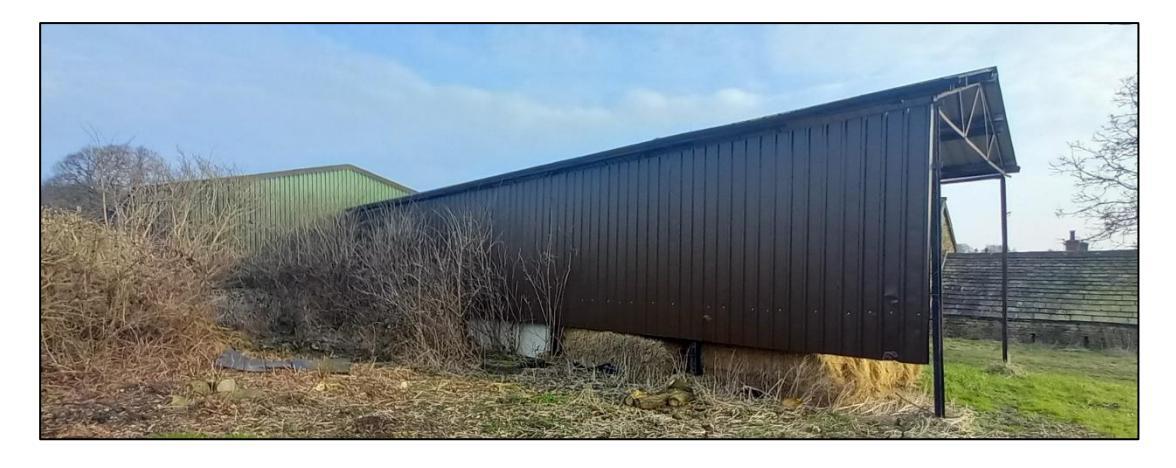
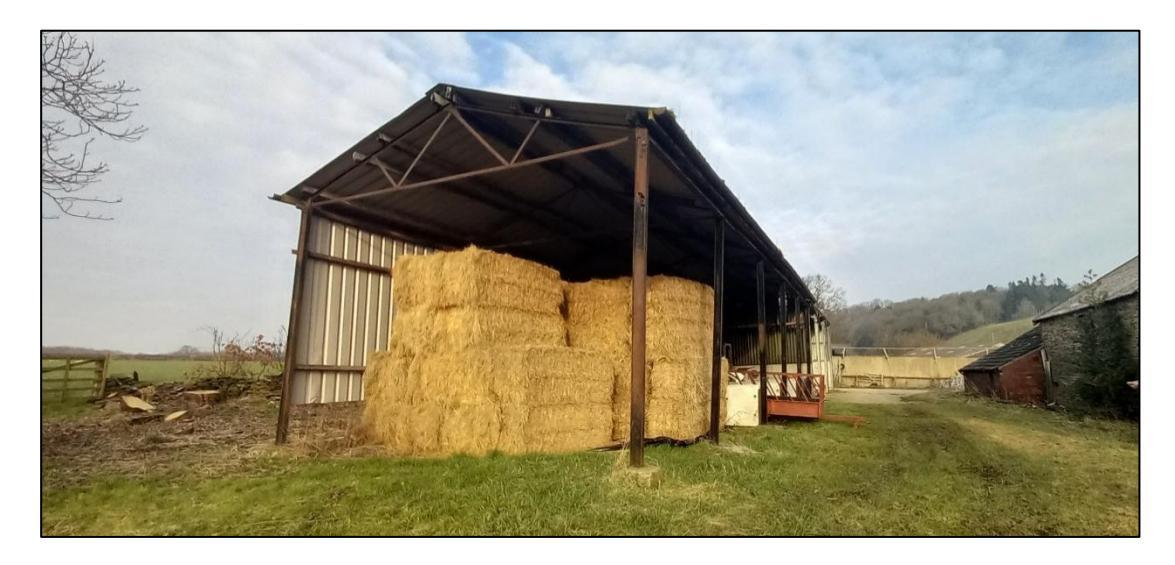
Plate 3. Rear of B2

5.2.4 Building B2 was a steal framed agricultural building beneath a pitched profiled sheet metal roof, supported by steel trusses and timber purlins. The barn was open on three sides whilst the rear was clad with profiled sheet metal (Plates 3, 4 & 6). No potential roost features were identified on the exterior of either building.

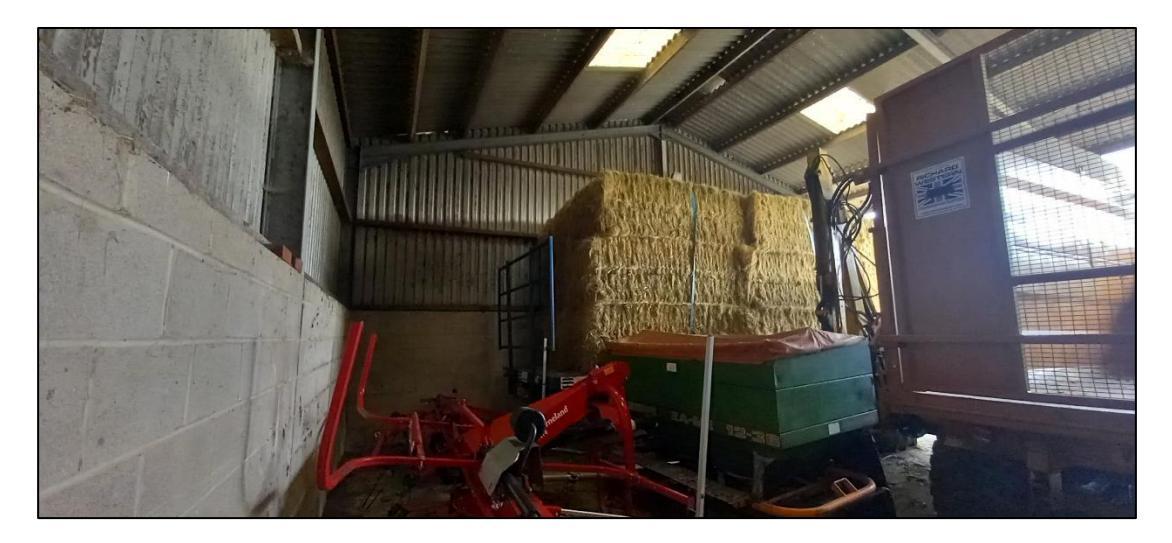
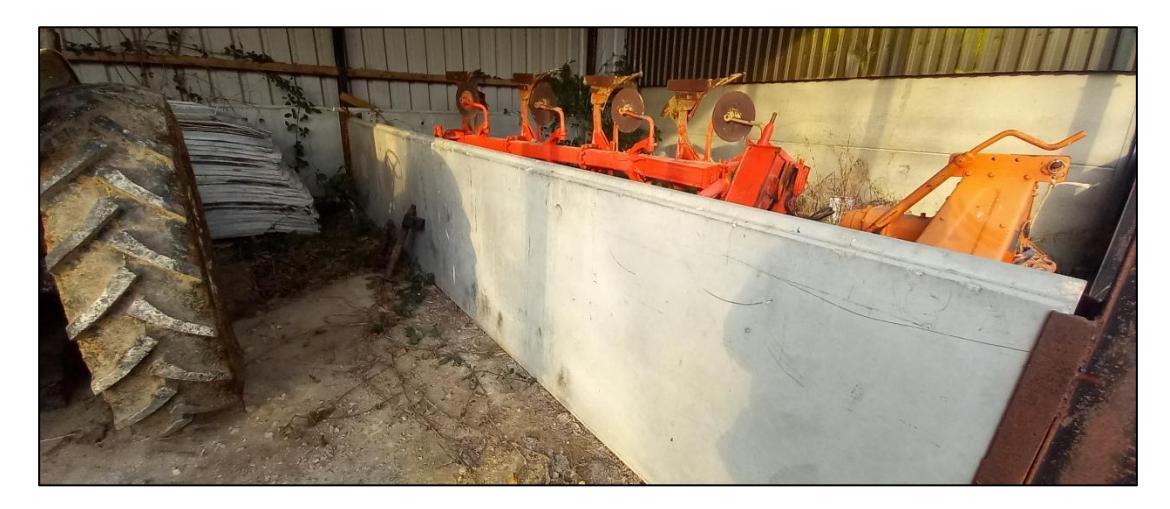
Plate 5. Inside B1

- 5.2.5 Both buildings were open to the underside of the roof covering and the only potential bat roost feature internally comprised the gaps between the corrugations of the fibre cement sheets and the purlins in B1. In this case the corrugations are large and therefore unlikely to be attractive to crevice dwelling bats. No potential bat roost features were identified on the inside of B2, given the presence of sheet metal roof covering which has no thermal mass and highly fluctuating temperatures. Three 1 m high precast concrete panels divided the floor space into three compartments in B2 (Plate 6).
- 5.2.6 No signs of bats were found in either of the buildings.

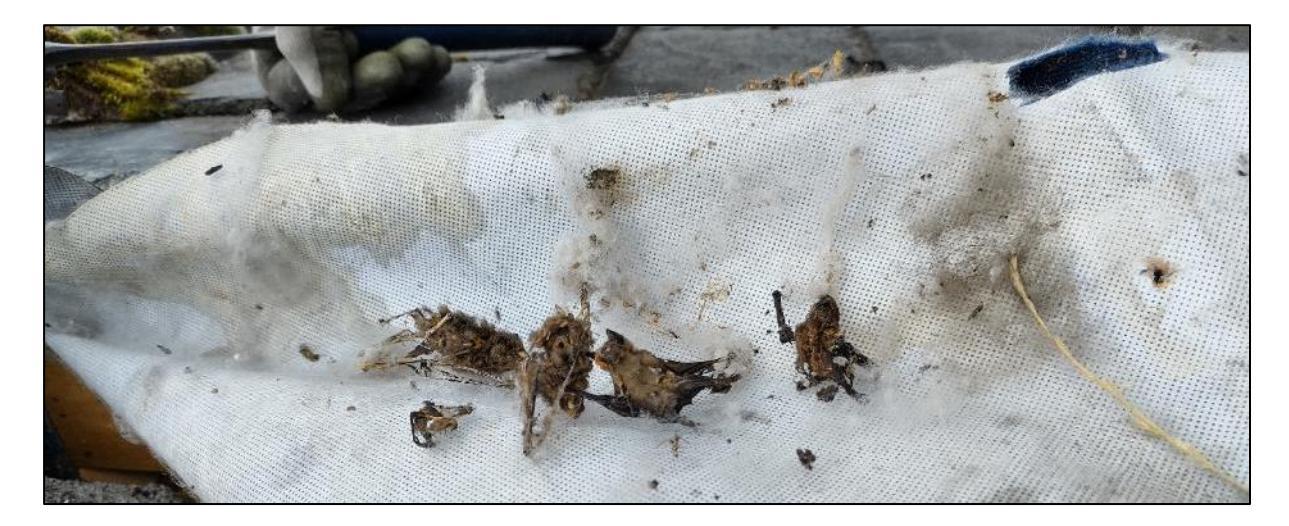
Standard non-bitumen coated membranes (including almost all breathable membranes) used below roof slates and tiles present a significant problem for bats. Over time, strands are pulled away from the surface of these materials as bats crawl over them. These fuzzy strands are very strong and can tangle and trap bats, sometimes causing the death of bats over multiple years¹.

One example we have encountered comprised a pipistrelle roost which formed in a building extension constructed in 2009. Over the course of just 13 years the roofing felt degraded to the extent that it trapped and killed more than 10 bats. Fortunately, the problem in this roost was identified and remedial work was undertaken to replace the roofing membrane in 2022.

Plate A2.1. Four dead pipistrelles tangled in breathable roofing membrane

6.2.3 Over time bats will often get into new buildings. Bats have been shown to regularly become entangled and die in the component filaments of standard modern woven roofing membranes (Appendix 2). There are however now a number of modern roofing membranes which have been shown to be relatively safe for bats. As a result, the roof of the new dwelling must be lined with a 'bat safe' membrane.

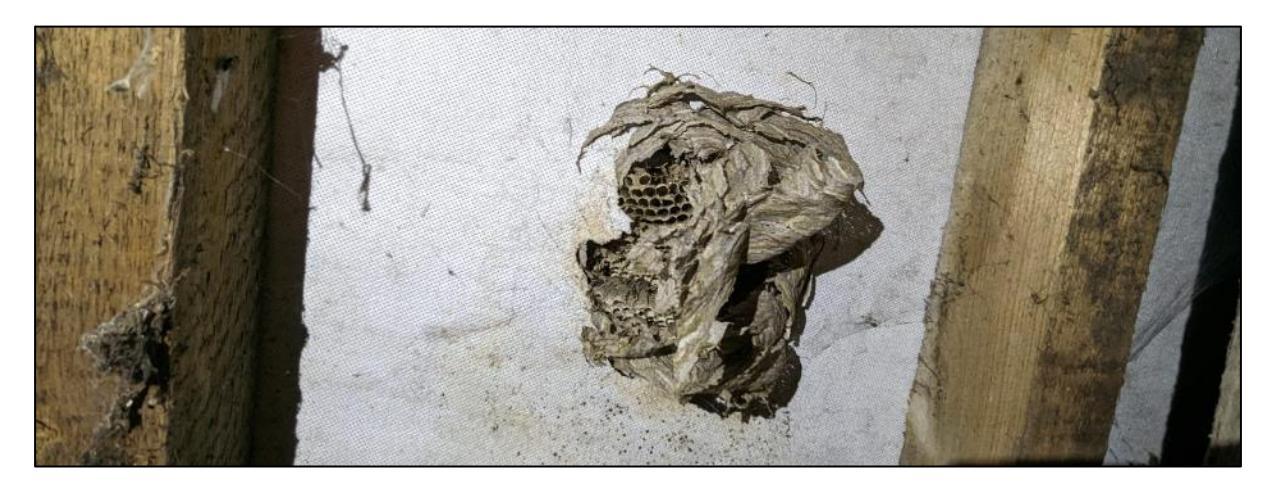
In recent years a fairly substantial proportion of the lofts we have surveyed which had existing breathable felt, were found to have been damaged by wasps (Plate A3.2). The wasps appear to have chewed holes in the felt and formed nests. This doesn't appear to be a problem associated with traditional bitumen coated roofing felt. Any holes within roofing felt are likely to significantly reduce its functionality as a secondary weather barrier. Where bats or birds come into contact with breathable roofing membranes, they can also damage it causing it to leak, they can also significantly reduce the breathability of the felt in that location.

Plate A2.2. Damage to a breathable roofing membrane adjacent to a wasp nest
