## **STATEMENT IN SUPPORT OF TOWN AND COUNTRY PLANNING APPLICATION**

### **RE-SUBMISSION –SEPTEMBER 2013**

**This Statement is submitted in support of a Town & Country Planning application for the erection of a 3m high security fence and associated camera poles by Apollo Cradles Ltd.**

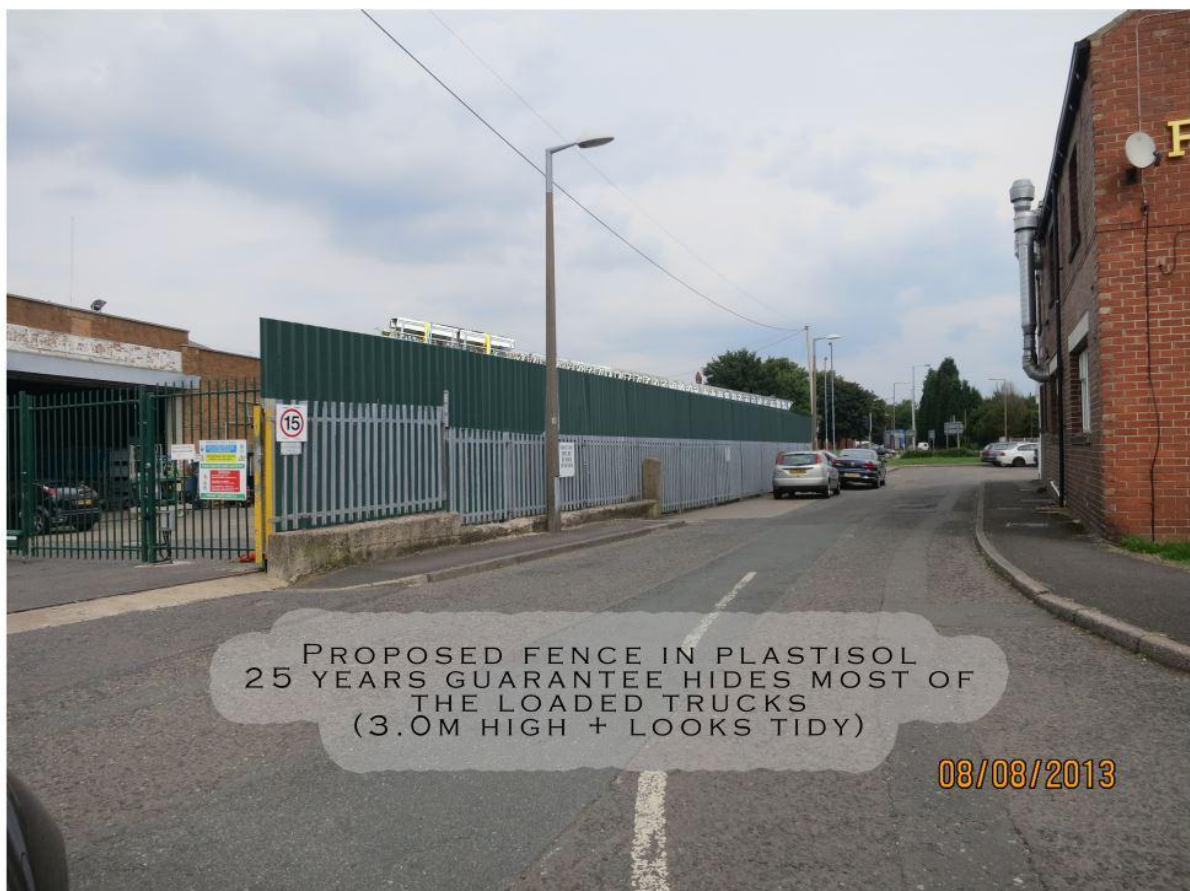
This is supplementary to the existing palisade and barbed wire perimeter fence.

The existing, low palisade fence alone does not provide adequate protection or security due to the clear vision it allows into the storage area from street level. It is too low to prevent the more efficient criminals who may use equipment to lift items over the fence.

The proposal is to replace the existing galvanised sheeting with profiled sheeting coloured dark green with Colorcoat® PVDF. This is a thin solution coating product that is particularly well suited to exterior wall cladding.

- Smooth 27 µm poly vinyl di fluoride stoved fluorocarbon coating offering good colour retention and stability.
- Galvanised substrate to BS EN 10346:2009 with a zinc metallic coating offering very good corrosion resistance.
- High performance reverse side backing coat.
