**Orchard View Care Home
39 Gawber Road
Barnsley**

Pre-development Arboricultural Report

29 October 2020

**By
Ian Kennedy
Wharnccliffe Trees and Woodland Consultancy**

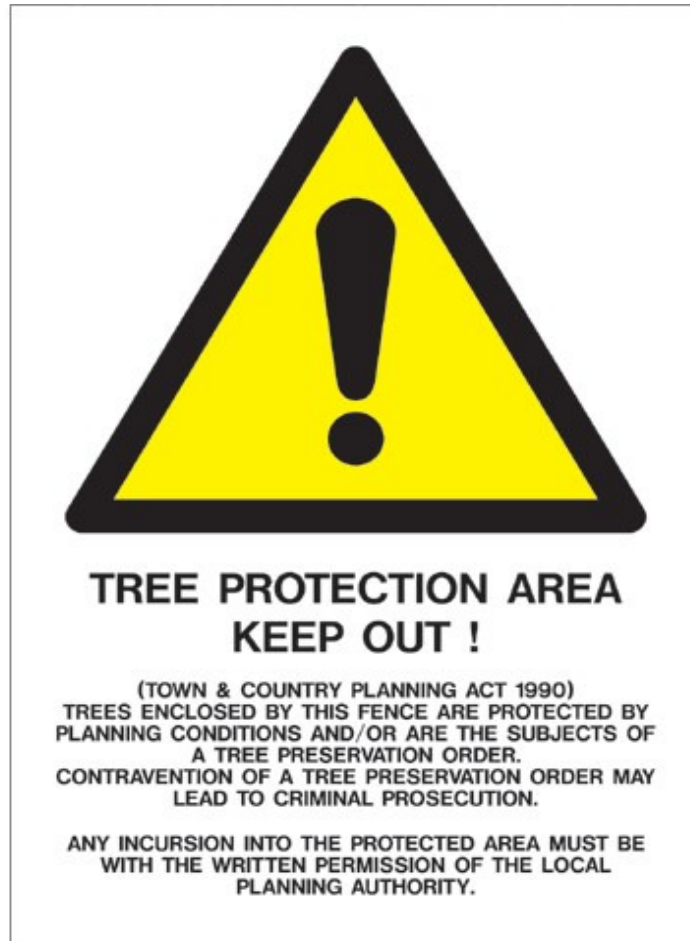
Example of a sign to attach to tree protective fencing
