**CAPE SITE SERVICES  
COAL MINING & GEOTECHNICAL  
CONSULTANCY**

Date: 26<sup>th</sup> April 2019  
Your ref: (S74 8JR)  
My Ref: SI 00208

**COAL MINING RISK INTERPRETATION REPORT – FOLLOWING THE SITE  
INVESTIGATION FOR PROPOSED RESIDENTIAL DEVELOPMENT AT LAND ADJACENT  
44 WILKINSON ROAD, ELSECAR, BARNSELY S74 8JR**

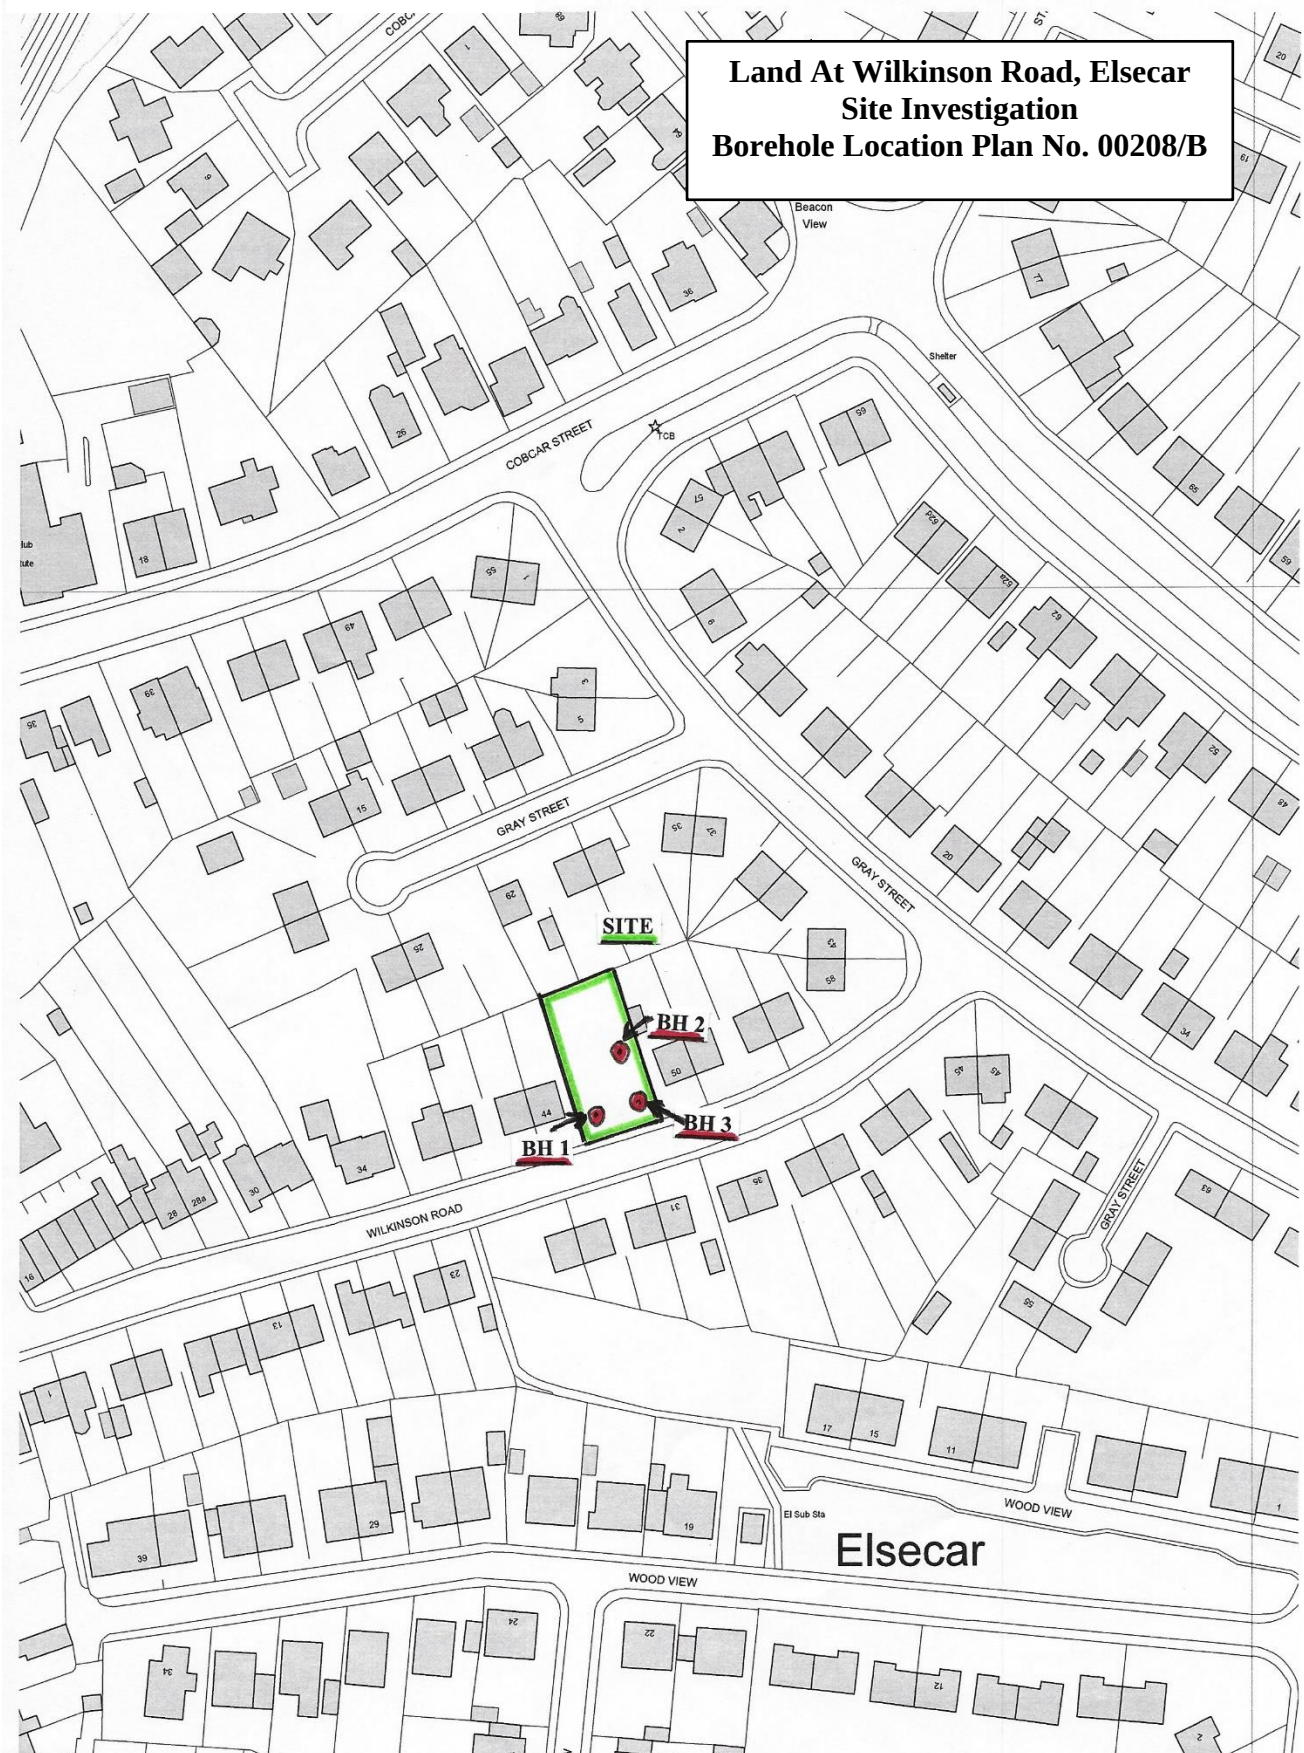
## 5.2 Borehole Location Plan

Planning permission is being considered for the development of two detached dwellings at the above location subject to the mining legacy risks been fully realised and mitigated from on site, if necessary. Cape Site Services has now undertaken this work via an intrusive site investigation of 3 boreholes, the locations of which are outlined on plan no. 00208/B – as illustrated in appendix 5.2.

Prior to the intrusive site investigation a search for utilities was undertaken both via online data providers and physically on site using a Cable Avoidance Tool (CAT). Boreholes were marked out with tape measure from boundary lines as illustrated on plan no. 00208/B outlined in appendix 5.2, where boreholes to investigate the coal seam are marked as 'BH'. As part of the mine entry watching brief, a pre survey was undertaken with no visible evidence of any uncharted mine entries. The process for the intrusive coal seam investigation is outlined via the system chart in appendix 5.4.
