MINING RISK ASSESSMENT

177 High Street, Royston, Barnsley, S71 4RR

REPORT: 26036-MRA

DATE: JUNE 2026

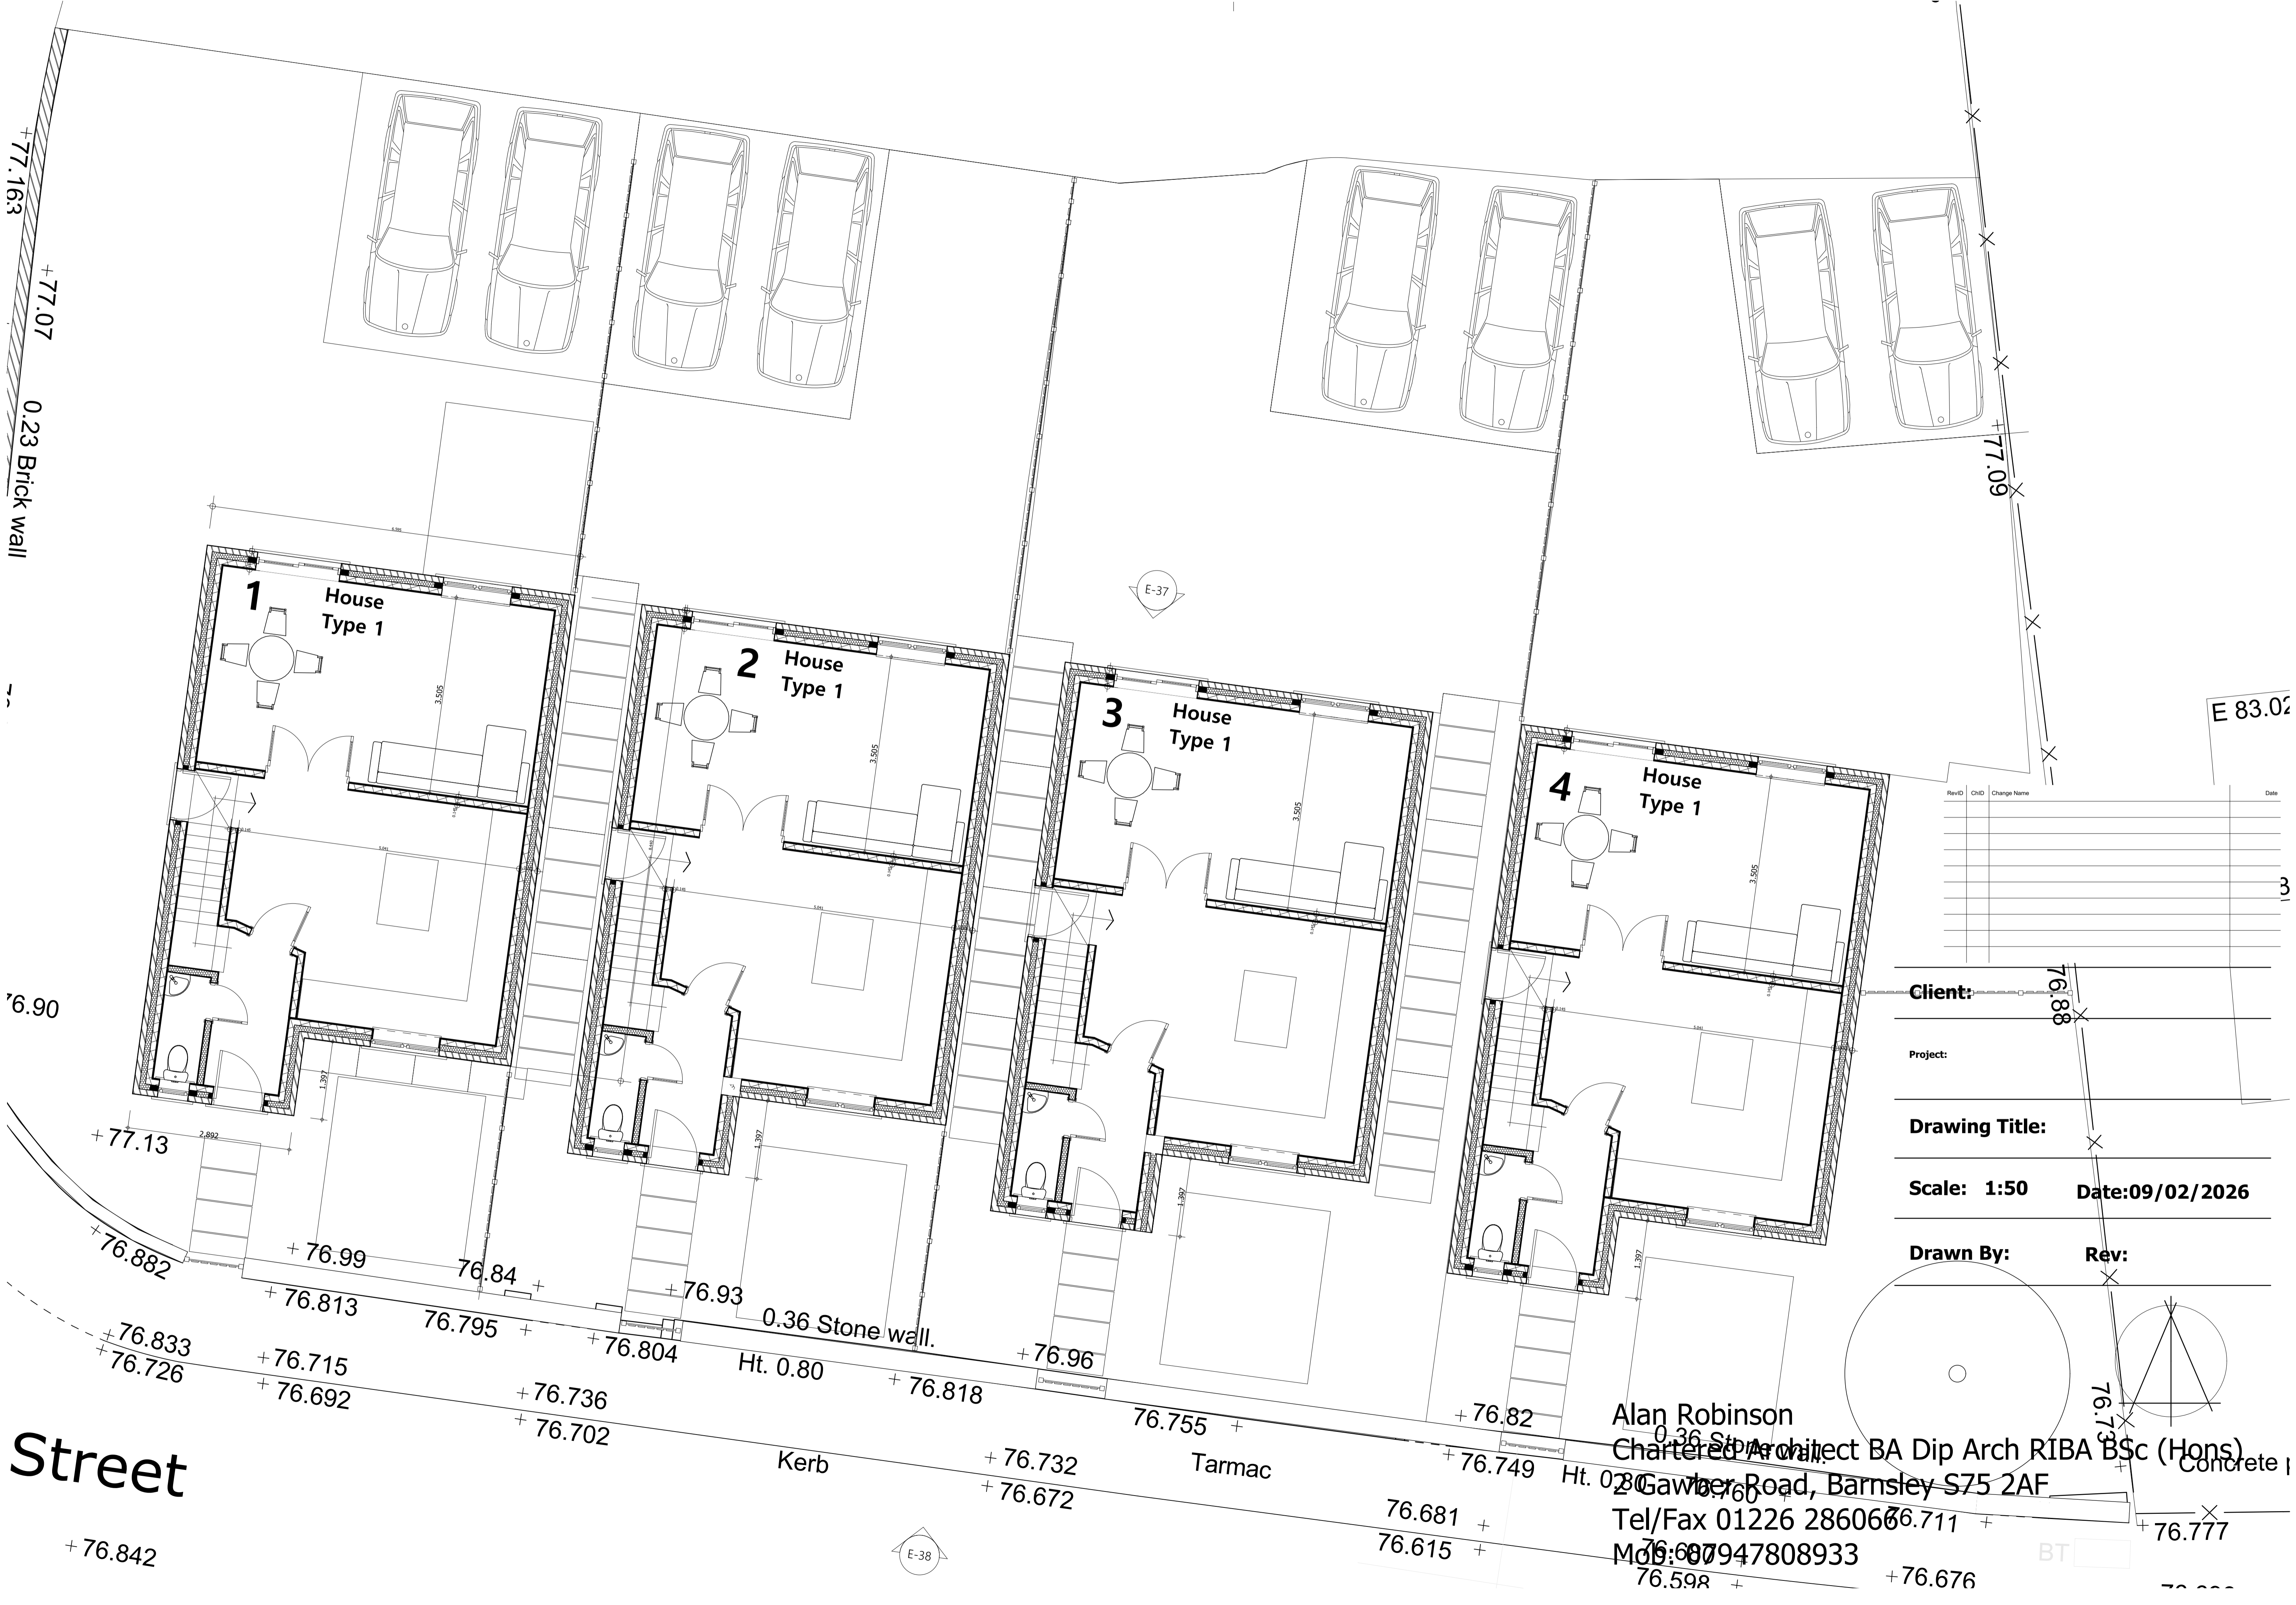
0.23 Brick wall

0.36 Stone wall.

When writing this report we had been provided with a proposed development plan. We understand that the proposal is to construct six new build properties at or around existing ground levels. Although not confirmed we'd assume that the loadings will be less than 100 kN/m. Some modification to the comments and recommendations provided may be necessary if different loadings or a different type of development is proposed.
