job number J3943/17/E	site address Land off Bismark Street
date June 2017	Worsbrough Common,
written by C. E. Mason	Barnsley,
checked by R. A. Palmer	S70 4NA
	issued by C. E. Mason

Report on a Coal Mining Risk Assessment

Location: Land off Bismark Street
Worsbrough Common, Barnsley, S70 4NA

Report No. J3943/17/EDS

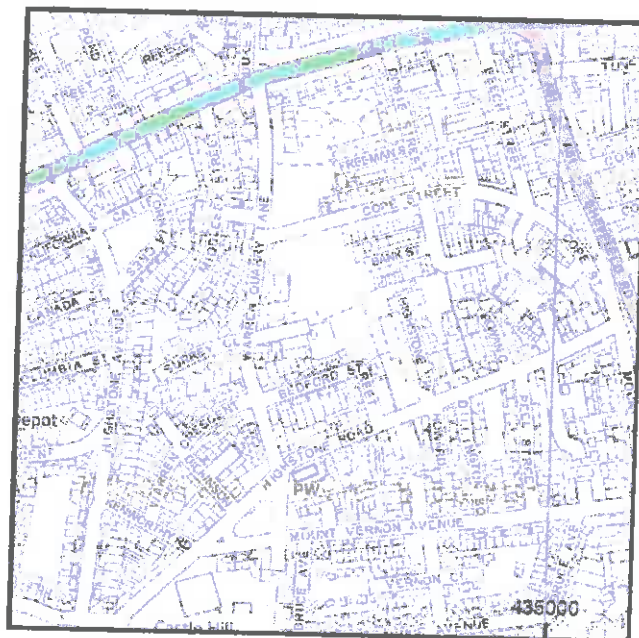
Approximate position of property
