### CONTOUR HOUSE

GUYDER BOTTOM FARM - DESIGN OVERVIEW

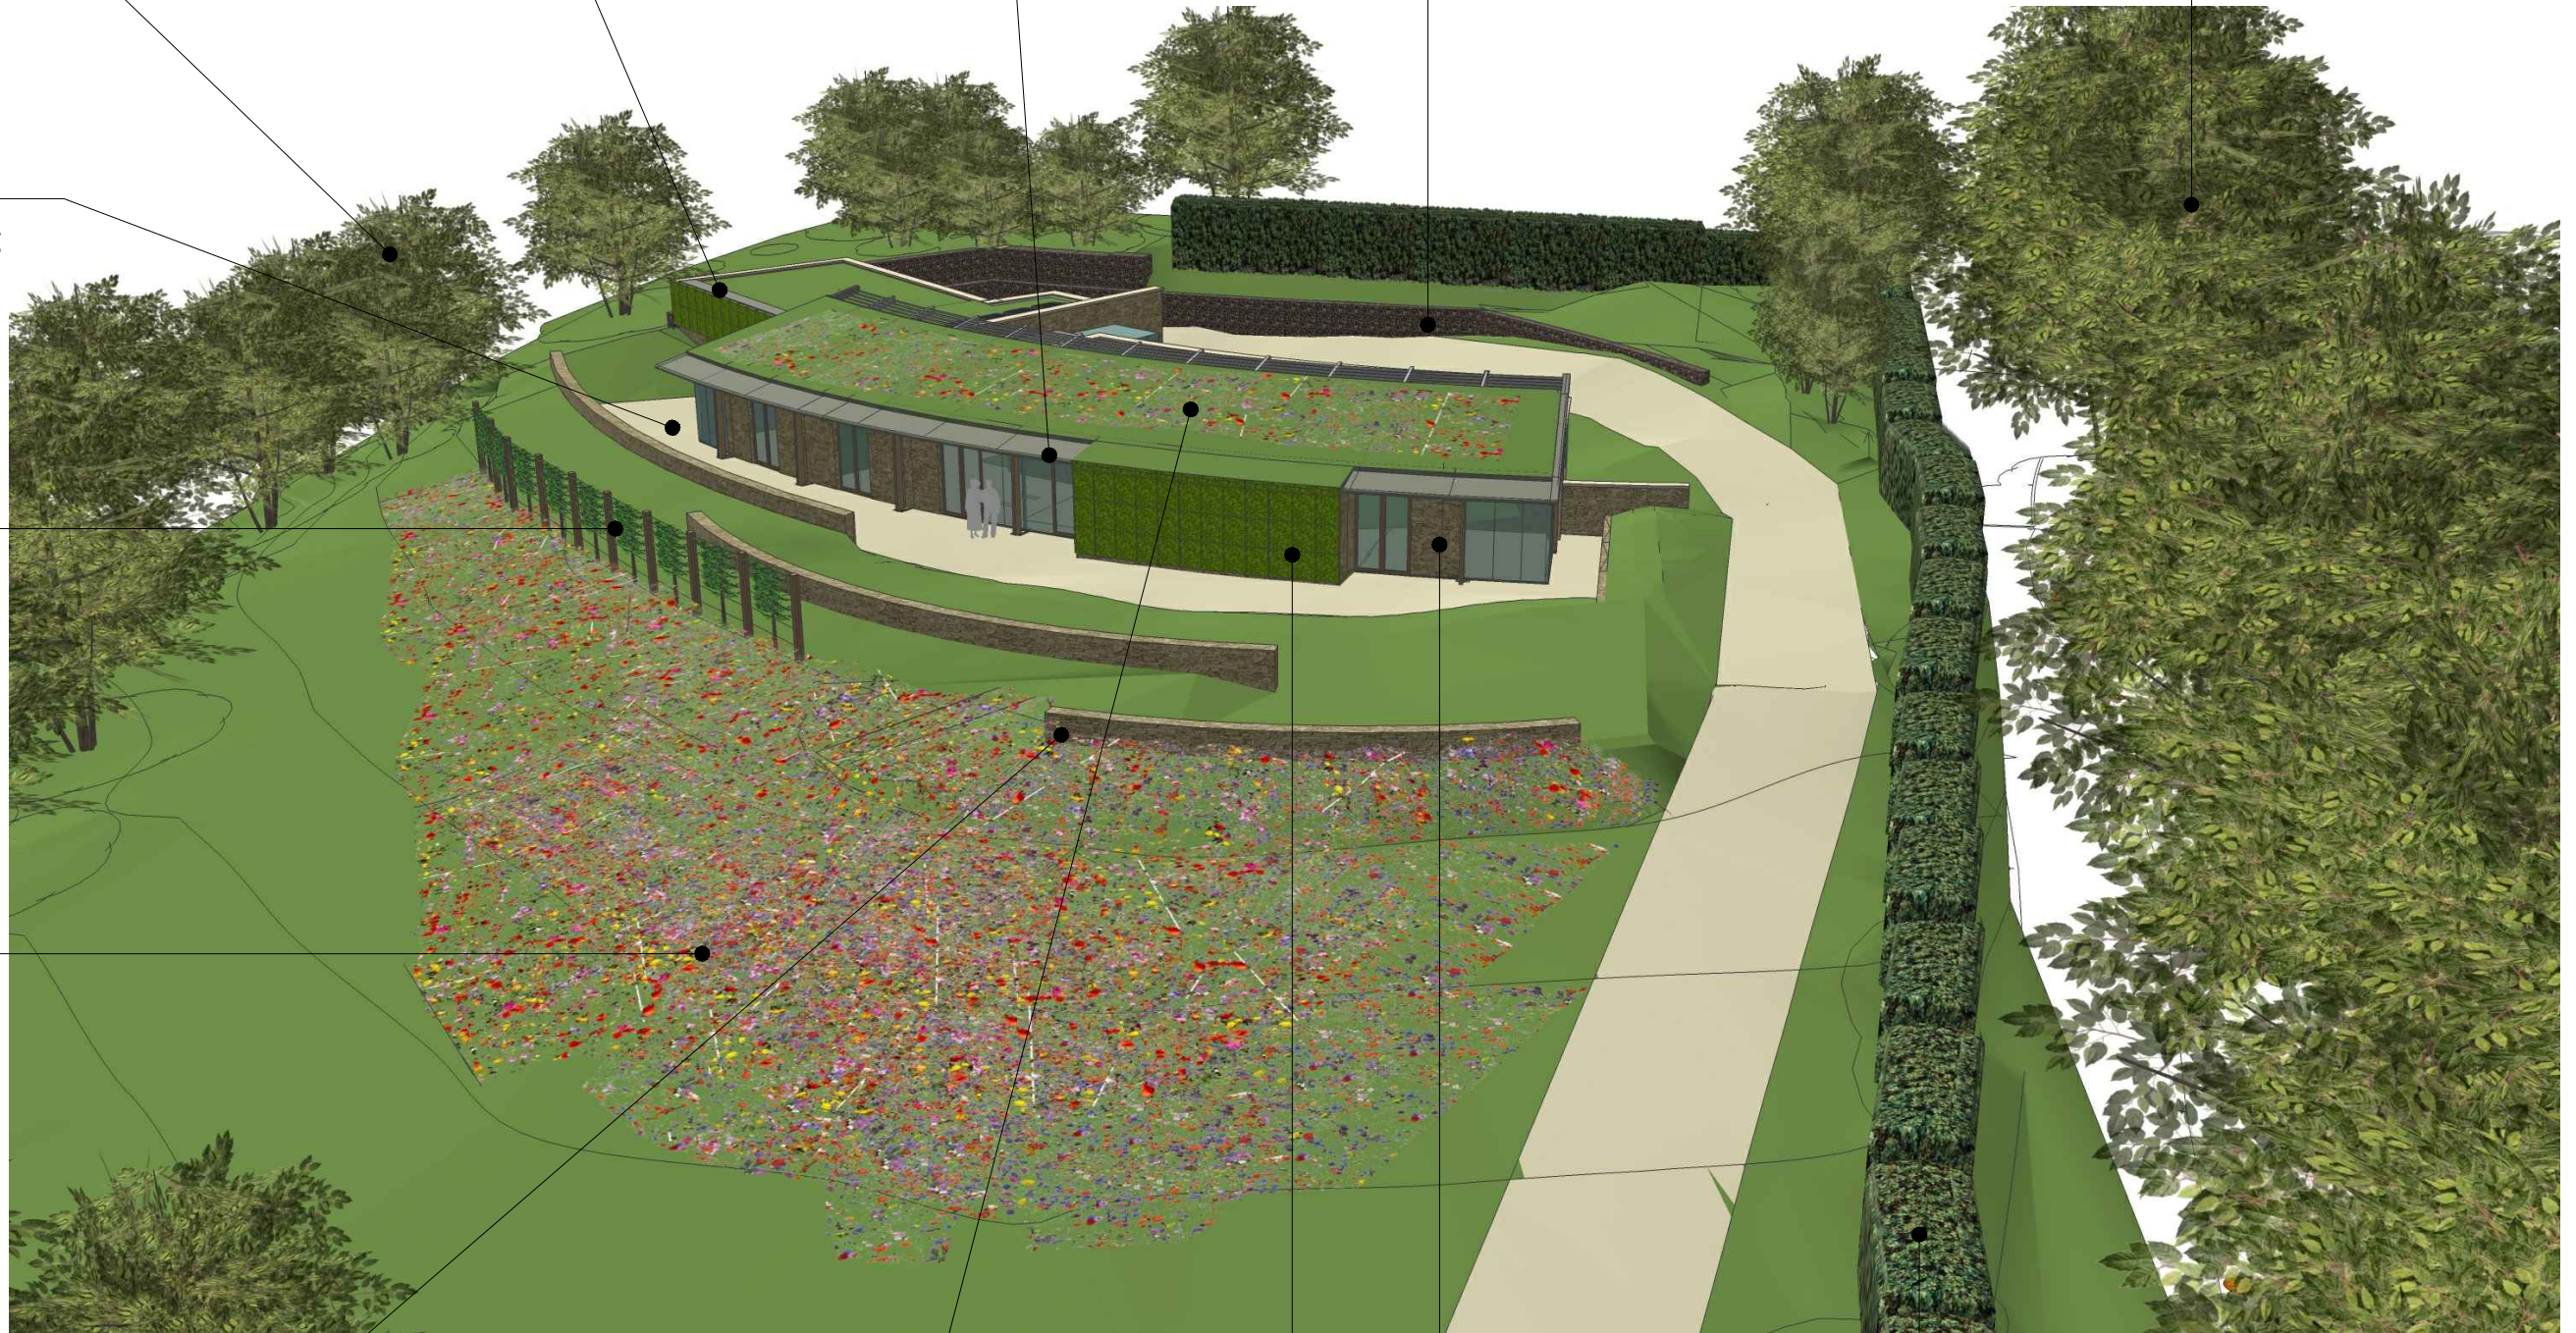
Existing trees and hedges to East boundary providing dense screening

Green living wall to external wall of garage

Low eaves line at front of house to reduce visual impact

Stone gabion walls at rear of site to allow house to be set low relative to existing levels at top of site and 'sunk' into the landscape.

Existing trees beyond West boundary

External terrace area with natural stone paving  
Level lawned areas in immediate curtilage of house.

Espalier fruit trees to provide screening to house and external terrace areas

Existing levels preserved and land planted with indigenous wild flowers in naturalistic pattern

Dry stone walls constructed to follow contours of site and to provide screening to proposed house

Green roof with grass surface, sown with indigenous seed mix and plug planting to replicate local environment. Curved monopitch roof slope to imitate the topography of the site

Green living wall to front of house

Dry stone wall cladding to external walls

Existing hedgerow retained to West boundary
