ARBORICULTURAL REPORT

to BS 5837:2012 at:

***Hoyland Road,
Hoyland,
Barnsley
S74 0AP***

Reference: AWA7420

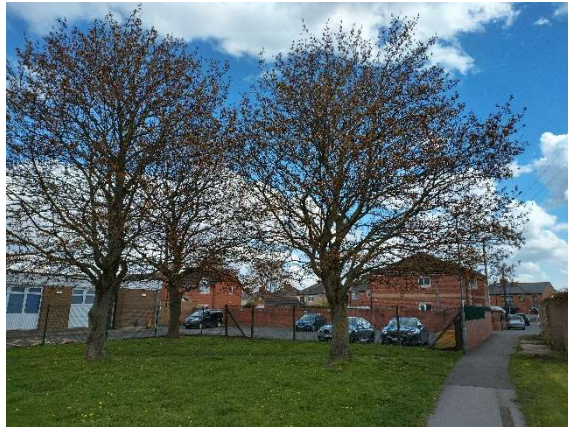
Photo 1: T1 – T3 from northwest

- 3.2.2 The site itself contained no arboricultural features of note; however, three trees were surveyed on adjacent land to the north.
- 3.2.3 T1 – T3 are all early-mature, category 'B' Norway Maple situated on a patch of grass between the site and the police station to the north. Trees are all prominent within the local area and in good condition.

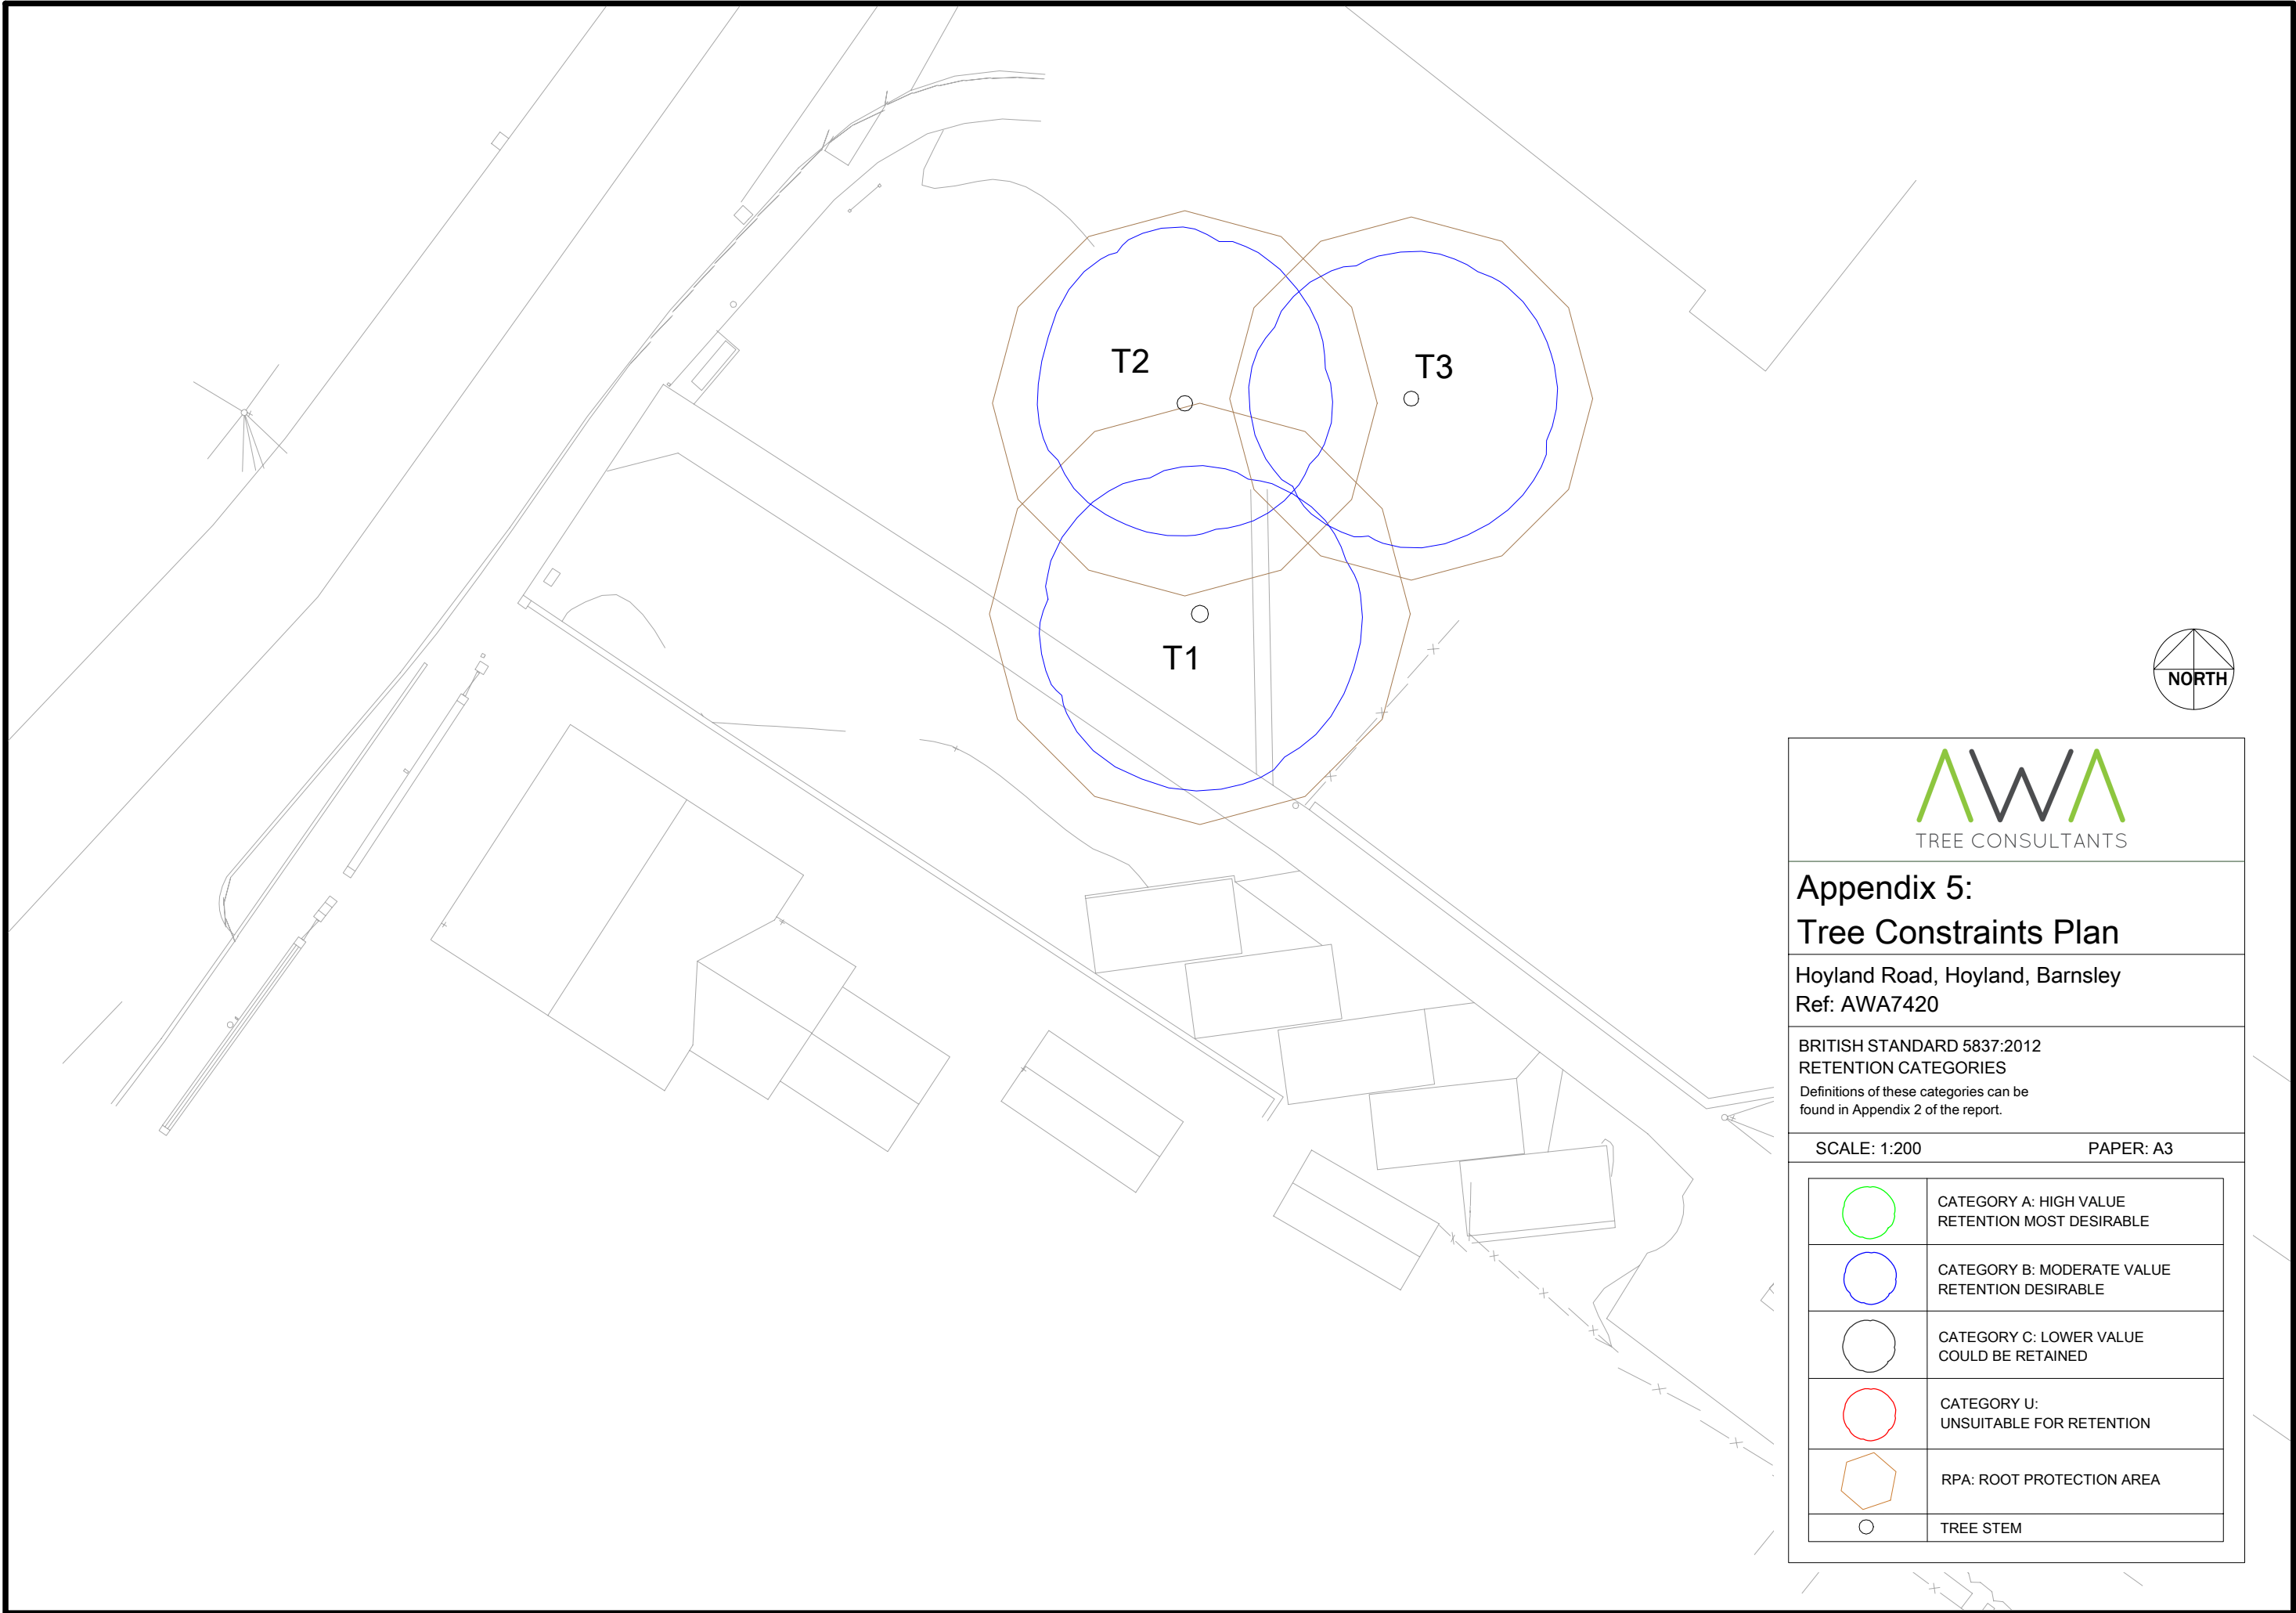
**Appendix 5:
Tree Constraints Plan**

- 3.2.4 The tree Root Protection Area (RPA) for each tree has been plotted as a polygon centred on the base of the stem. Due to the presence of roads, structures, topography (and past tree management) the RPA is likely to be a simplified representation of the tree roots actual morphology and disposition. However, detailed modifications to the shape of the RPA would largely be based on conjecture and so have been avoided.

- 3.2.5 T2 and T3 are located on adjacent land to the north and are sufficiently offset from the site boundary such that they are unlikely to be directly affected by a proposed development. Their Root Protection Areas (RPAs) do not extend into the site and any indirect impacts are expected to be minimal.

- 3.2.6 T1 is positioned closer to the site boundary, with both its crown spread and a portion of its RPA extending into the site. As such, T1 presents a potential constraint to development and should be given due consideration during the design process to ensure that any encroachment within its RPA is avoided or appropriately mitigated.

- 3.2.7 A footpath is present between the trees and the site, which is likely to have influenced root distribution. This may reasonably reduce the extent of rooting towards the site; however, the plotted RPA should be treated as a precautionary constraint.

- 3.4.4 The tree Root Protection Area (RPA), detailed on the Tree Constraints Plan at Appendix 5, should be used as a layout design tool, to inform on the area around a tree where the protection of the roots and soil structure is treated as a priority.
