# St John's Church, Penistone

## Heritage Impact Assessment

October 2022

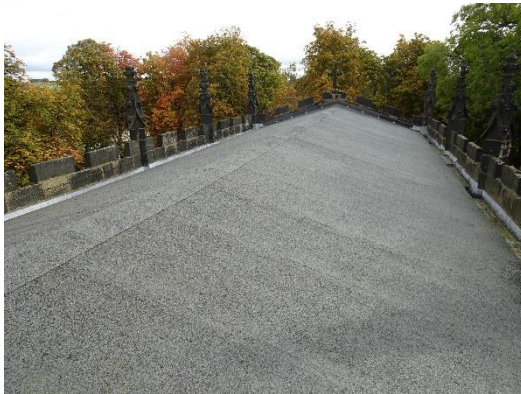
Felt roof covering to the Nave

In September 2007 the lead roof covering to the north and south slopes of the Nave was stolen leaving only the lead gutters in place. Following the theft, the roof was temporarily covered with bitumen felt.

While the bitumen felt roof covering is still performing, the material has a limited life expectancy, the PCC are keen to undertake works to replace the felt with terne coated stainless steel the safeguard the future of this well used building.

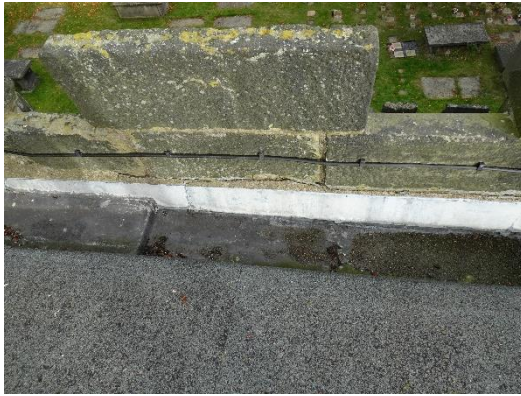
Lead gutters and outlets remain in place.

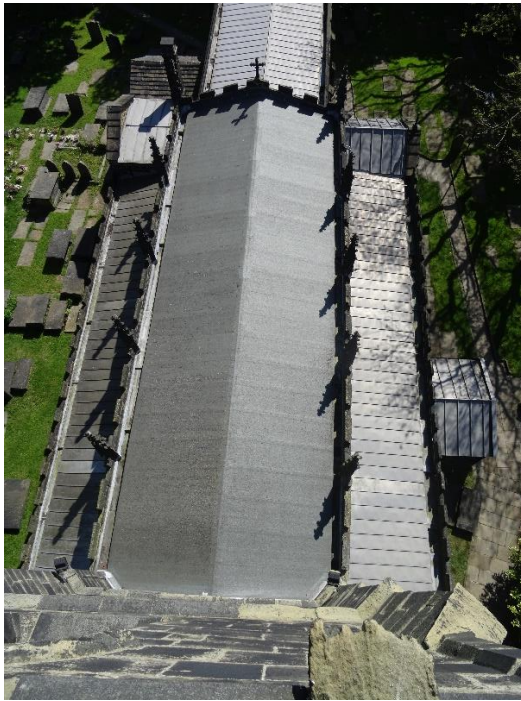
Nave roof viewed from the Tower

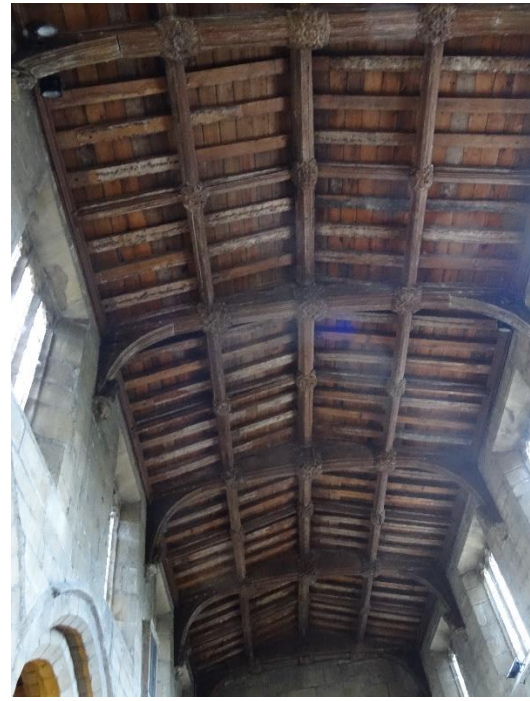
Exposed Nave roof structure (14<sup>th</sup> Century)

Interior: 6-bay arcades on alternate round and octagonal piers. Good nave roof, arched-braced to figure-head corbels and with elaborate bosses (c1375). Octagonal bowl-shaped font on square pedestal. Monuments in chancel, north side: 1708 shaped marble tablet with scrolled

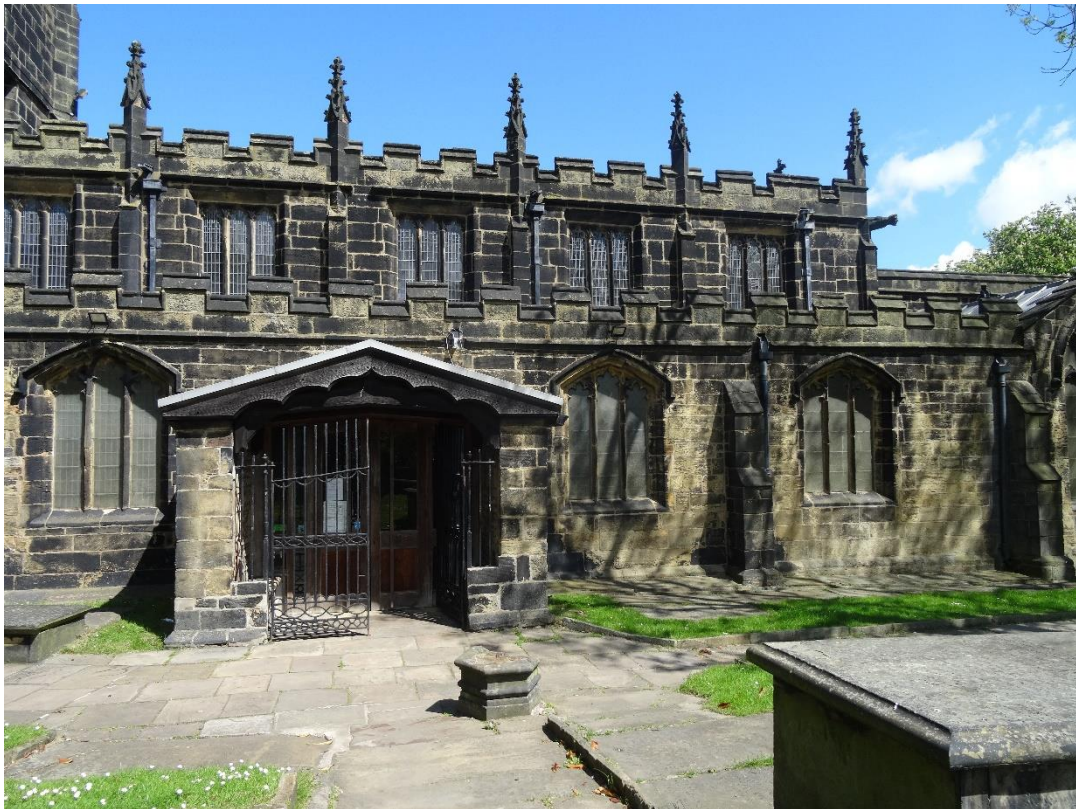
Nave roof is hidden by the parapet walls to all sides.

The use of solid rolls will ensure that new covering retains visual similarities with lead. The use of stainless steel will have a neutral impact on the historic value of the building. The roof can only be glimpsed over the parapet and therefore the terne coated stainless steel will have minimal visual impact.
