CANNON HALL, BARK HOUSE LANE, CAWTHORNE, BARNSELY S75 4AT

WALLED GARDEN NORTH RANGE – CONVERSION TO TRAINING ROOM

SLIP GARDEN – STORAGE UNITS

DESIGN AND ACCESS STATEMENT

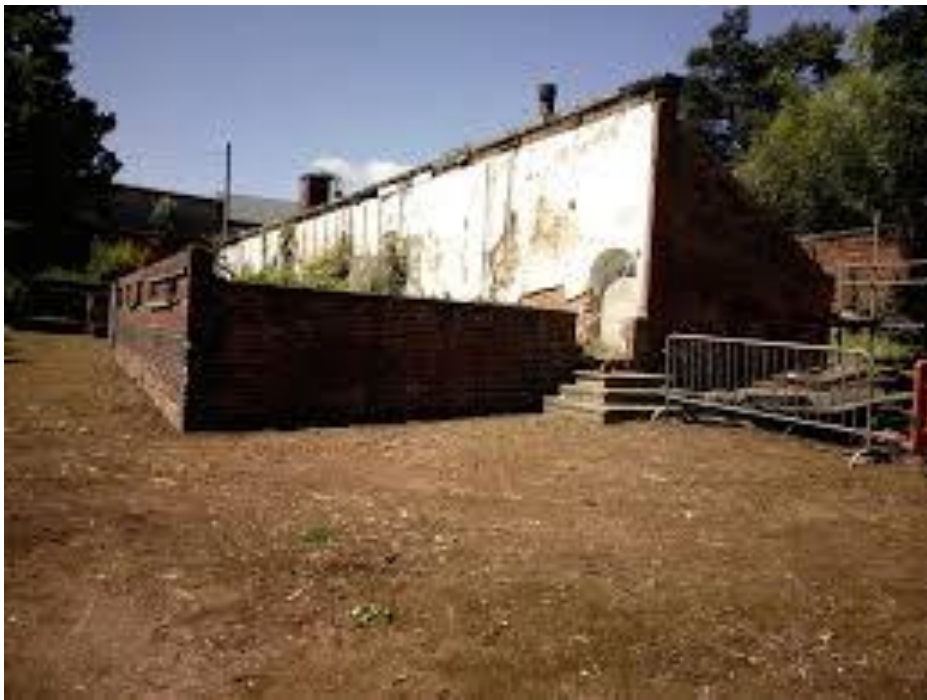
SOUTH EAST VIEW PRIOR TO REPAIR OF GLASSHOUSE TERRACES

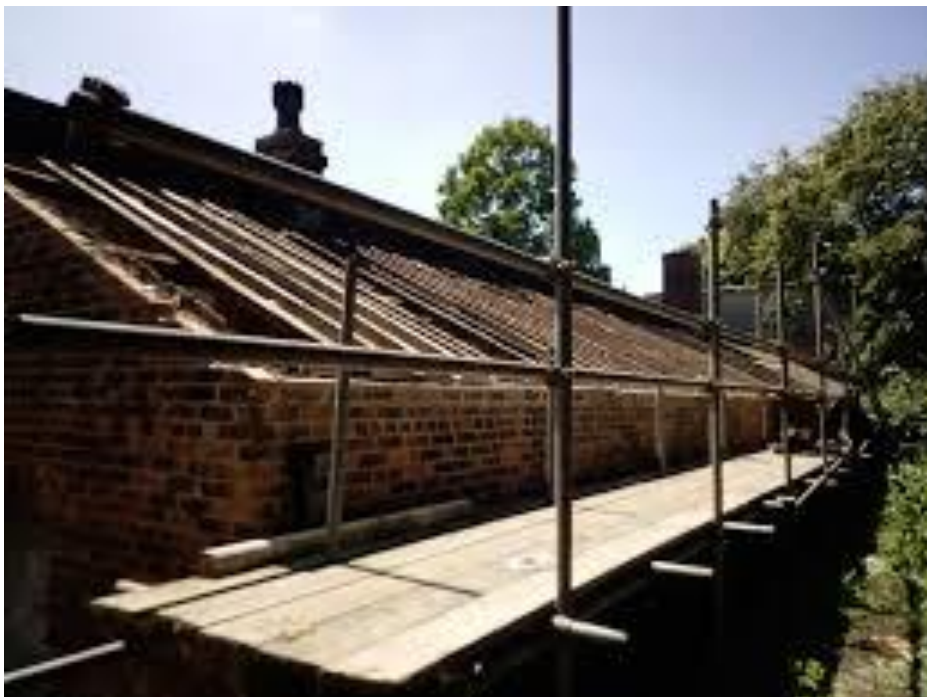
NORTH EAST VIEW OF ROOF UNDER RECENT REPAIR

- 9.1 Our developments at Cannon Hall are being monitored by Brookes Ecological Ltd. Previously completed work to the North Range to replace the stone slate roof and repair the windows were carried out under an existing licence. The building is now sealed, and little work is proposed to the external fabric.
