Coal Mining Risk Assessment

Parkside, Hoyland Common, Barnsley

October 2023

Client Name: Barnsley MBC
Document Reference: WIE20198-100-R-1.1.3-CMRA
Project Number: WIE20198

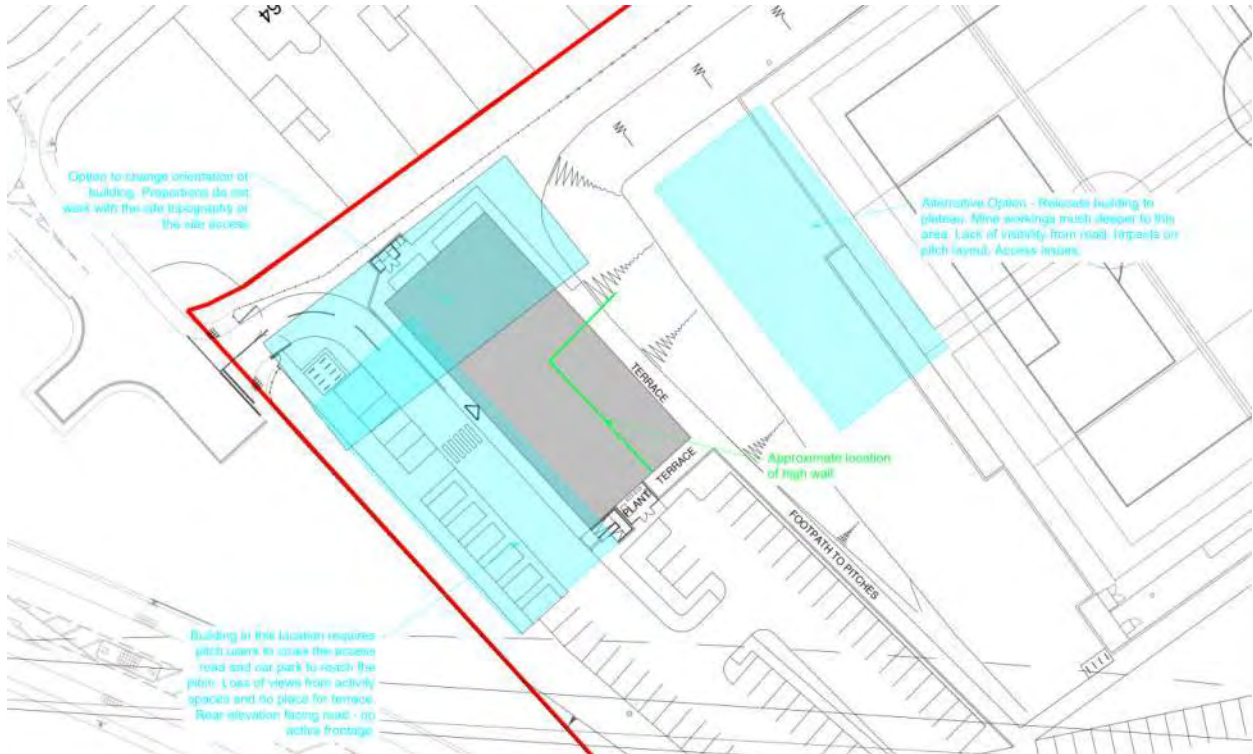
Figure 1: Initial design proposals

The pavilion building has undergone several design iterations in an attempt to locate the entirety of the build off the footprint of the backfilled opencast mine. A summary of the initial proposals is detailed below and in Figure 1.

The first option looked to position the building to the south towards Sheffield Road; however, this led to the pitch users having to cross the access road and car park in order to reach the pitches. Additionally, there would be loss of views from the activity spaces and no available space for the terrace. The rear elevation of the building would also face the road, with no active frontage.

The second option proposed that the building be orientated along the northern boundary; however, this would not suit the sites’ topography and restrict the access road coming onto the site.

The final option was to relocate the building further north, wholly onto the opencast backfill deposits where the mine workings are known to be at a greater depth. This would also create issues with regard to pitch layout and restrict visibility from the access road.

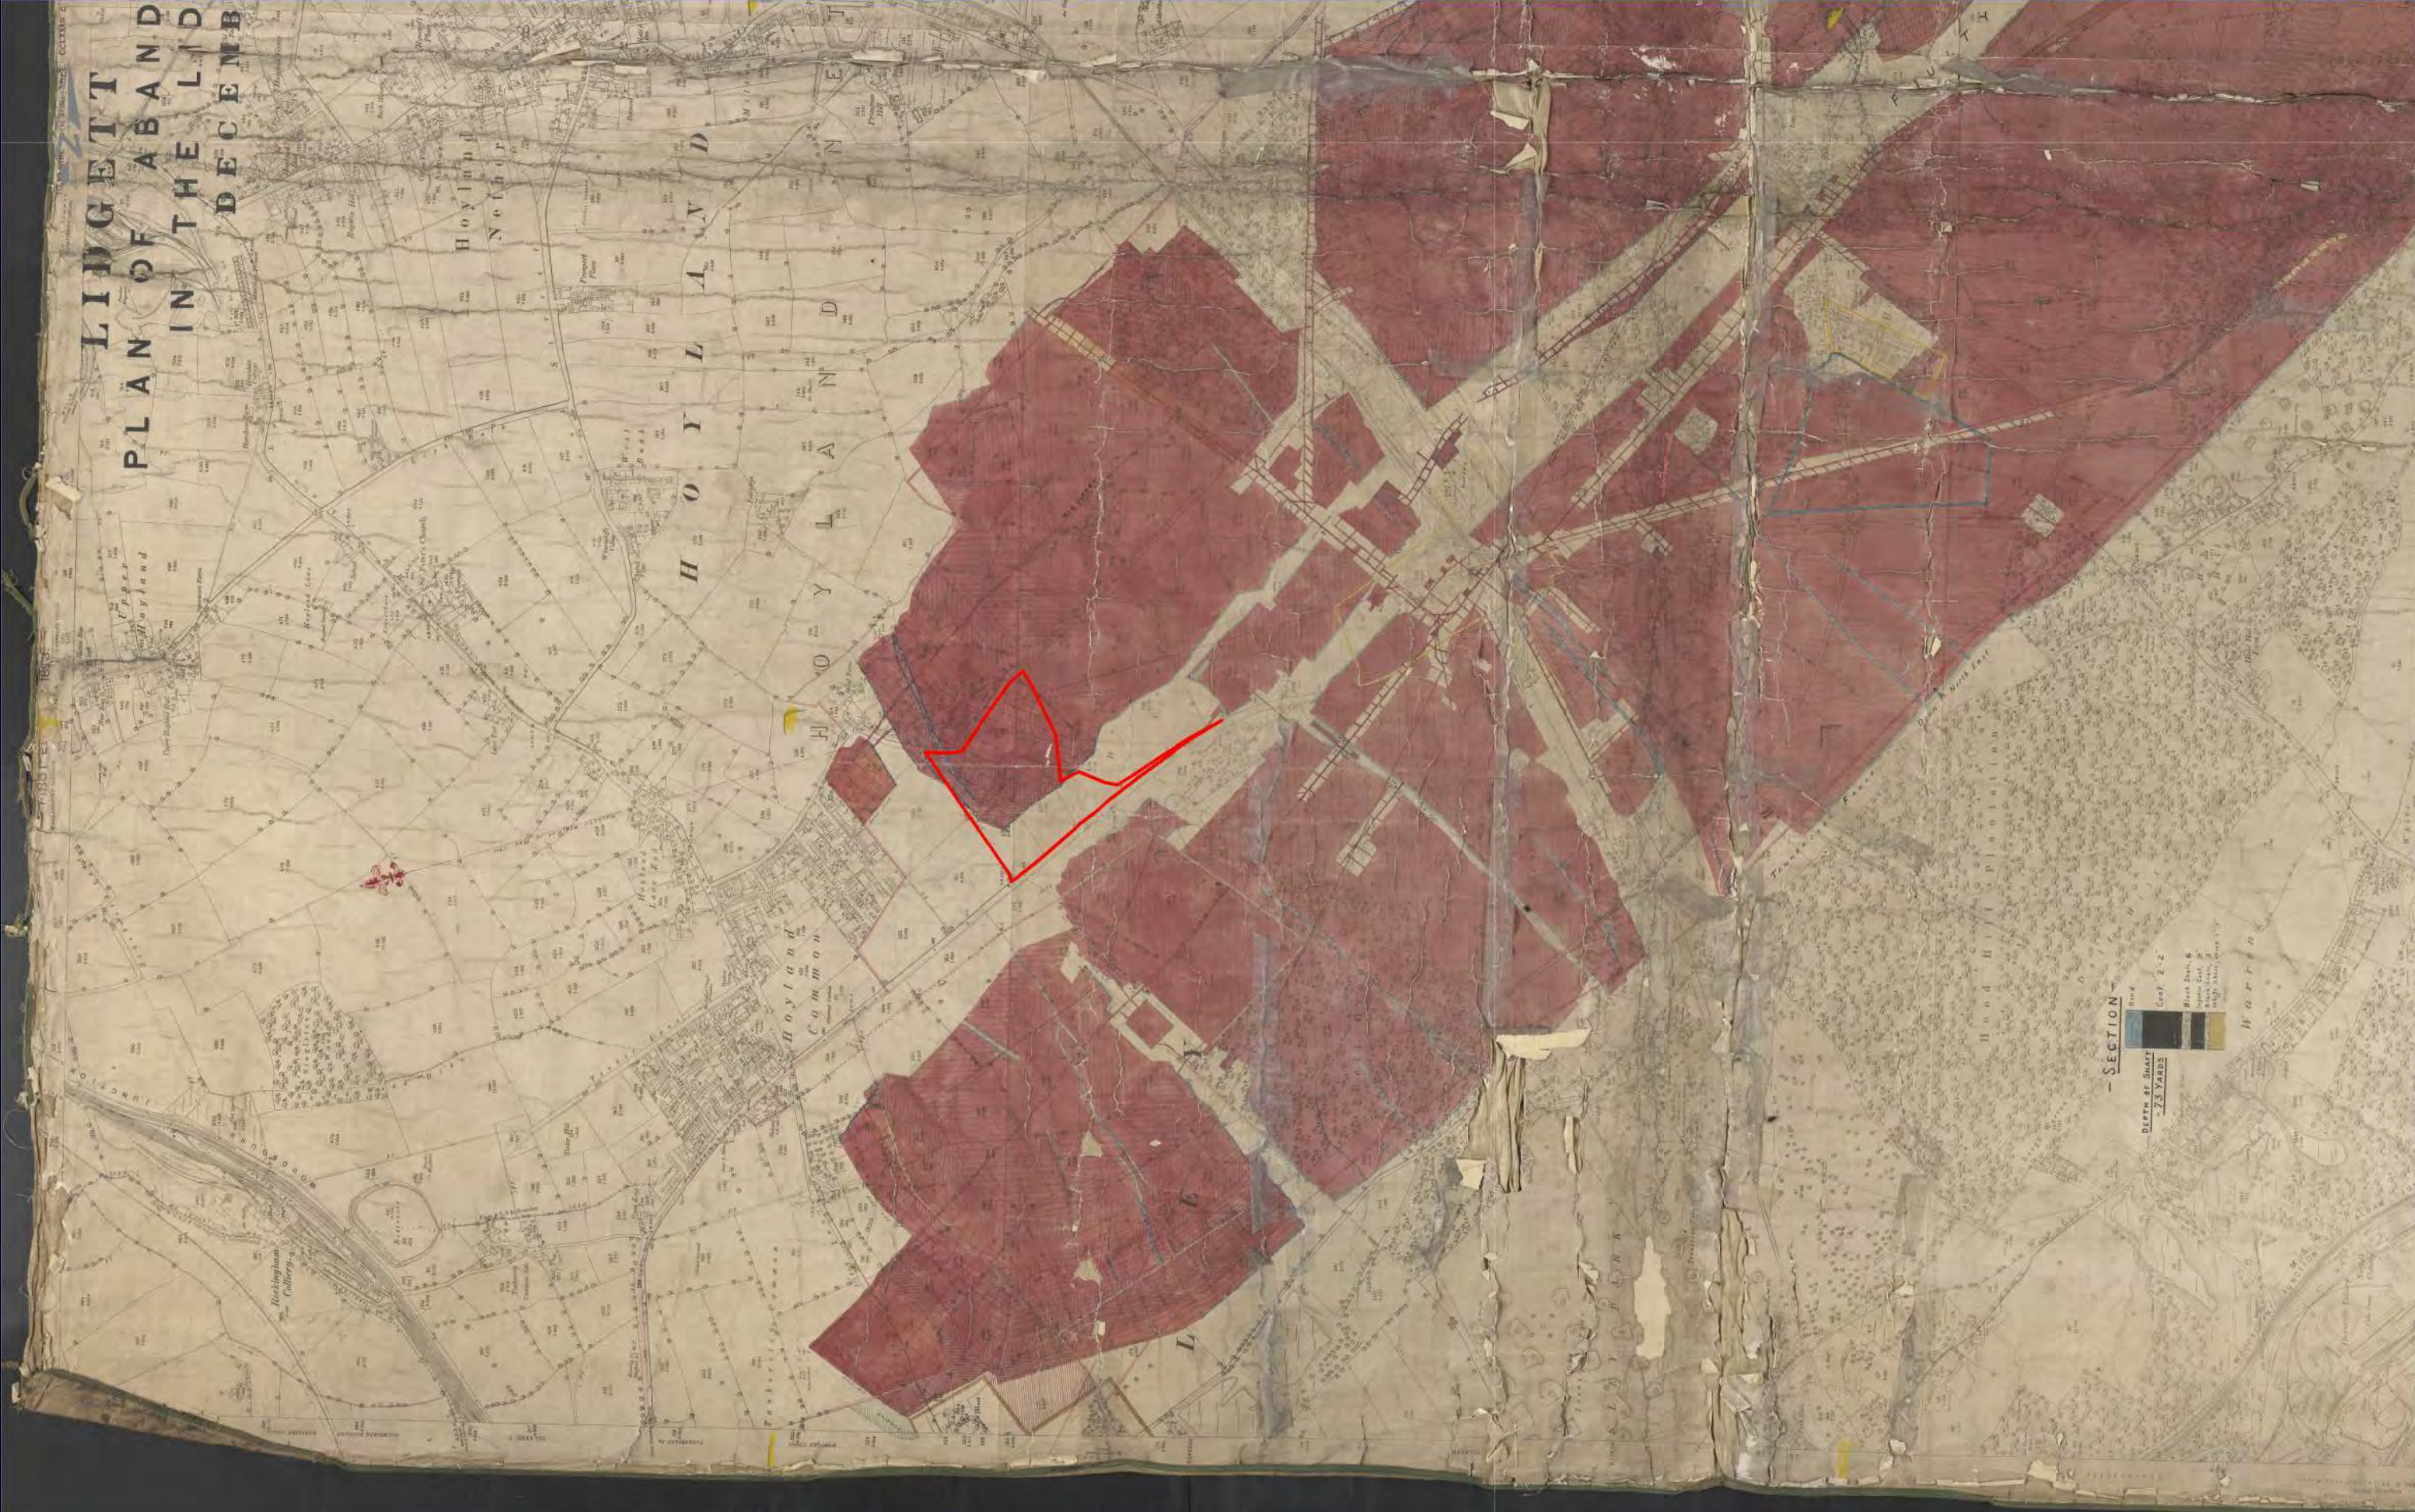
D. Overlain Mine Abandonment Plans

Catalogue No. M796 Sheet Info:	
Date: 20/08/2020	Scale: 33 YARDS TO 1 INCH (1 TO 1188)
Database Right and Copyright The Coal Authority 2003. Unauthorised Use Prohibited	
Data Provider: The Coal Authority 2003. Licence: www.coal.gov.uk
