| Project: | Cannon Hall, Cawthorne | | Job No. | Calc Sheet No. |
| | | | 19399Y | SK03 |
| Part of Structure: | Plunge Pool - existing | | Date | Calc By |

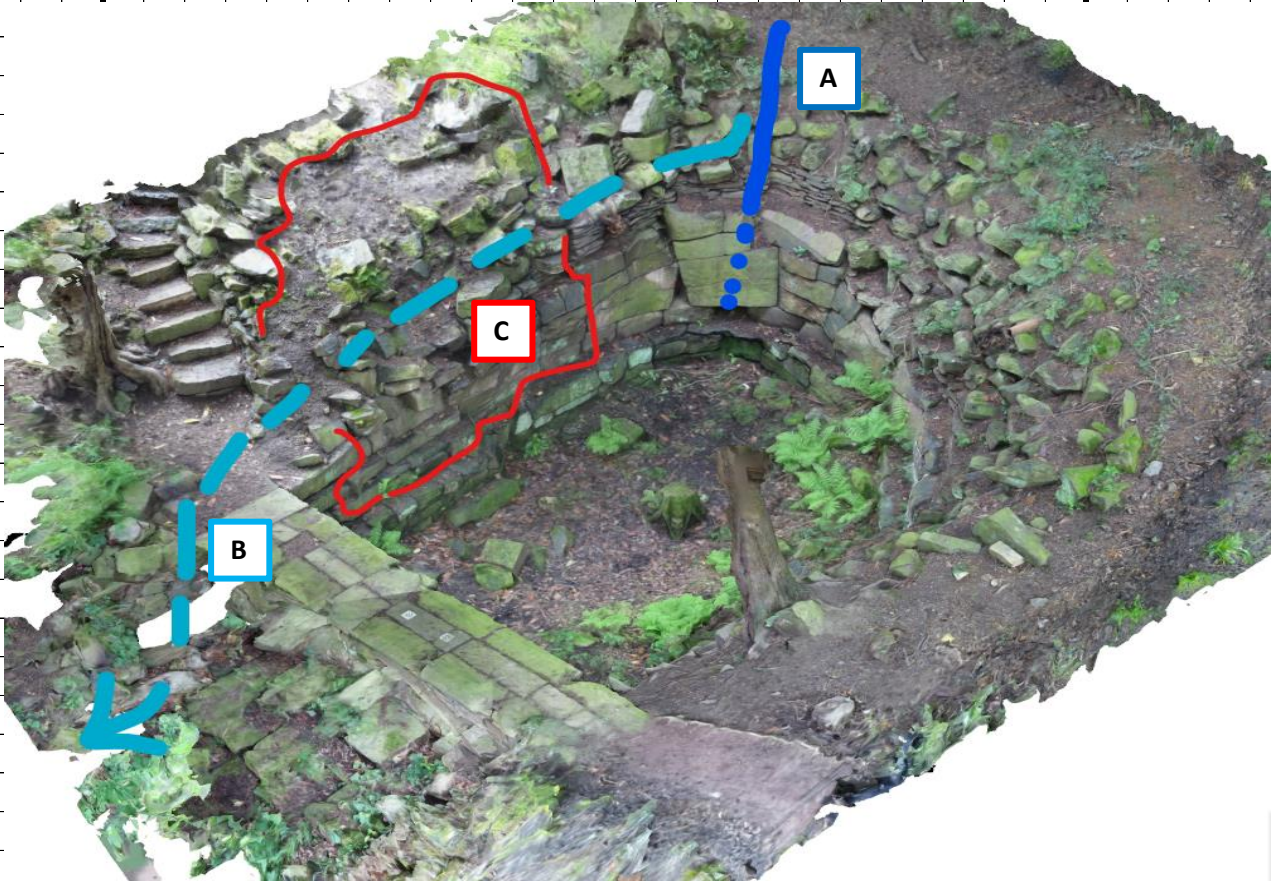
| A | Waling boards and scaffold props to be fitted across pool to prevent further movement of bank. |
| B | Prevent access to area immediately behind propped areas. |
| NB | Assumes source of water cannot be accessed, diverted or stopped.<br>Temporary works design by others. |

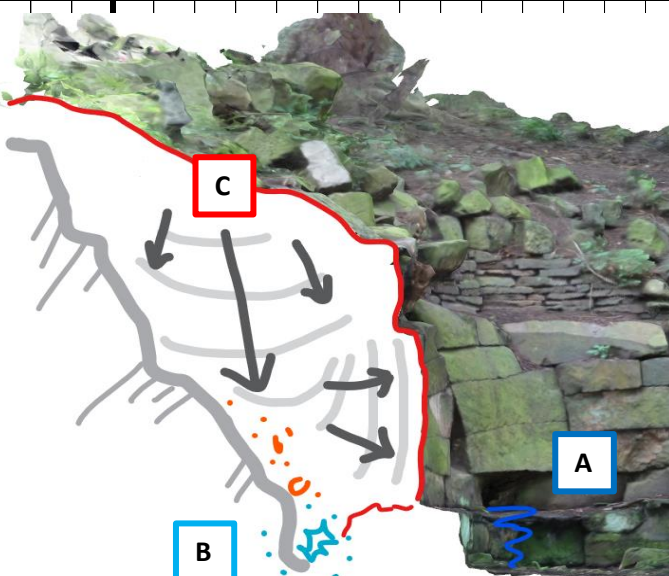
| <b>A</b> | Bank masonry to be carefully dismantled and rebuilt with suitable lime mortar. | | | | | | | | |
| <b>B</b> | New bank core, suitably benched onto solid material behind. Possibly rock fill, gabions or masonry - TBC with excavation. | | | | | | | | |
| <b>C</b> | Stone or concrete lintel to form culvert over assumed existing water channel, with geotextile over and suitably bedded into sound materials either side. | | | | | | | | |
