Construction Environment Management Plan (CEMP: Biodiversity)

Land South of Halifax Road, Penistone

Barratt and David Wilson Homes Yorkshire West

ER-4578-05-A

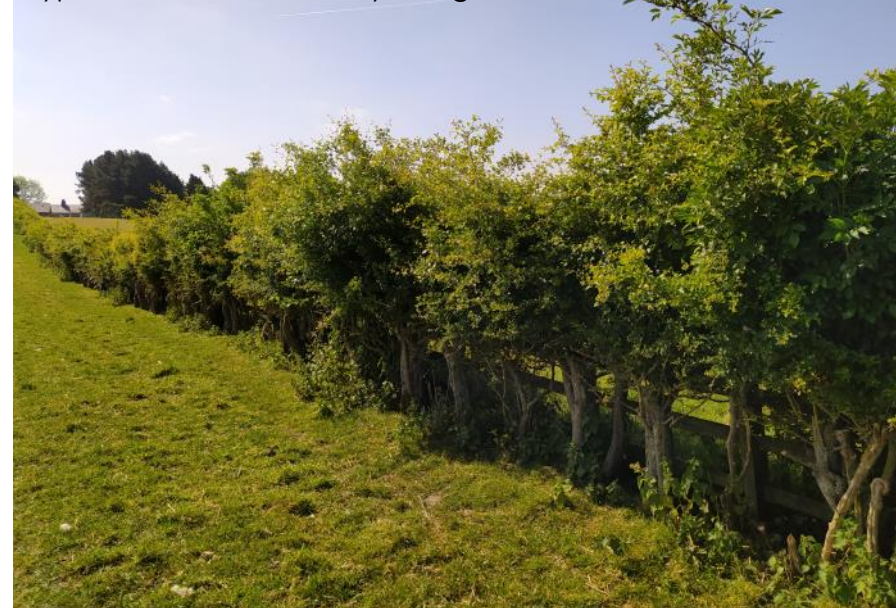
Typical view of boundary hedges

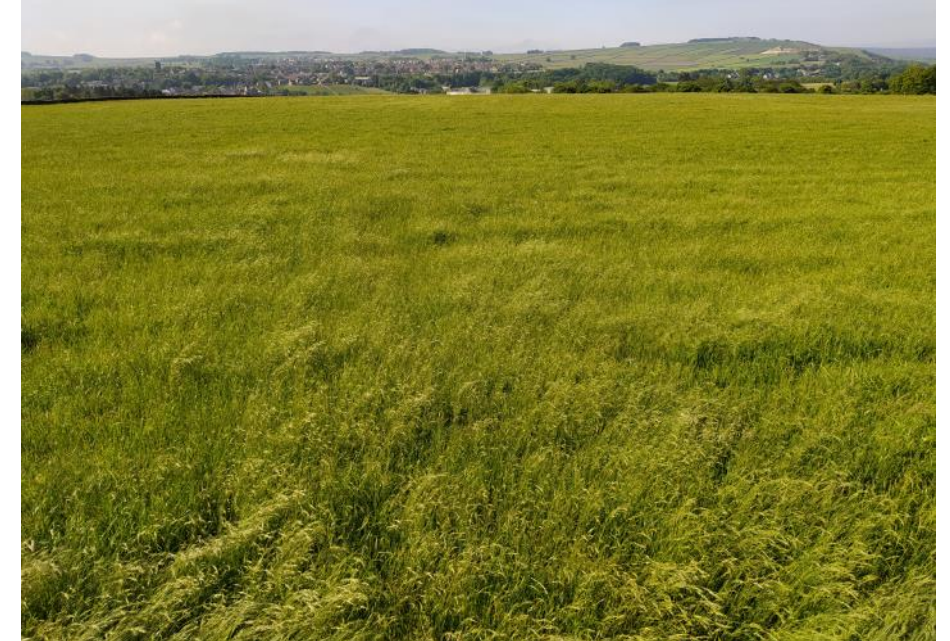
Typical view of the Site's interior—species-poor modified

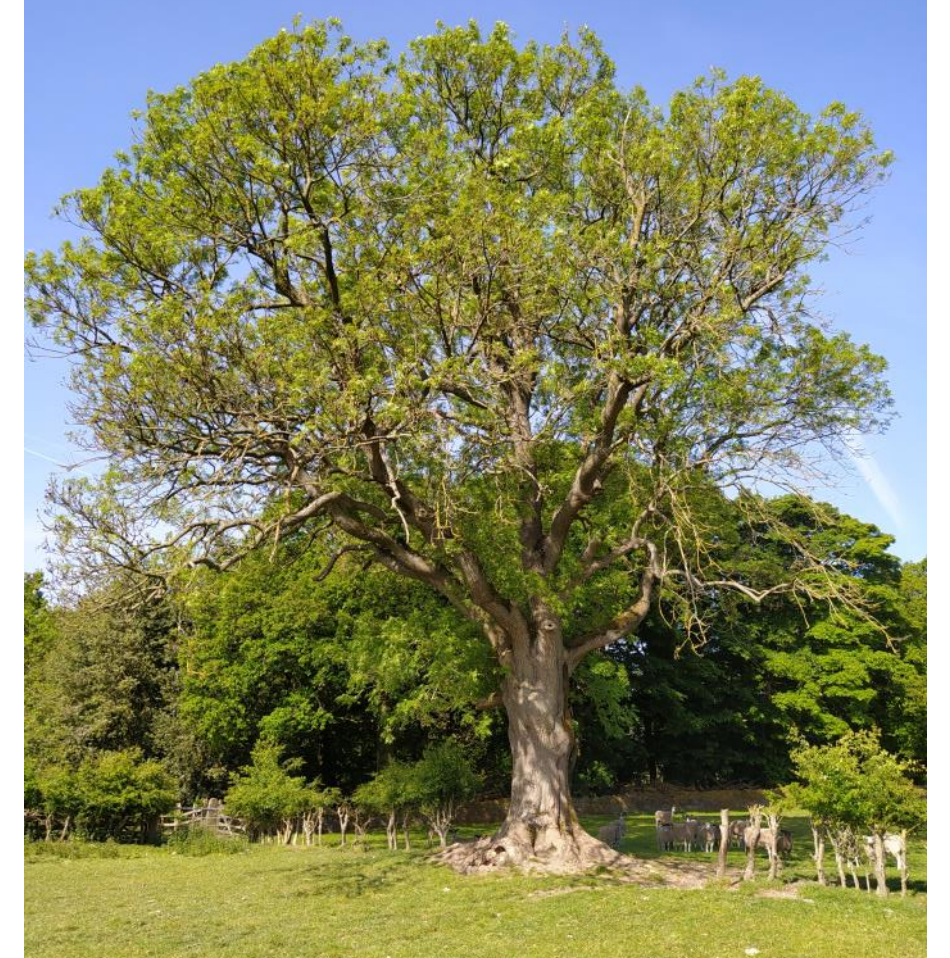
Veteran tree

The mature tree would qualify as a transitional veteran, and is of district level importance. It also contains features with bat roost suitability.

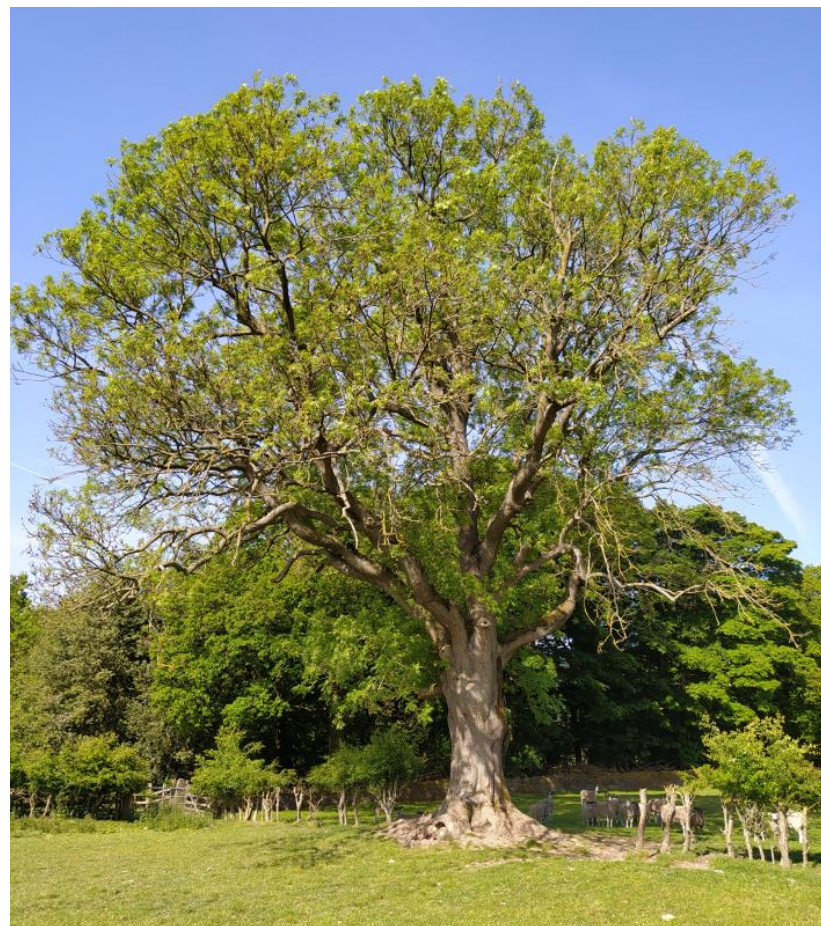
Control 2 : Barrier Fencing

A single mature tree within the southwest corner has been assessed as containing features with bat roost suitability. This tree will be retained on Site, but will need to be suitability protected during Site preparation and construction.

Fencing installed as per Control 1 will also act to protect this tree and all potential roost features.

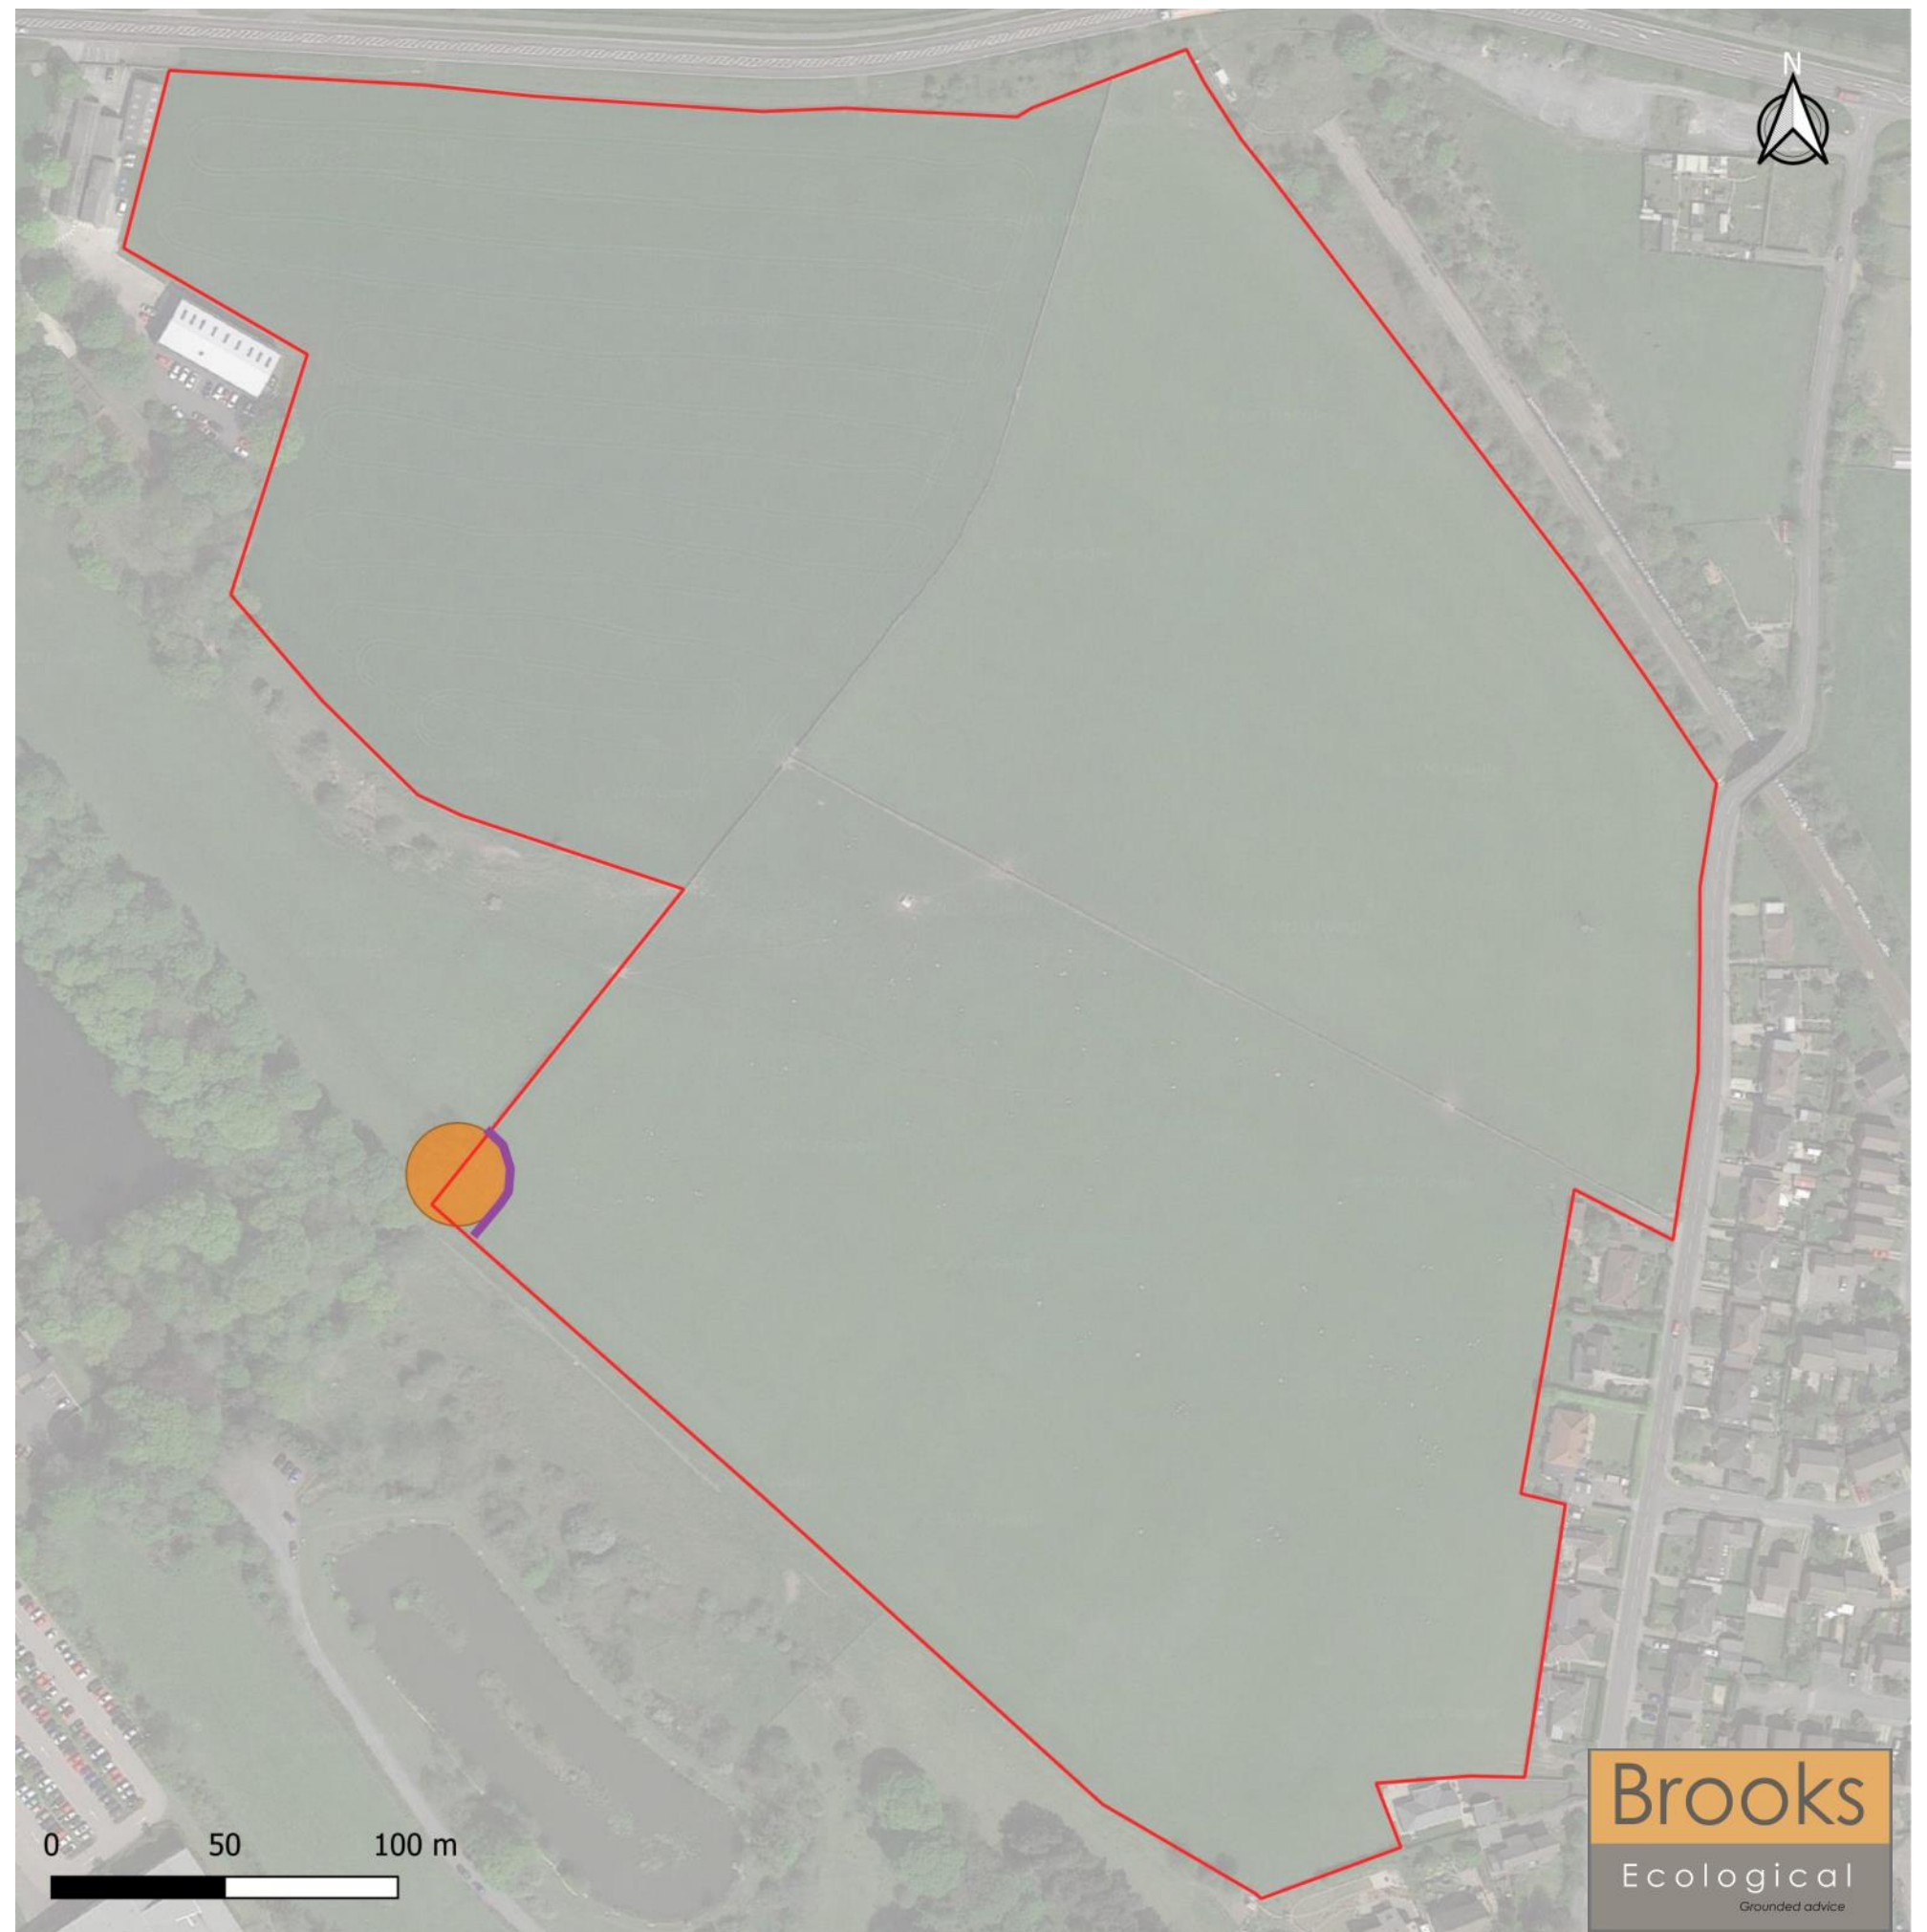
No tree works will be carried out on this tree, before first consulting a bat licenced Ecologist. Should remedial pruning works be required, further survey or investigation will first need to be undertaken to ascertain the status of roosting. Should roosting be identified, a Mitigation Licence from Natural England will be required prior to works commencing.

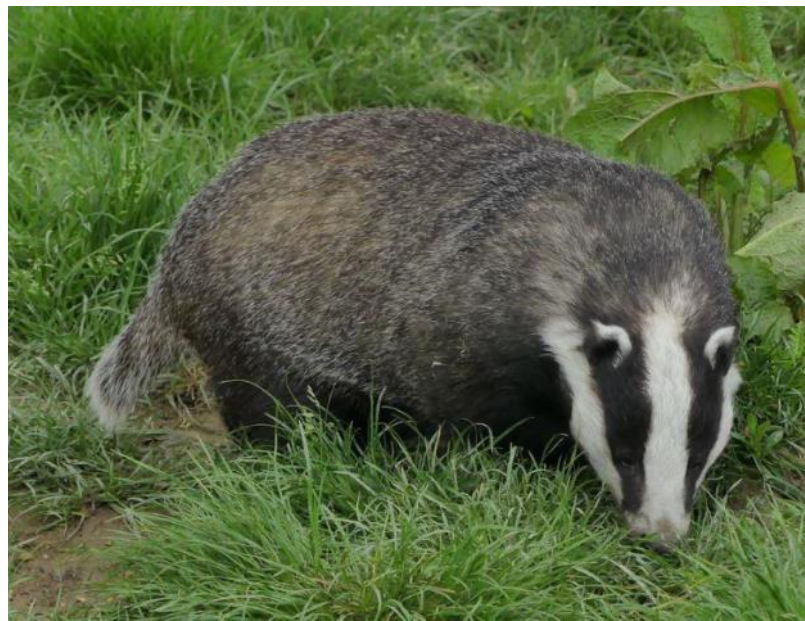
Control 3 : Survey and supervision

Survey: Prior to site clearance works commencing, the entire Site and surrounding suitable habitat within 30m will be re-surveyed for badger.

If a badger sett is found it will be marked out on the ground by the ECoW using temporary barrier fencing and pins and notices will be erected advising of a No Works Area.

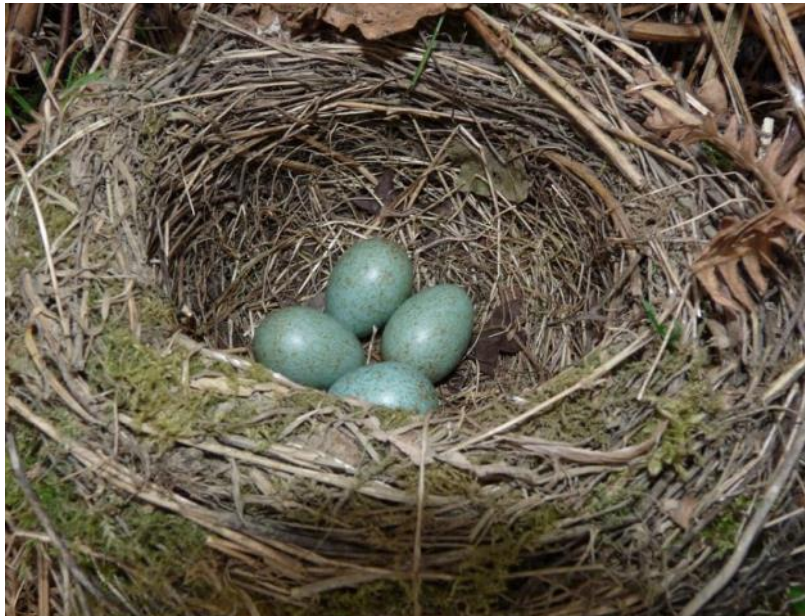
Control 4 : Timing and Survey

Timing : The site will be cleared outside of the bird nesting season (i.e. September-February, inclusive).

If nests are found, these will be demarcated on the ground and works will avoid them until birds have fledged or abandoned the nest. An ecologist inspection report will be produced before works continue.

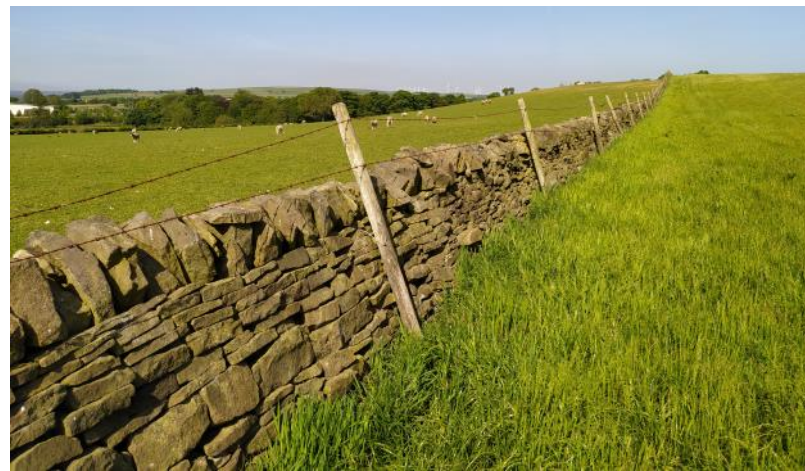
Control 5 : Safe removal of walls

Toolbox talk: Prior to the dry-stone walls being dismantled, the EcOW will carry out a toolbox-talk with the Site Manager and all contractors involved in the work. Contractors will be made aware of the risk of herpetofauna being present within the walls, and instructed to dismantle the walls with care and vigilance. Contractors will be provided with information guides on how to recognise common herpetofauna, and a protocol will be put in place, in the event that any amphibians are discovered (as described below).

Replacement shelter: Prior to works commencing, a single large (2m x 5m x 1m) rubble / log pile will be constructed in a suitable location along the southwest boundary, so as to avoid conflict with existing vegetation, and to blend in with new landscaping.

Safe practice of work: Should any herpetofauna be discovered sheltering within the drystone walls, these will be rescued by the contractor, and immediately released into the pre-constructed rubble log pile along the southern boundary. The EcOW will be kept aware of any herpetofauna that are discovered.
